INSPECTION REPORT

For the Property at:
1234 HOME
CENTRAL POINT, OR 97502

Prepared for: EXAMPLE REPORT
Inspection Date: Tuesday, May 16, 2017
Prepared by: Zach Macormic

Apex Home Inspection & Construction
120 Meadowbrook Dr
Central Point, OR 97502
541-821-3473

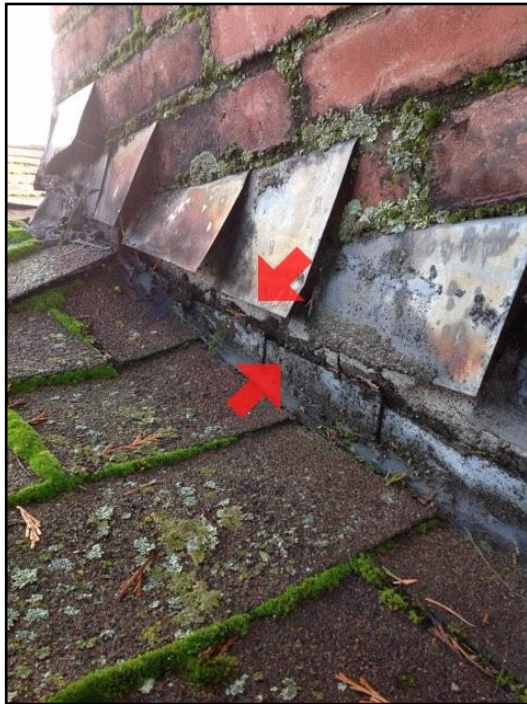
Condition: • Cap flashing too short

Chimney flashing and step flashing do not overlap. This will allow possible water penetration behind the step flashing and down into the attic space. I recommend having it properly flashed by a qualified roofer.

4. Cap flashing too short

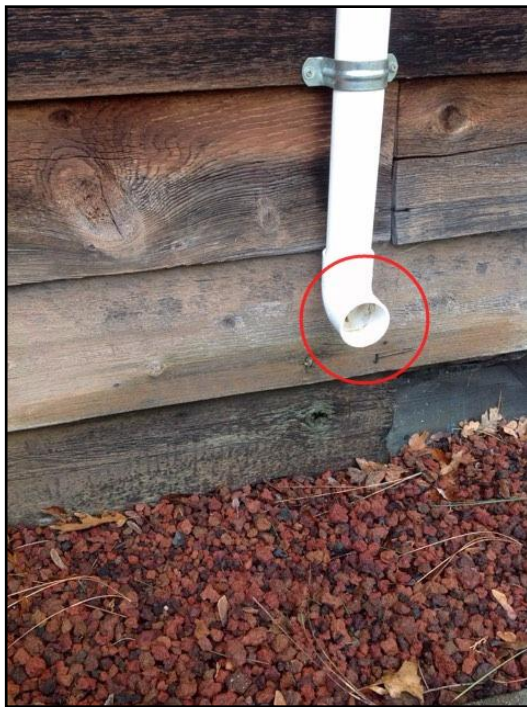
Condition: • Downspouts discharge too close to building

Gutters discharge too close to the house. This can invite water under the house and can lead to mold, rot, and soil deterioration. I recommend discharging downspout in a manner that prevents it from intruding under the home. This is the leading cause of the standing water under the home in my opinion.

7. Downspouts end too close to building

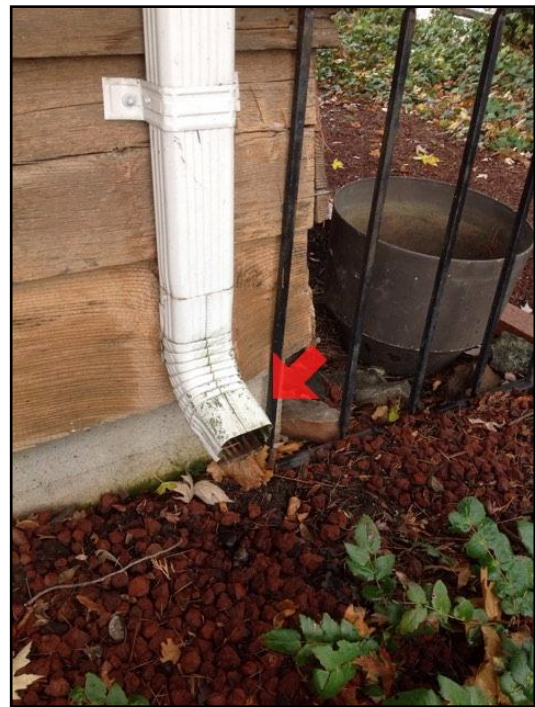
8. Downspouts end too close to building

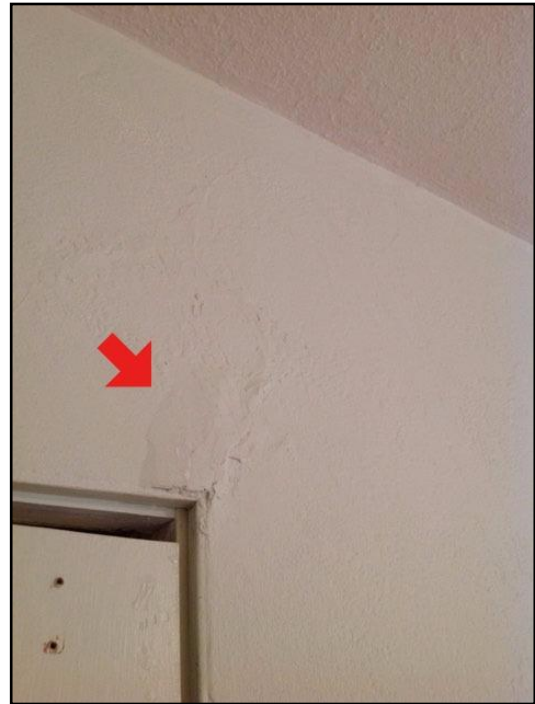
16. Settled

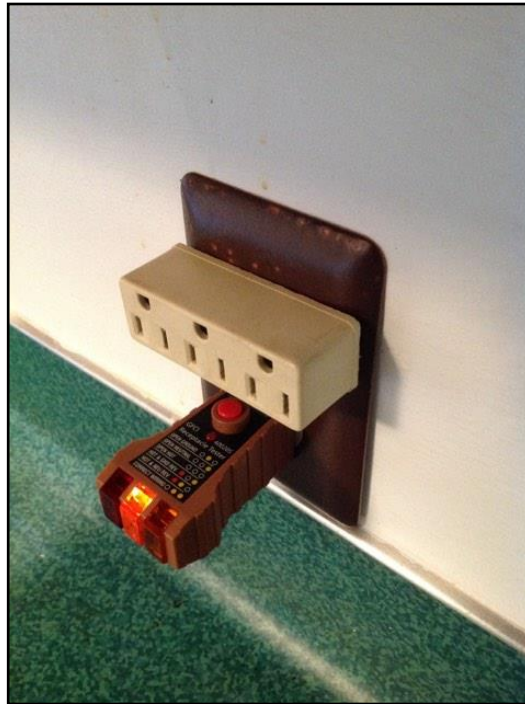
No GFCI outlets were noted in the kitchen or Bathrooms. Current building codes mandate that kitchens and bathrooms be protected by GFCI receptacles. I highly recommend Ground Fault Circuit Interrupters be installed by a qualified electrician to prevent possible electric shock.

27. No GFCI Outlet in Kitchen

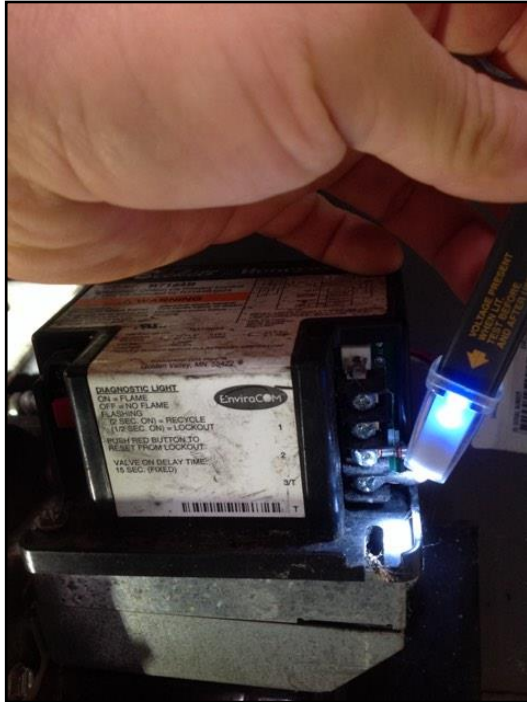
Oil furnace was not functioning when inspected. An indicator light was flashing that it was in Lockout mode. Power was live to it and the thermostat shows the heat to be on. This may be caused by low oil in the tank. I recommend filling with new oil and testing again. If that doesn't work, I recommend consulting a professional heating and air technician.

28. Inoperative

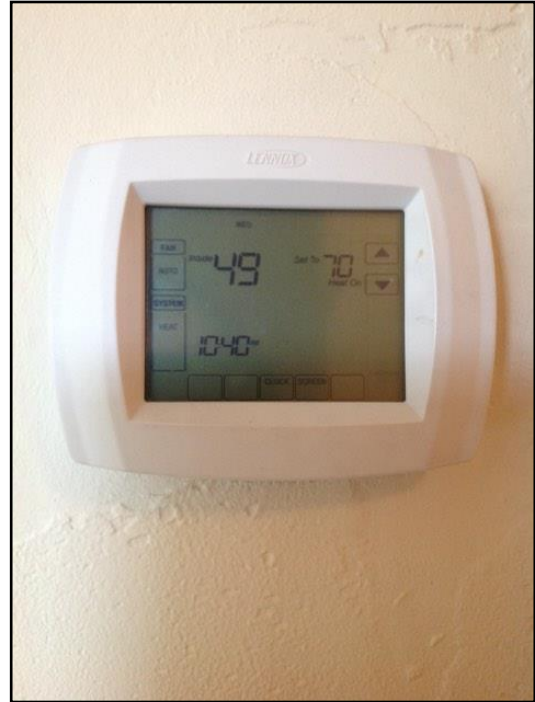
29. Inoperative

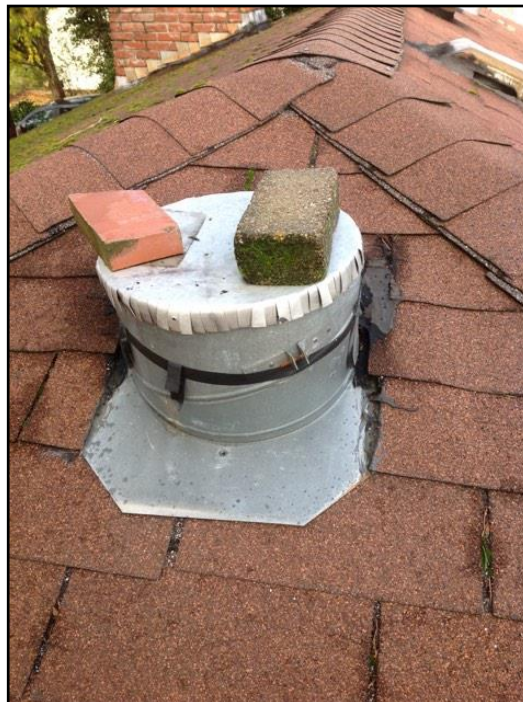
I noted to turbine style vents that were on the roof but not installed in their respective roof vents. I recommend proper re-installation to allow proper airflow to reduce energy costs and moisture.

30. Missing Vents

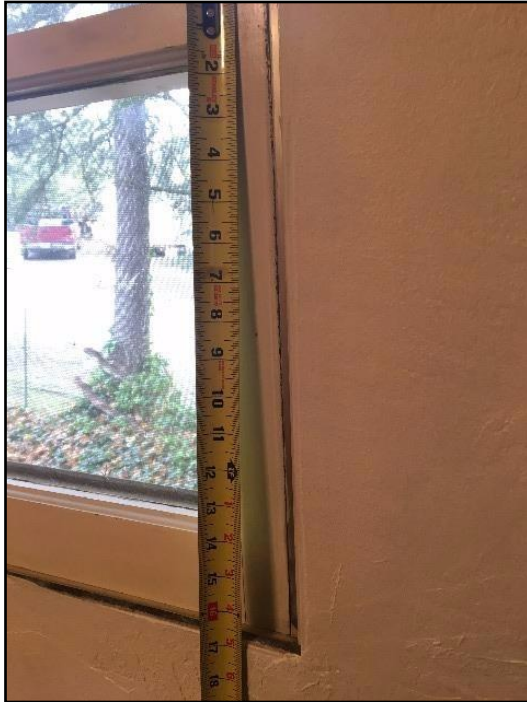
The South West bedroom and West bedroom do not meet current egress code for emergency exits. Current code requires egress in each bedroom. Code mandates the window be a maximum of 44" off the floor and the window shall have 5.7sqft of space to climb through. I recommend the installation of windows that meet egress to prevent a safety hazard.

31. Window height is too small

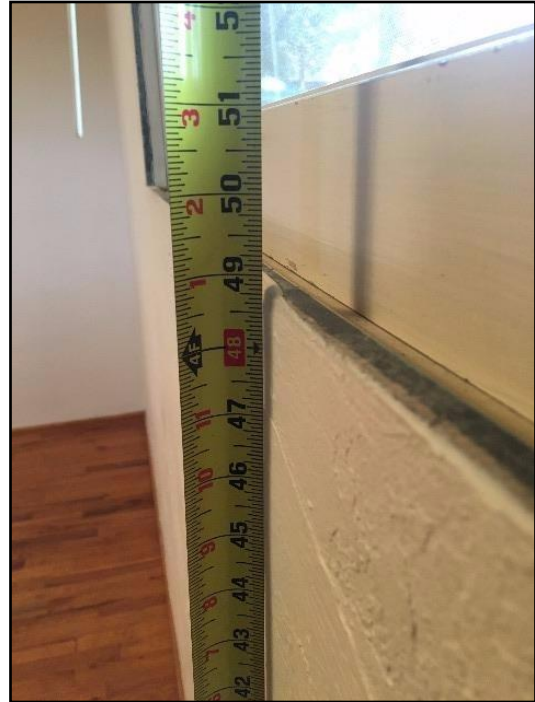
32. Sill is too high for egress

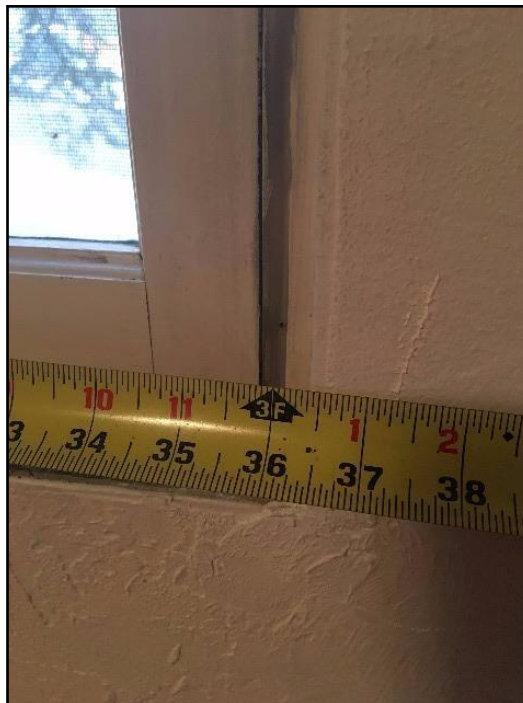
33. Window width

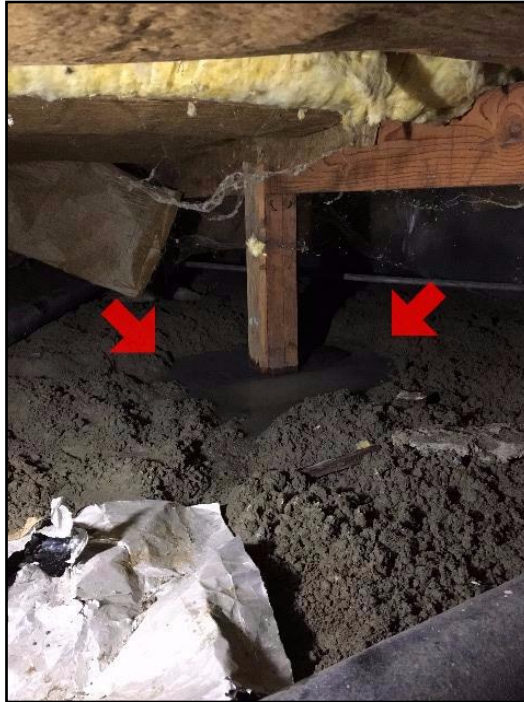
34. Settled

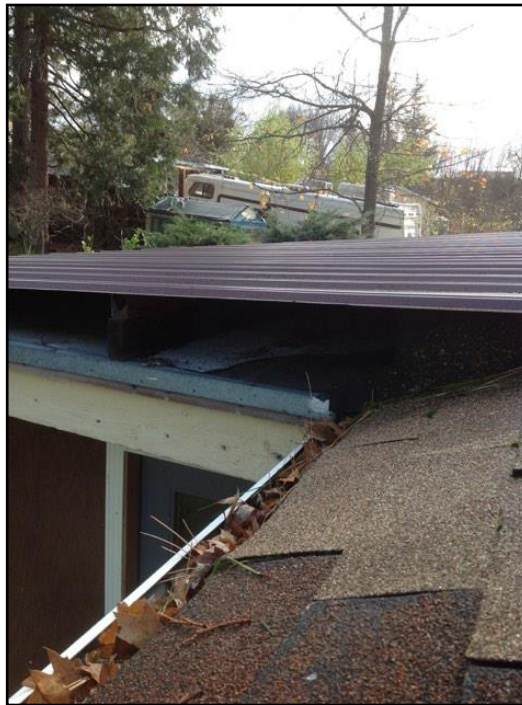
35.

General: • The Bonus room on the East side of the home has a roof built on top of a roof to allow for better drainage. It appears to be poorly constructed and I recommend keeping a watchful eye on it or improving it.

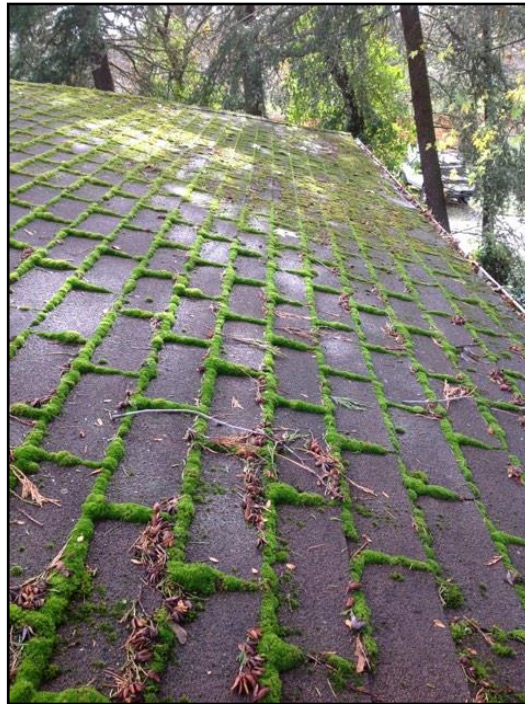
39. Moss Growth

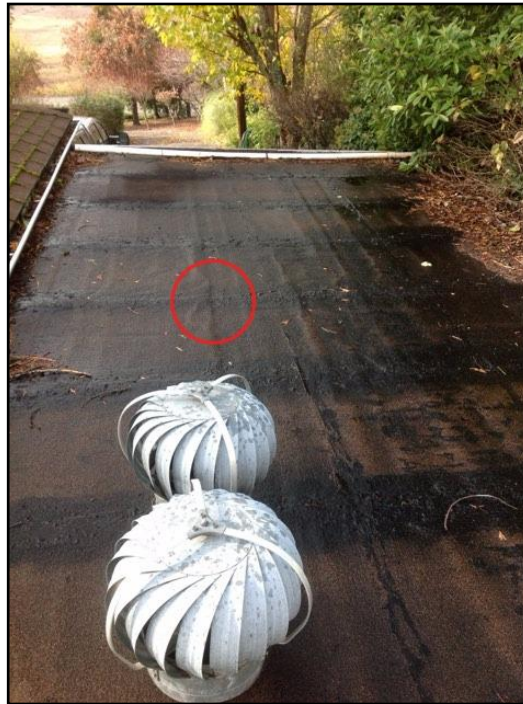
40. Leak

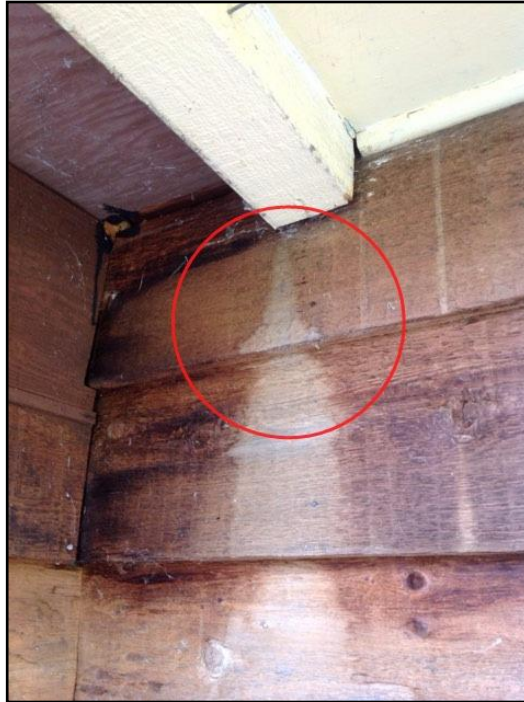
44. Leak

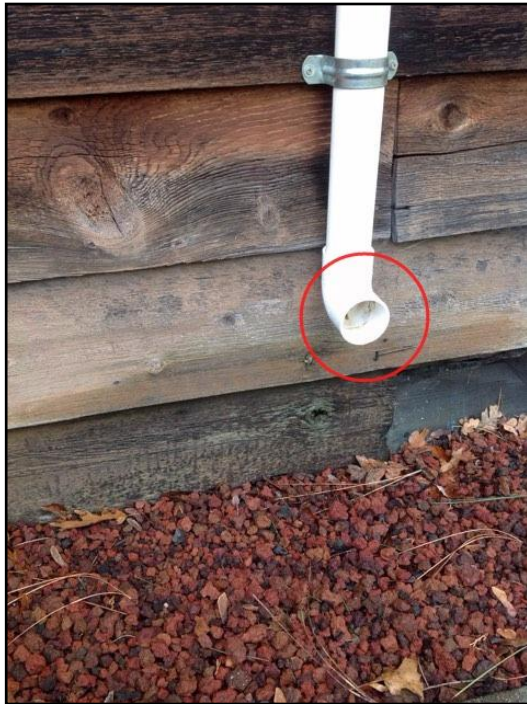
48. Downspouts end too close to building

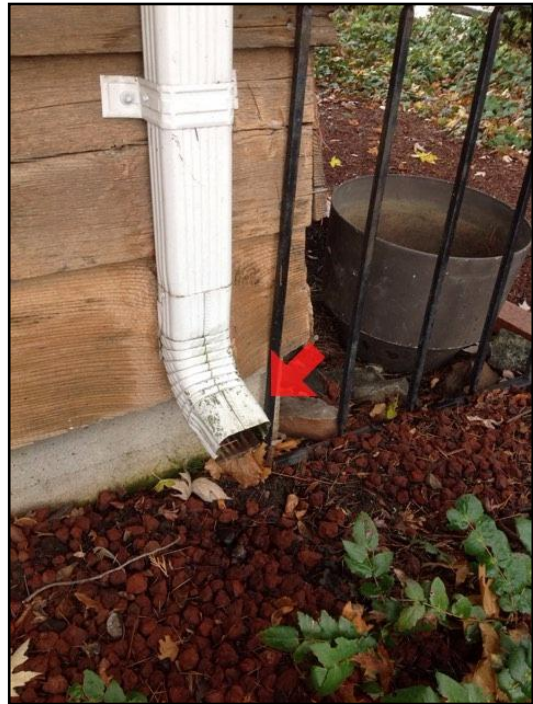
49. Downspouts end too close to building

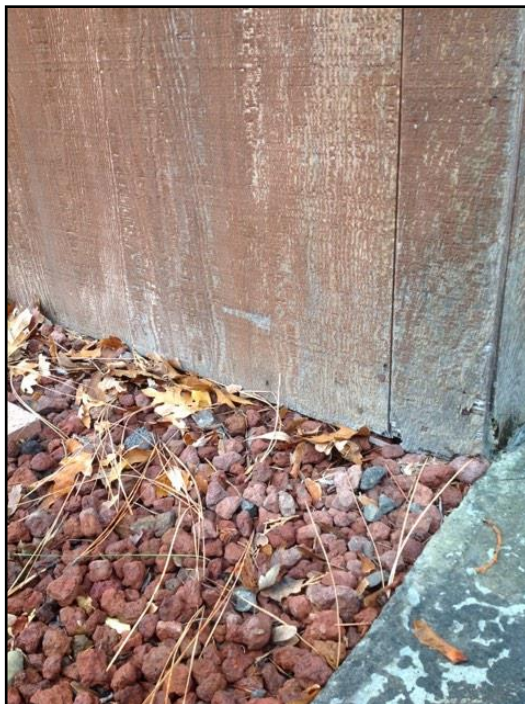
50. Too close to grade

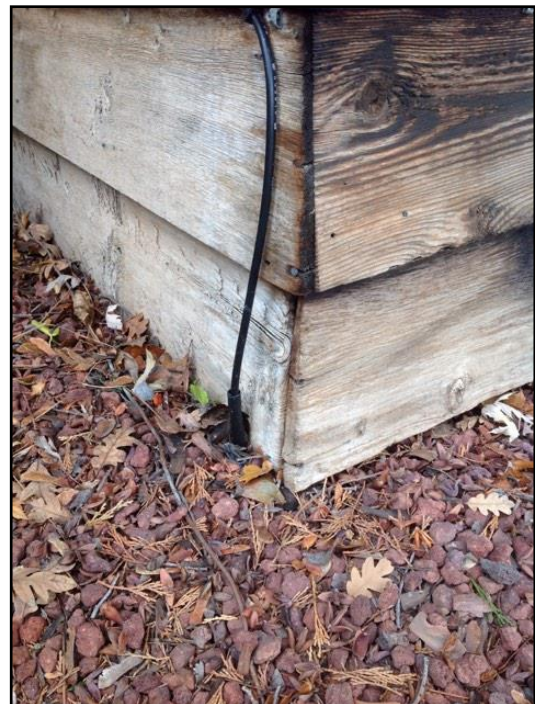
51. Siding too close to grade

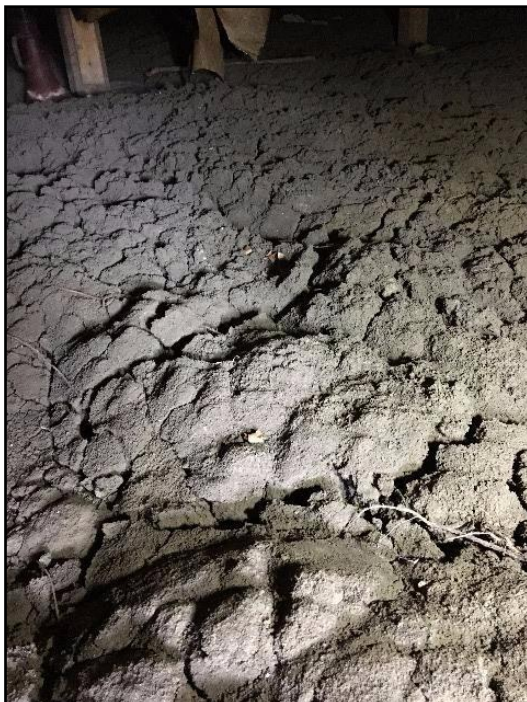
57.

19. Condition: • Expansive Soil Found

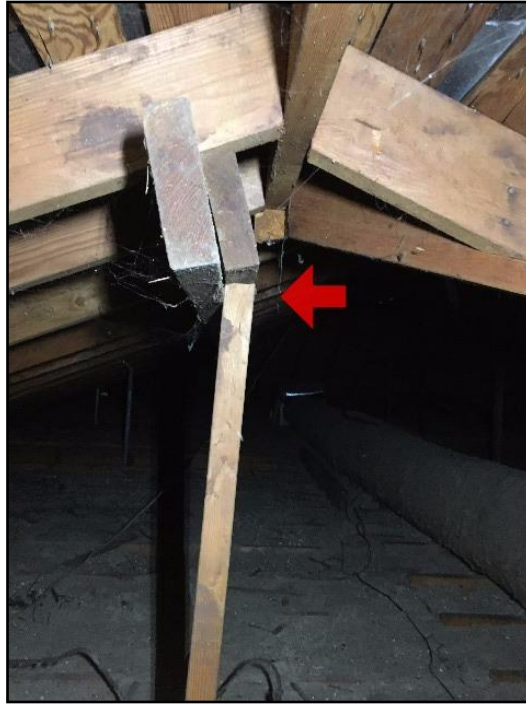
Poor purlin connection does not adequately transfer roof load. I recommend having a qualified builder re-install the purlin support correctly. This support may allow the roof to sag if not fixed.

74. Poor connections

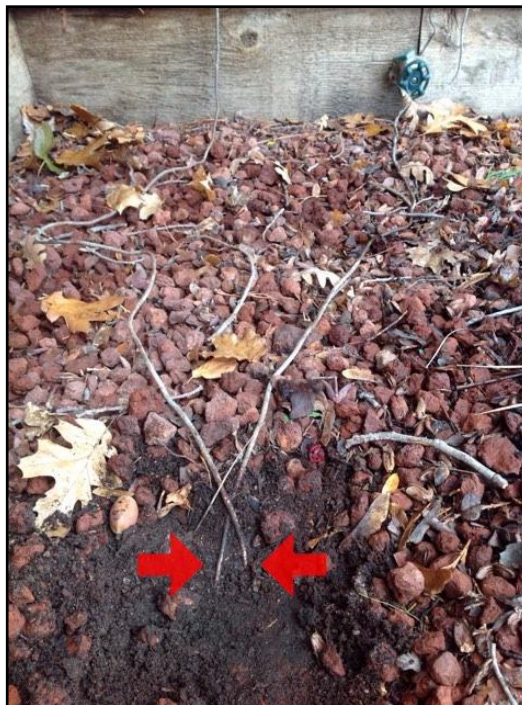
75. Copper - ground rods

I found two copper wires buried for a ground. One of the grounds is coming from the main service box. I assume a grounding rod has been driven deep into the soil, but I couldn't verify this.

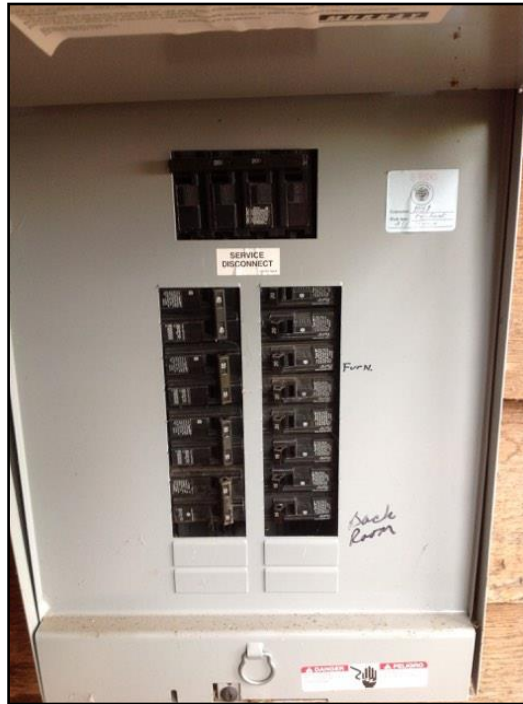
26. Condition: • Circuits not labeled

79. Circuits not labeled

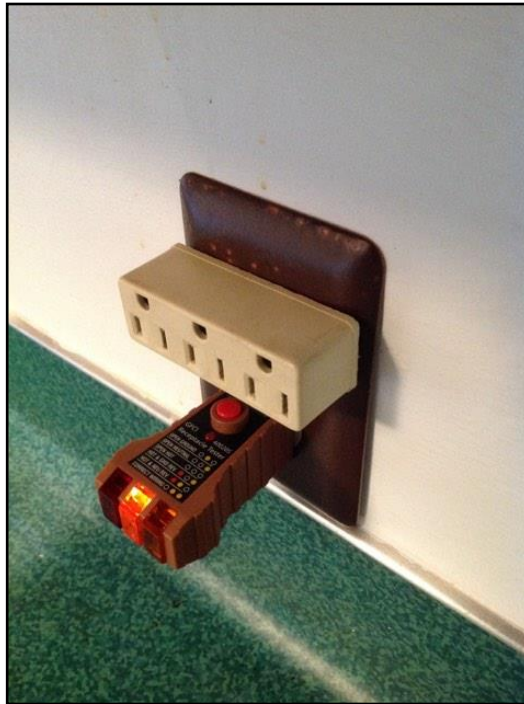
No GFCI outlets were noted in the kitchen or Bathrooms. Current building codes mandate that kitchens and bathrooms be protected by GFCI receptacles. I highly recommend Ground Fault Circuit Interrupters be installed by a qualified electrician to prevent possible electric shock.

82. No GFCI Outlet in Kitchen

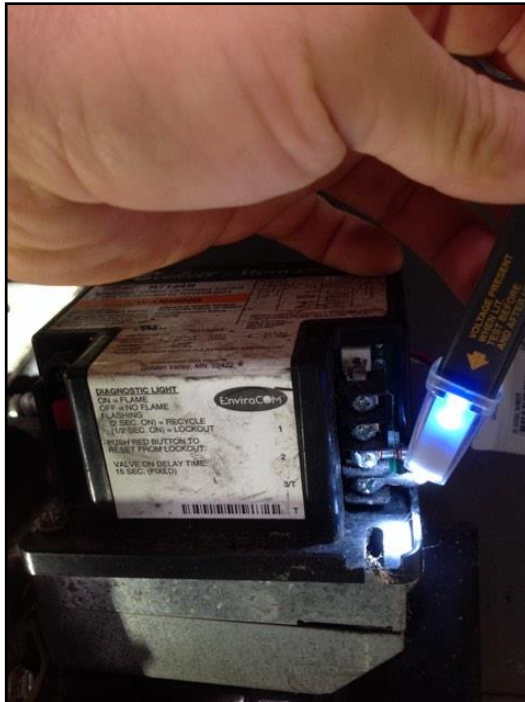
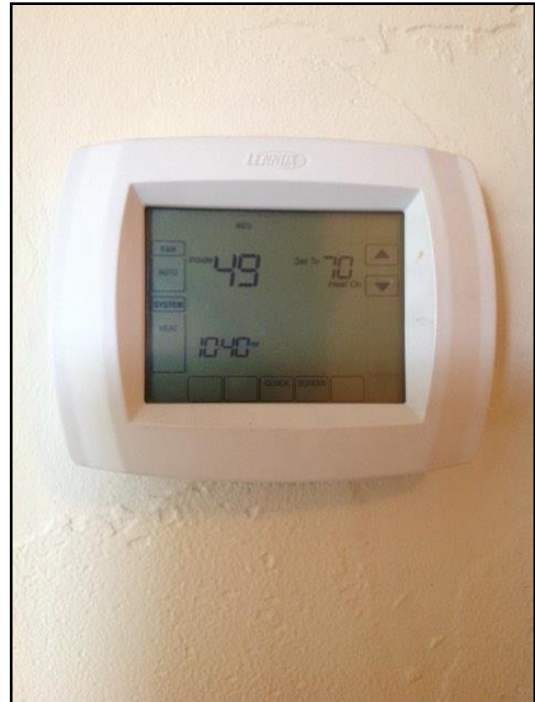
Oil furnace was not functioning when inspected. An indicator light was flashing that it was in Lockout mode. Power was live to it and the thermostat shows the heat to be on. This may be caused by low oil in the tank. I recommend filling with new oil and testing again. If that doesn't work, I recommend consulting a professional heating and air technician.

85. Inoperative

86. Inoperative

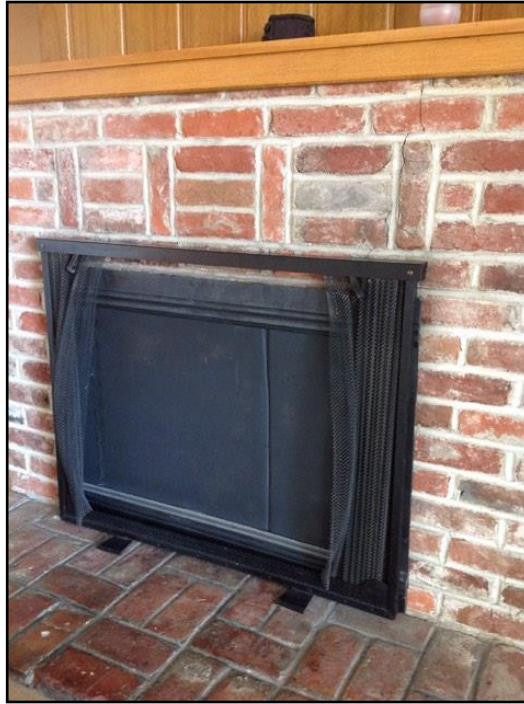
The chimney appears to not have been used in a while. Before the next use, I highly recommend having a professional inspect the flu for safety and proper use.

87. *Wood-burning fireplace - not in service*

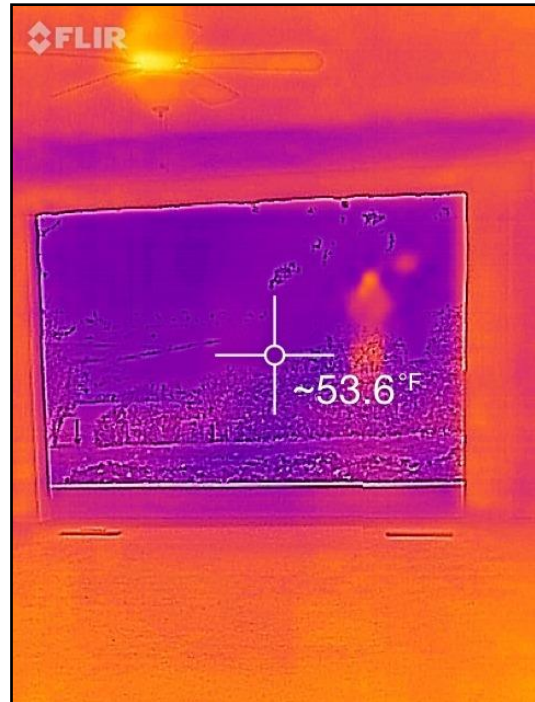
89. Window Unit

Air conditioning type: • Window Unit was tested for functionality and works

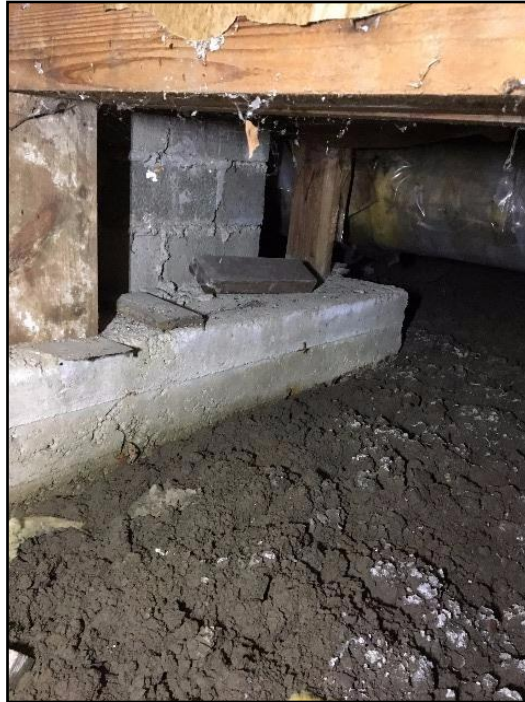
92. No vapor barrier

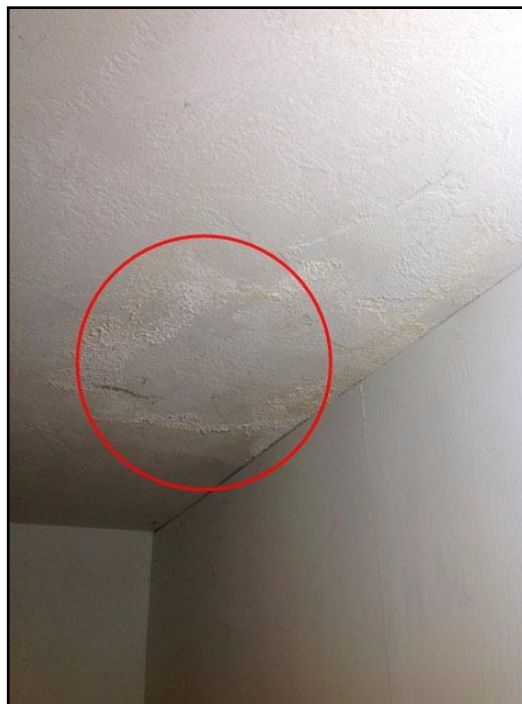
97. Water damage

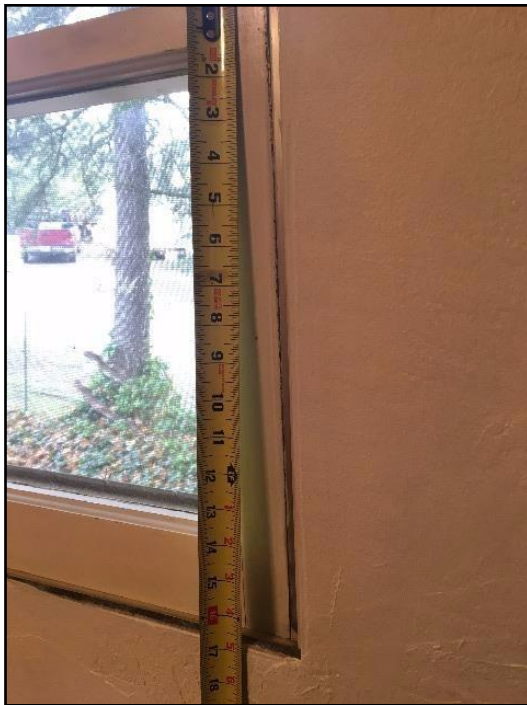
99. Window height is too small

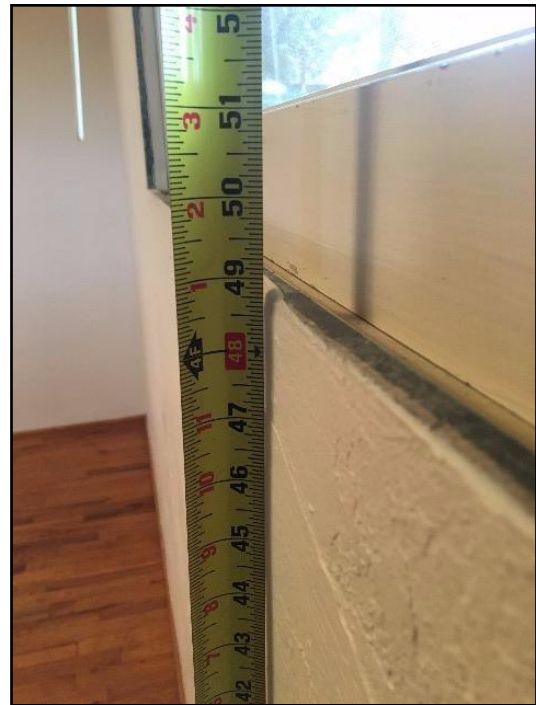
100. Sill is too high for egress
