INSPECTION REPORT

For the Property at:
123 YOUR STREET
NEW ORLEANS, LA 70118

Prepared for: SAMPLE COTTAGE
Inspection Date: Tuesday, November 28, 2023
Prepared by: Turk Schexnayder LHI Lic.10679

RE: Report No. 2572, v.3
123 Your Street
New Orleans, LA
70118

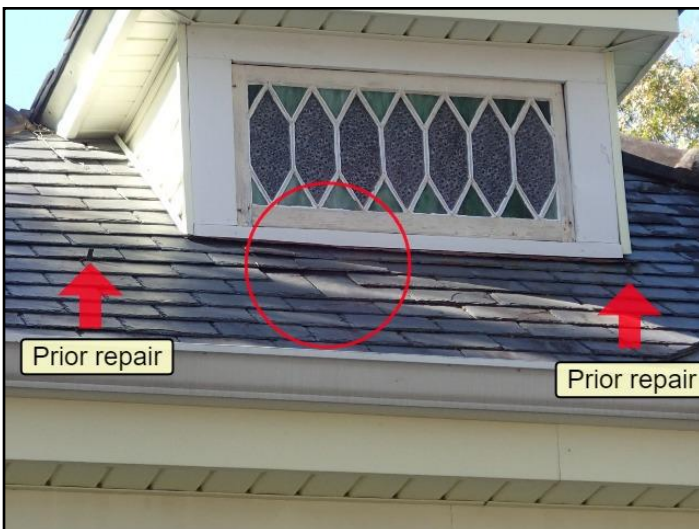
2. Condition: • The slate roof appeared mostly functional at the time of inspection with general maintenance recommended. Prior repairs and/or slipped slates were noted. The slate roof should be checked at least twice annually by a qualified roofing contractor and regular maintenance performed as needed to extend roof life and prevent leakage. The photos taken are intended to describe the roof issues and do not point out every deficiency.

Items noted at time of inspection were but are not limited to: Chipped/Slipped/Missing slate; Prior repairs and moss on roof noted; Torn or missing underlayment noted in attic; Plastic sheet secured to rafters on under side of roof. Broken deck plank noted. Prior repairs to other decking noted.

2. The slate roof appeared mostly functional a...

Task: Further evaluation by a qualified roofer.

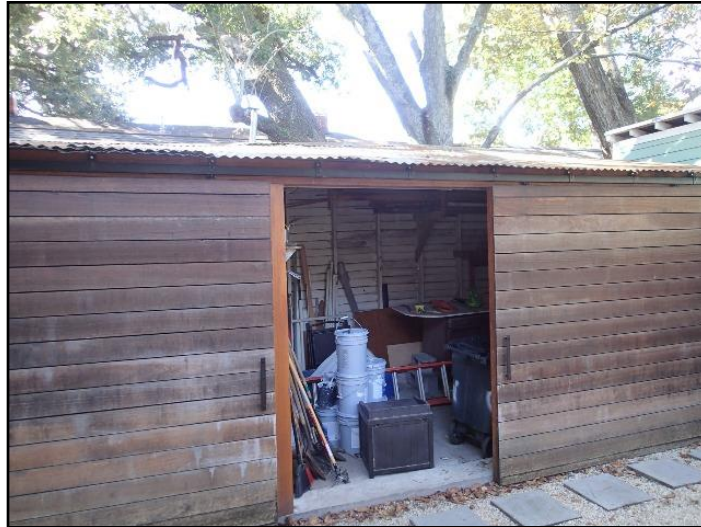
11. Exterior shed

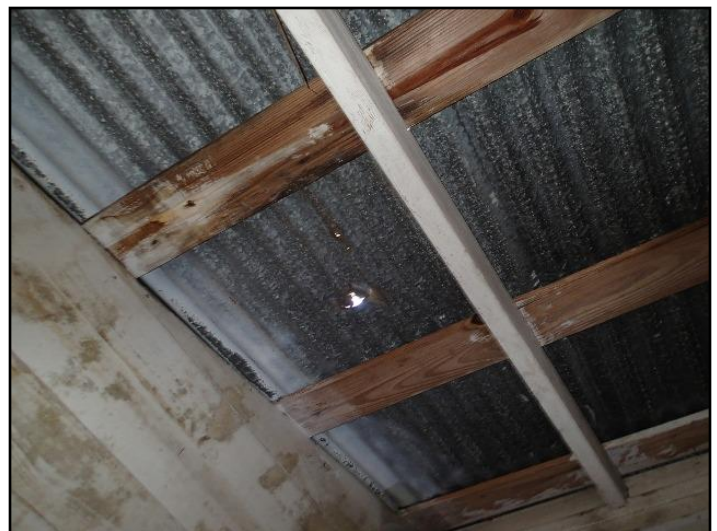
It is my opinion the rear shed had some minor issues. The trees growing behind the shed on the neighbors property is having a negative impact on the shed. The base of the trees and/or roots are cracking the concrete flooring and raising the framing. Cut framing at front above right side door should be repaired. There is a section of the roof on right that has a hole. Items on left side were draped in a tarp indicating the roof may be leaking. Personal items and / or storage prevented access to most areas inside shed. The water and gas lines into the shed should have been wrapped or sleeved to allow separation between pipes and concrete.

15. Hole in roof

Task: Repair as needed.

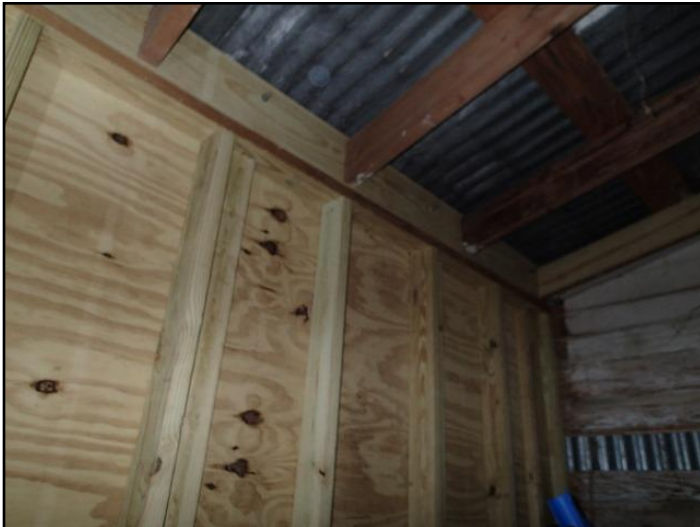
22. Rebuilt front left wall

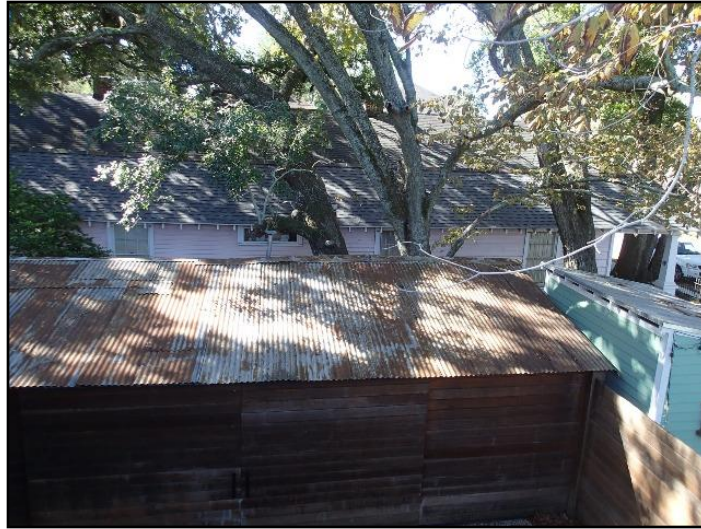
24. Raised section at tree

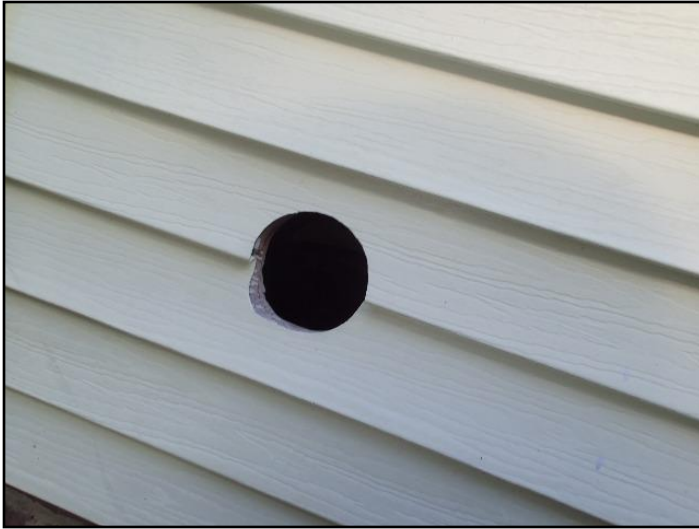
5. **Condition:** • Openings in siding should be sealed.

26. Opening in siding

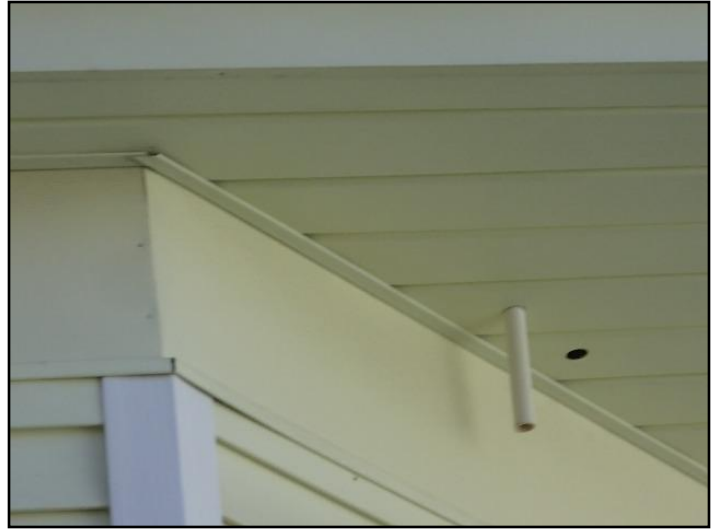
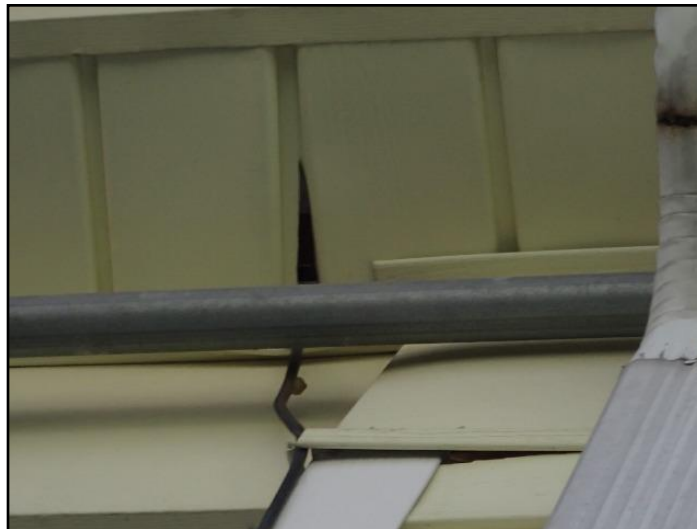
27. Opening in soffit

28. Opening in soffit

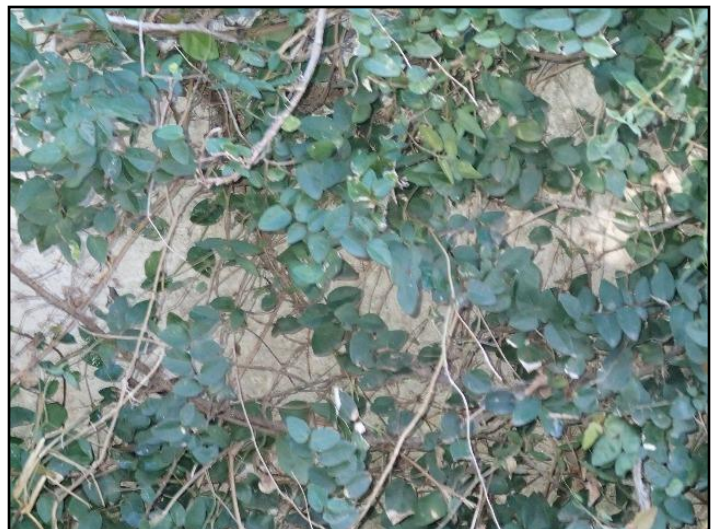
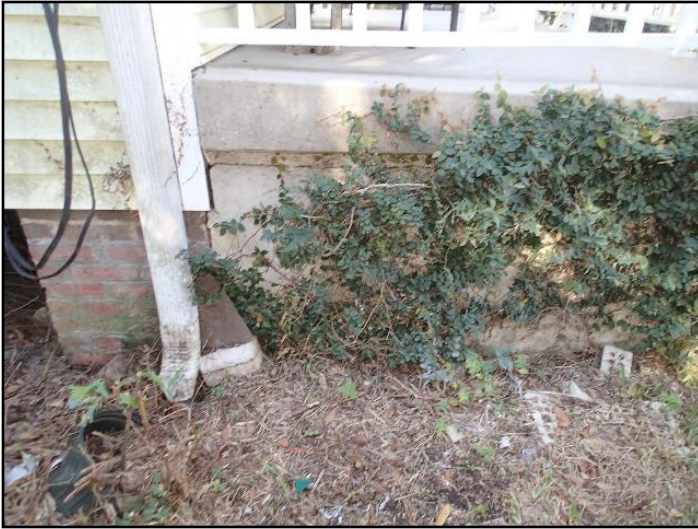
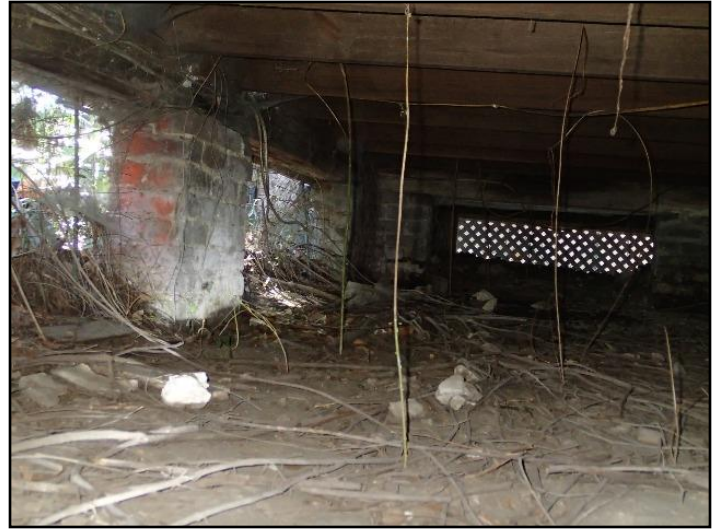
Vines on exterior masonry or wood. While masonry walls are more tolerant of vine damage than wood or siding, vines will facilitate insect and pest entry and moisture damage due to slow drying. Damage to mortar can also occur. Roots create the most serious mechanical damage. Wood trim is especially susceptible to rot caused by vines. Some people are prepared to live with the disadvantage of the plants due to the cosmetic effect, but the removal of vines on any exterior surface is recommended.

31. Vines

32. Vines

33. Vines in crawl space

Task: Remove vines to prevent material deterioration

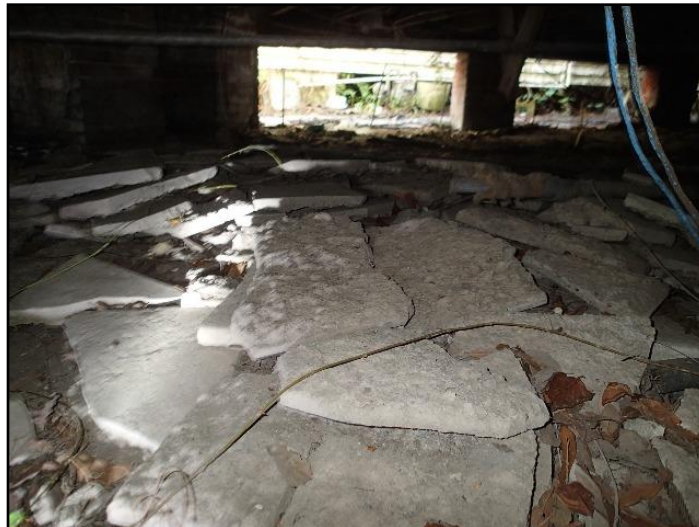
- Entered but access was limited
- Low height clearance and debris limited access.

36. *Low height clearance and debris limited...*

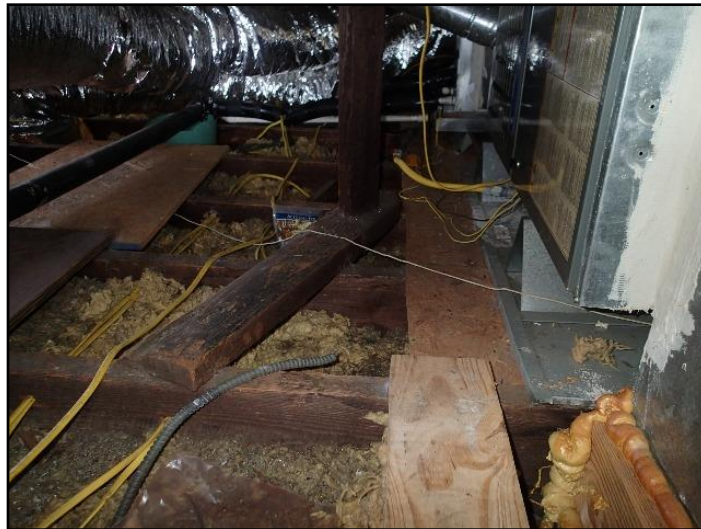
No flooring provided to reach and service furnace in attic.

55. No flooring for service.

Task: Install flooring in front of unit for service.

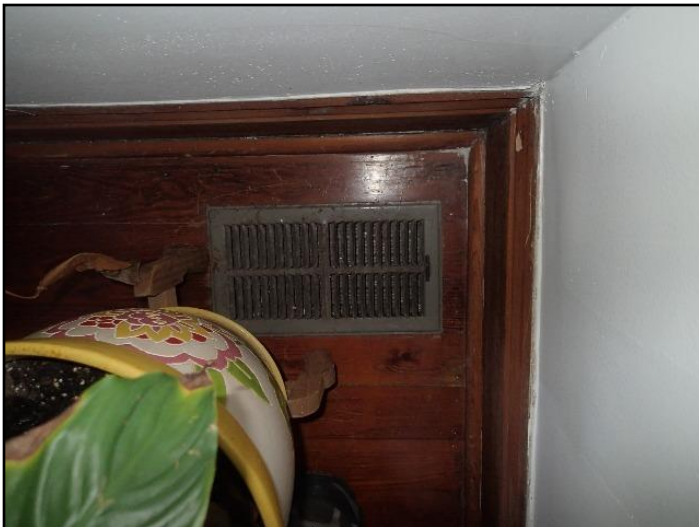
It appears the home AC ducts in the crawl space at some point. The existing registers that were installed in the floor were left in place and are not sealed from below but the damper appeared closed from the inside. More than one location exists, only one is pictured as an example.

63. Abandoned register

Task: This is an observation only.

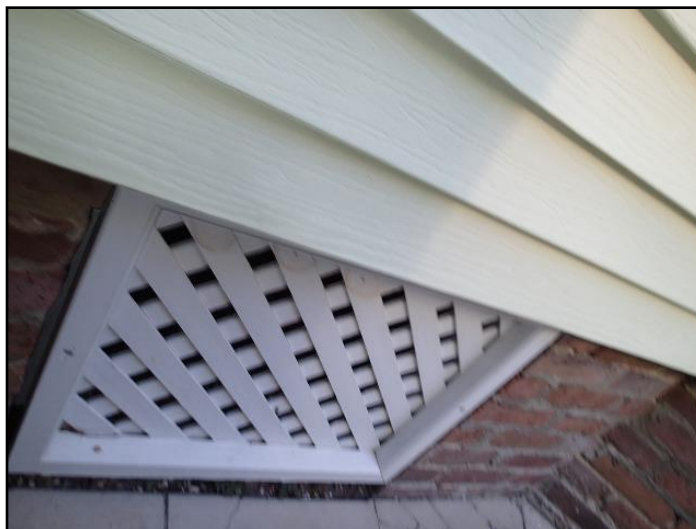
68. Lattice or barrier preventing access.

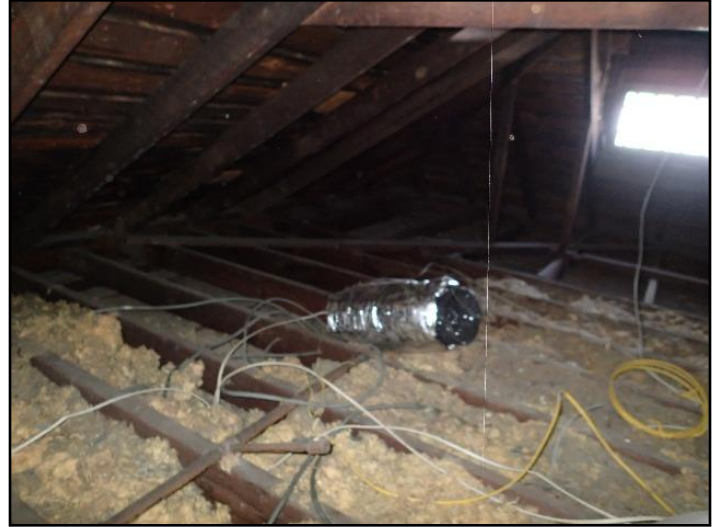
70. *Gaps or voids*

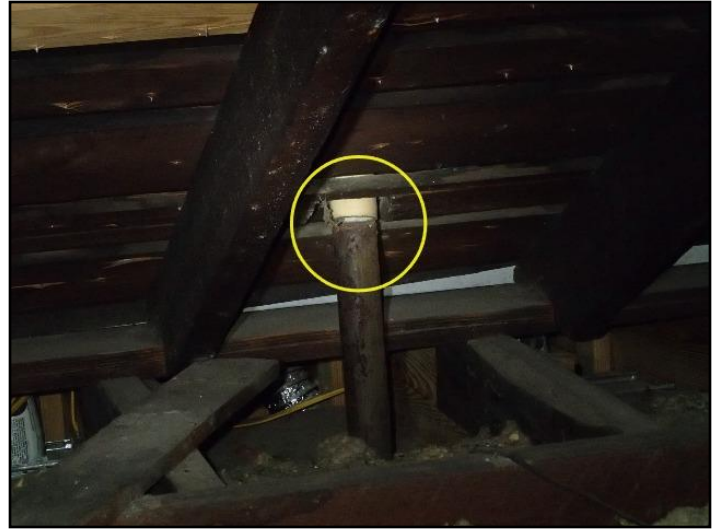
40. Condition: • [Vent termination problems](#)

82. Not connected in attic

Task: Repair by a licensed plumber

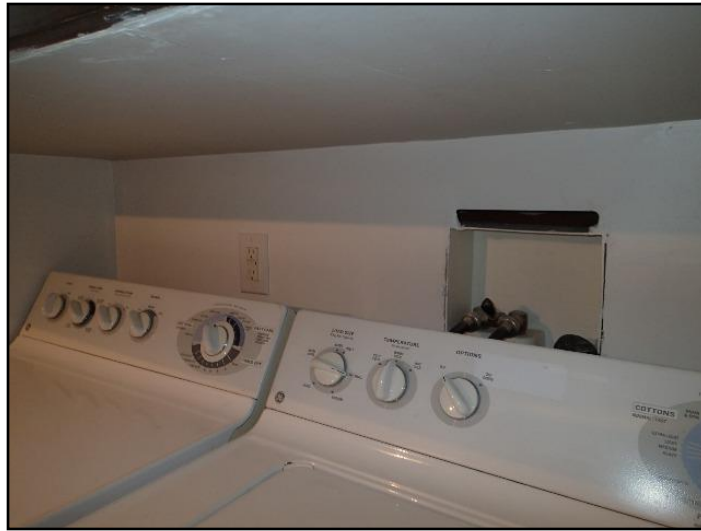
• Washer and dryer not tested

Units were unplugged. Turning on or plugging in appliances that are unplugged are beyond the scope of a home inspection.

85. Washer and dryer unplugged

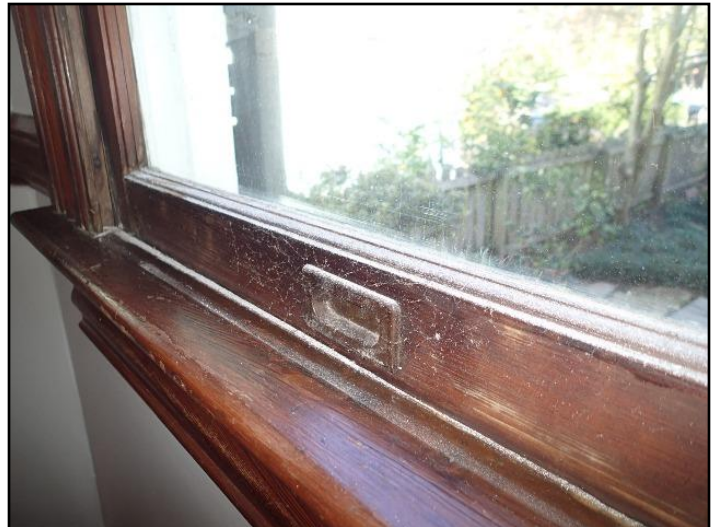
92. Insert installed

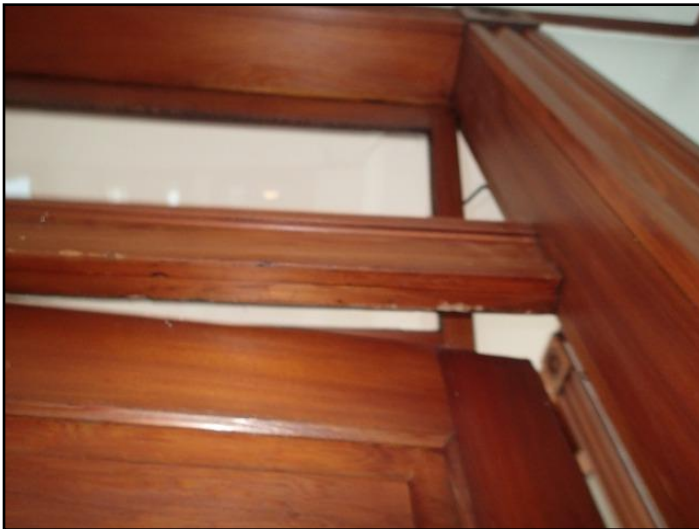
Implication(s): Reduced operability

95. Stiff / Poor fit / Unable to open or close

Task: Adjust doors as needed.
