YOUR Inspection Report

123 Address Ave.
Your town, MA 01519

Tuesday, February 26, 2019

RE: Report No. 1056, v.2
123 Address Ave.
Your town, MA
01519

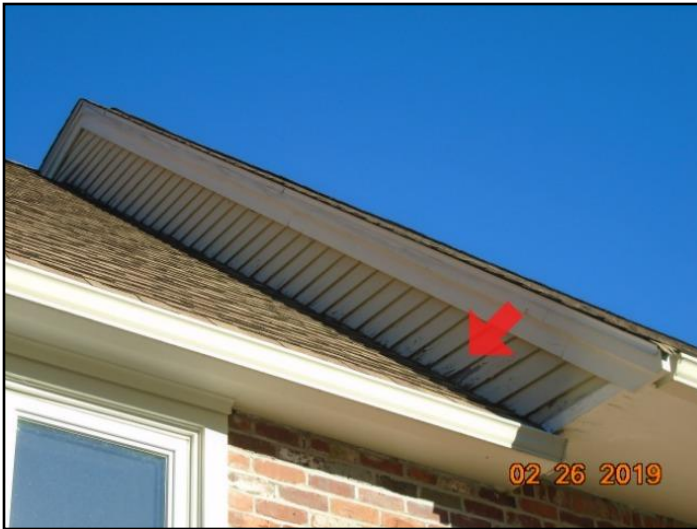
6. Scrape, prime, and paint

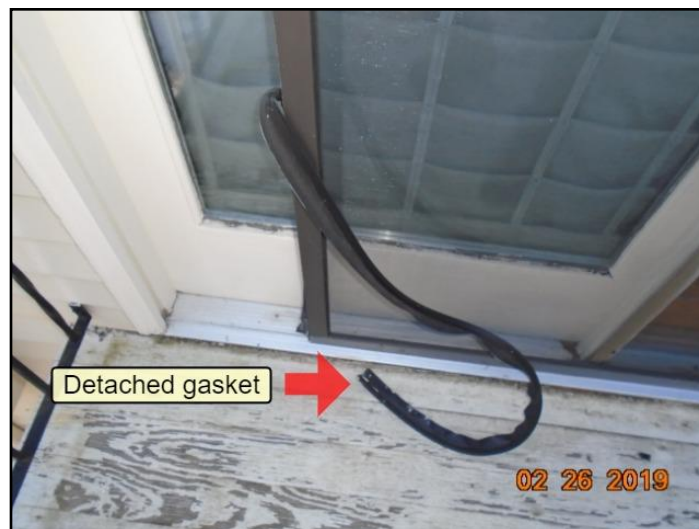
16. Screen door/balcony

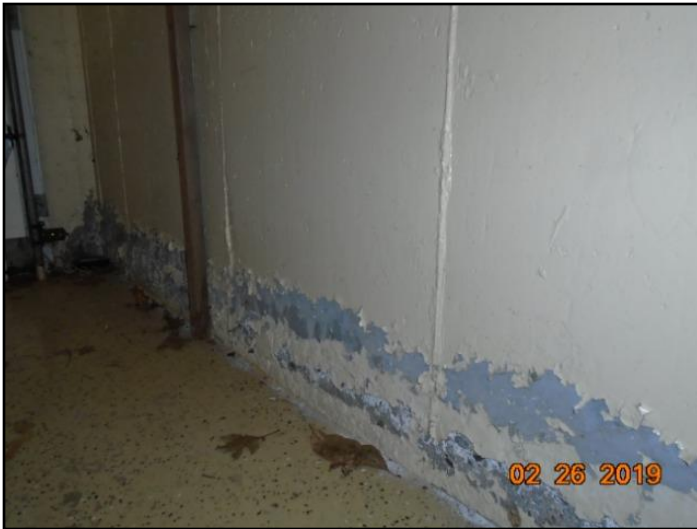
22. Condition: • Damage to concrete possibly by washing salt off cars in garage.

27. Scrape, prime, and seal concrete

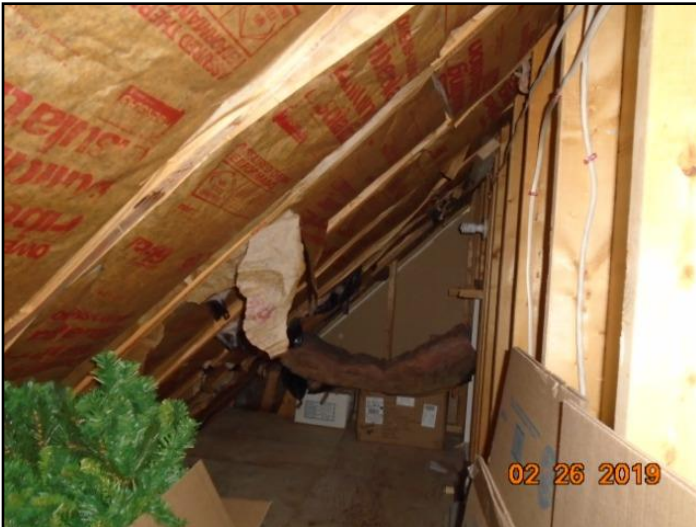
31. Closet view of roof

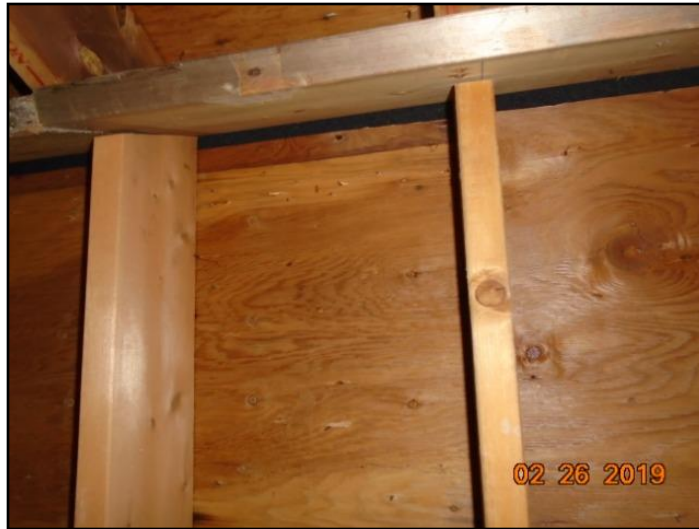
31. Condition: • Minimal amount of roof framing exposed.

33. Amount viewed satisfactory

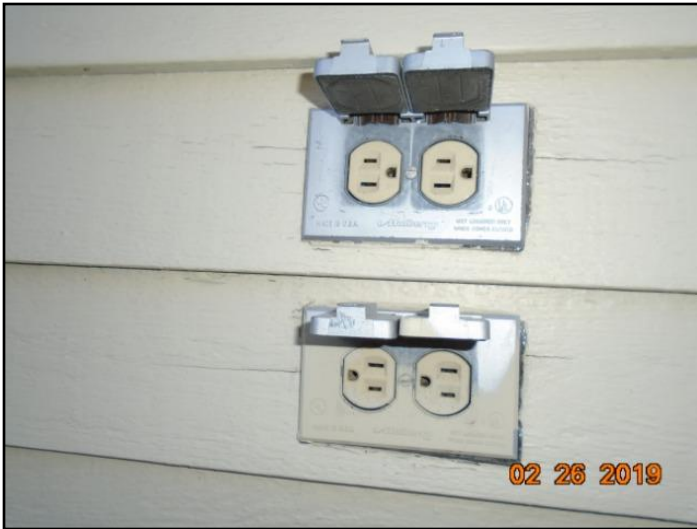
35. No GFCI location determined

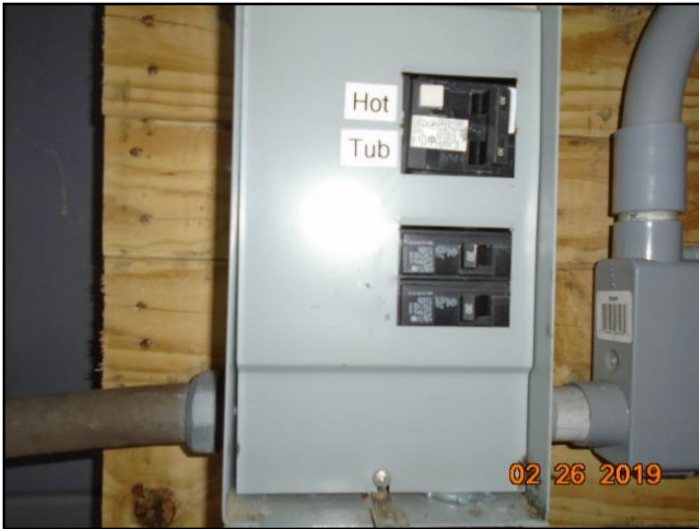
42. Breakers/Hot tub under deck

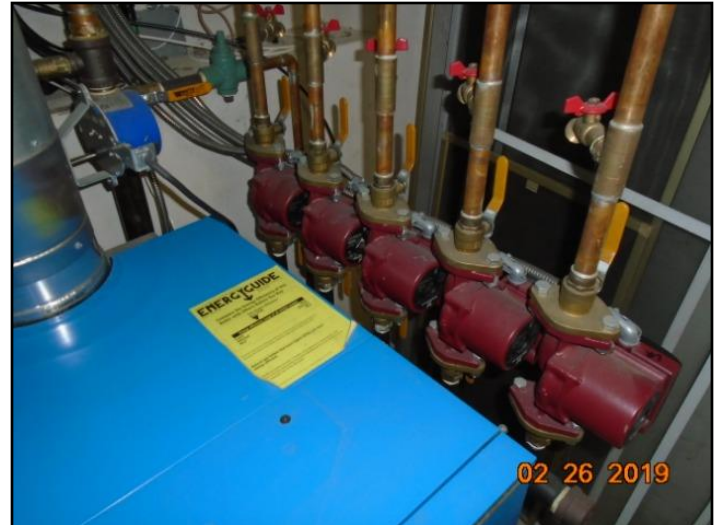
42. Condition: • Gas boilers and furnaces should be serviced every 6-8 years for proper efficiency.

44. Service regularly for maximum efficiency

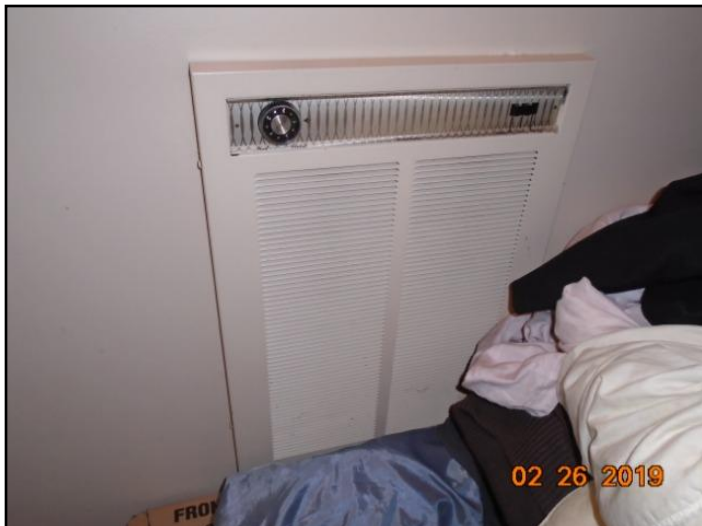
51. Inoperative

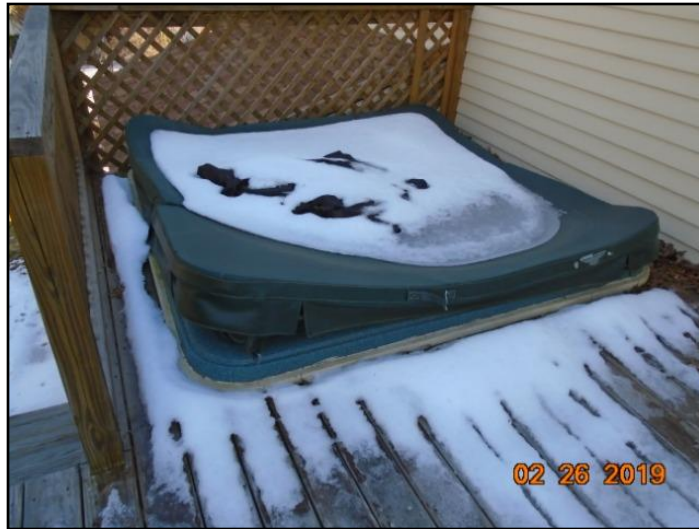
65. Hot tub on back deck out of service

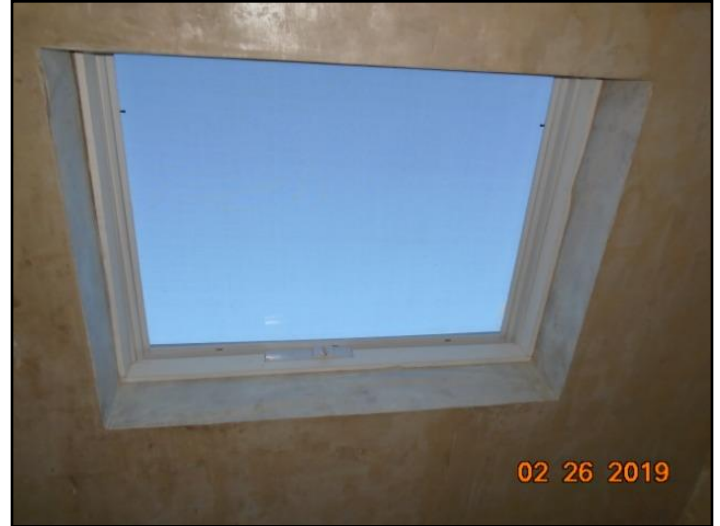
69. INSPECTED/new skylights

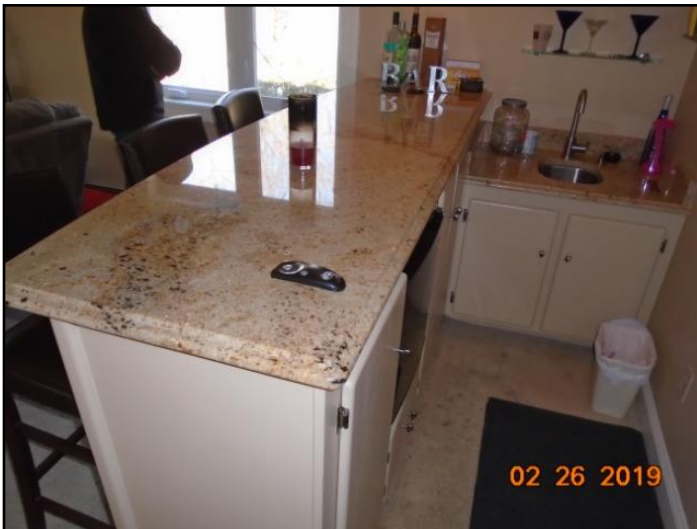
76. INSPECTED

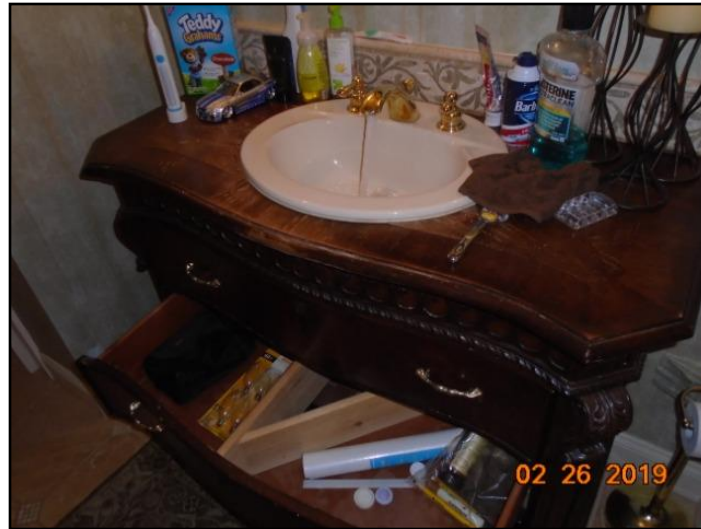
78. INSPECTED

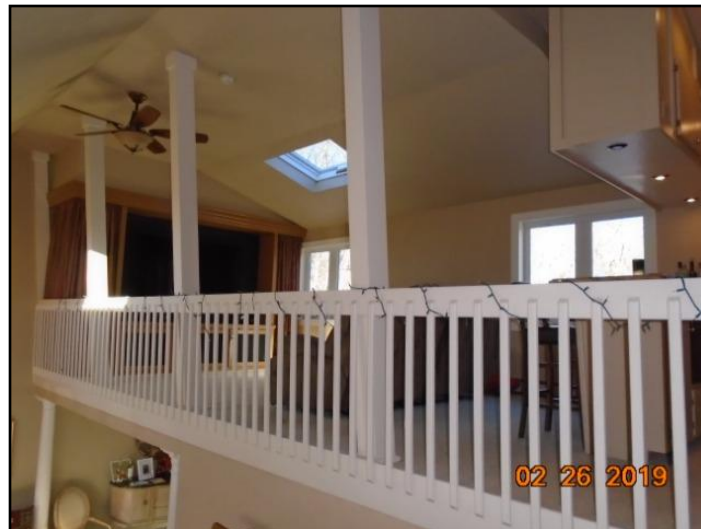
79. INSPECTED
