PROPERTY CONDITION ASSESSMENT REPORT

FOR THE PROPERTY AT:
123 Main Street
Medicine Hat, AB T1A 5P6

INSPECTION DATE:
Friday, January 1, 2021

RE: Report No. 1082, v.5
123 Main Street
Medicine Hat, AB
T1A 5P6

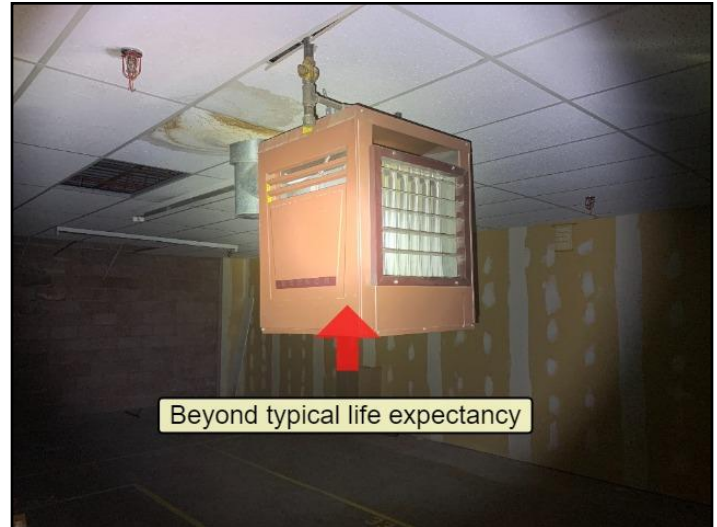
4. Beyond typical life expectancy

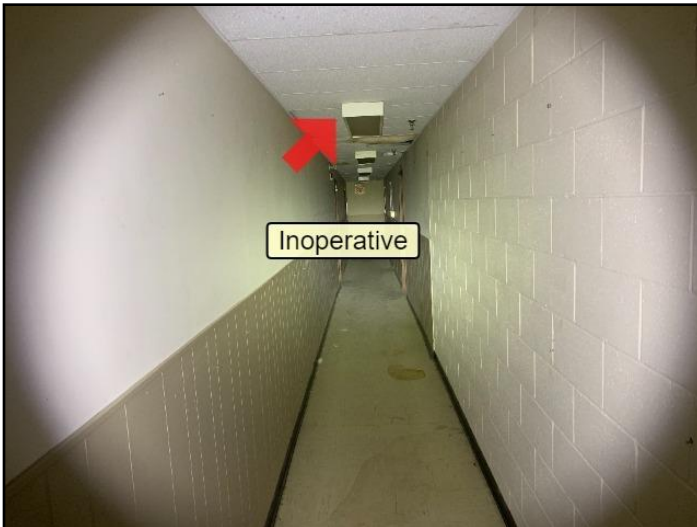
19. Inoperative

Cost: \$12,000 - \$15,000

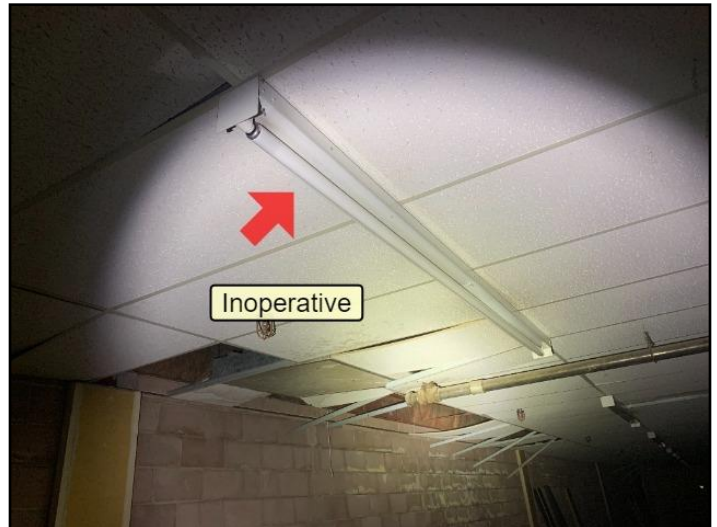
20. Inoperative

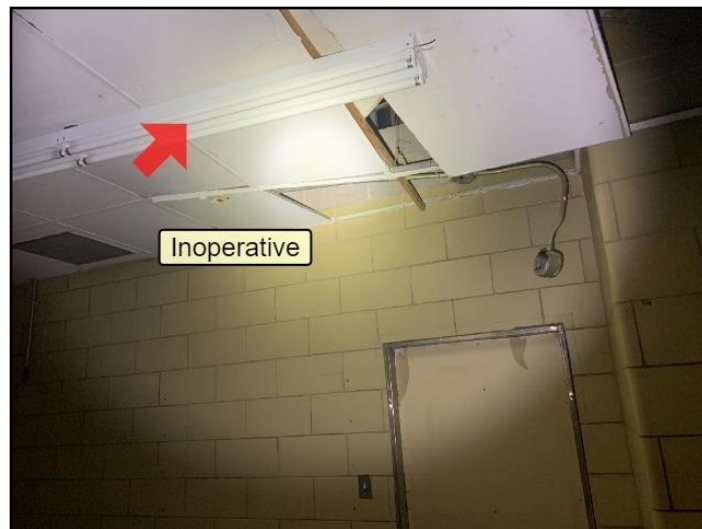
21. Inoperative

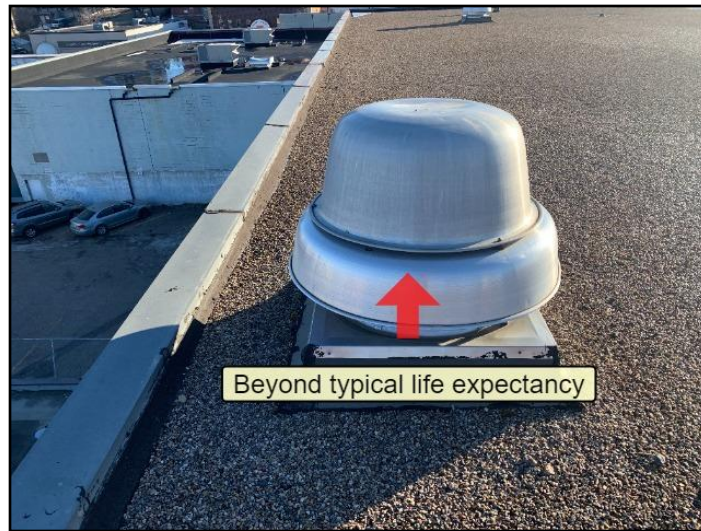
36. *Beyond typical life expectancy*

\$12,000 Replace roof top exhaust fans

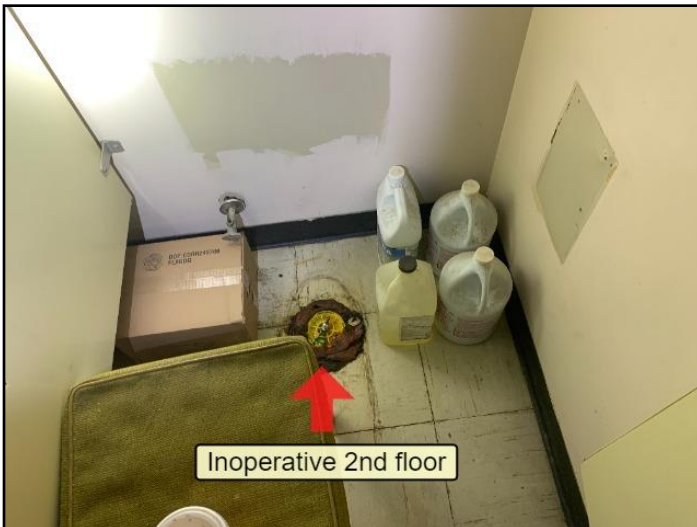
42. Inoperative 2nd floor

Cost: \$7,000 - \$9,000

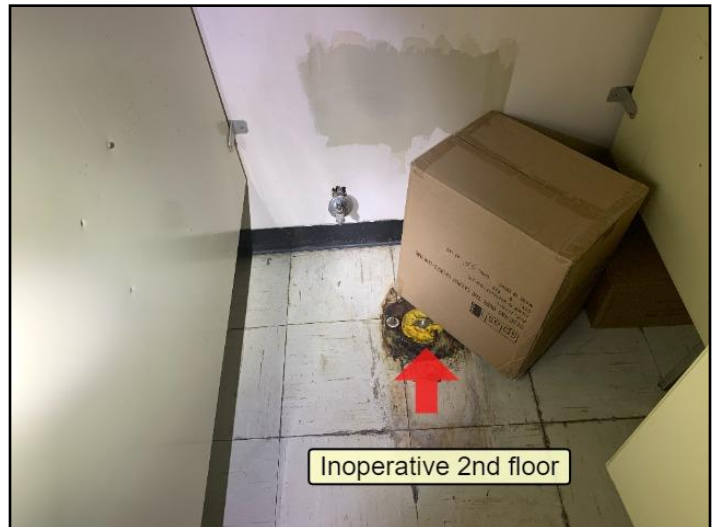
43. Inoperative 2nd floor

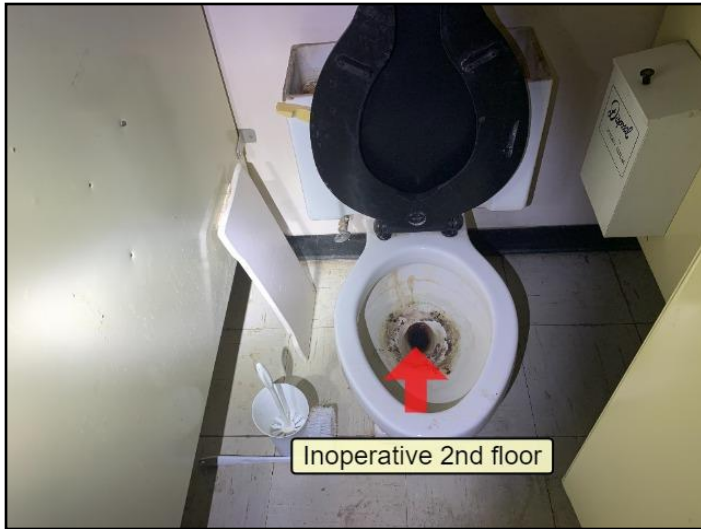
44. Inoperative 2nd floor

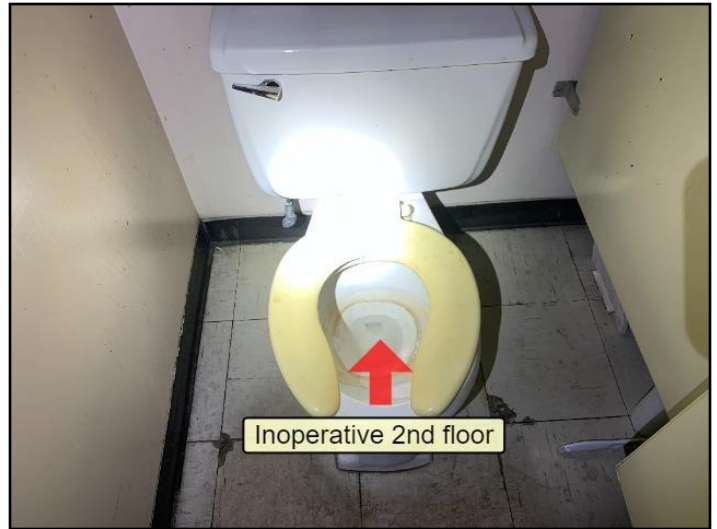
45. Inoperative 2nd floor

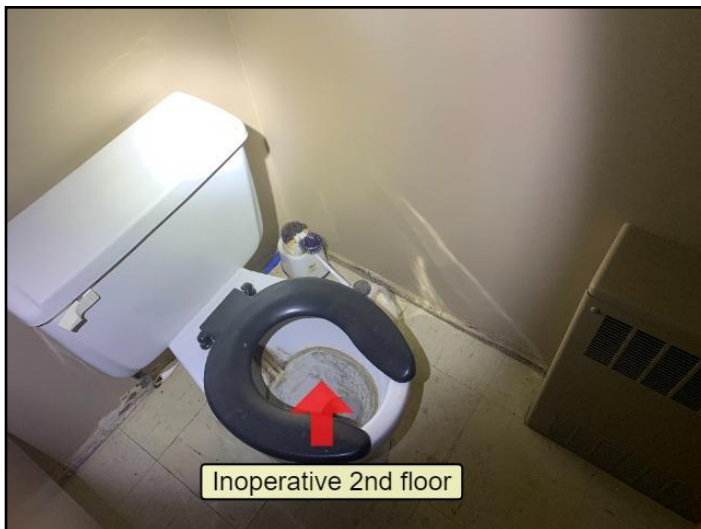
46. Inoperative 2nd floor

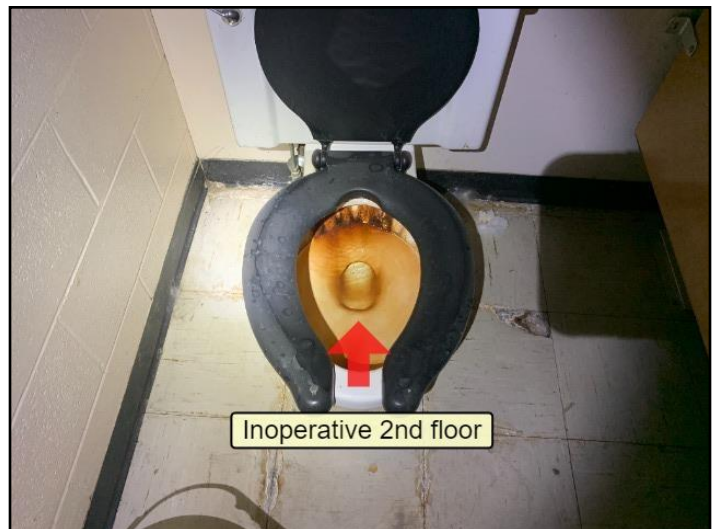
47. Inoperative 2nd floor

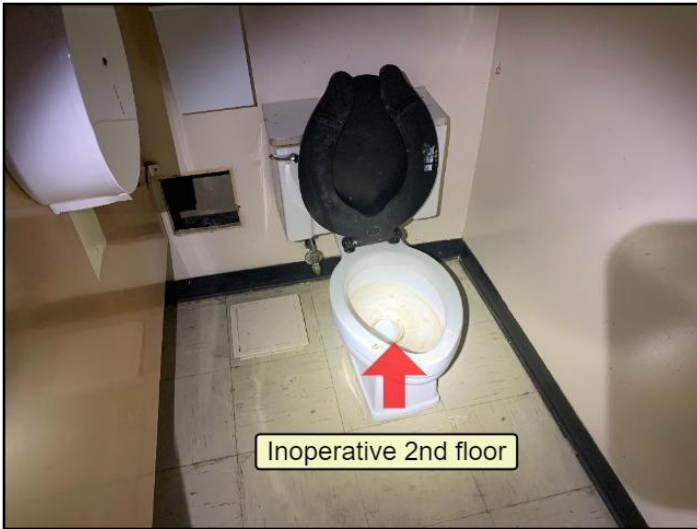
48. Inoperative 2nd floor

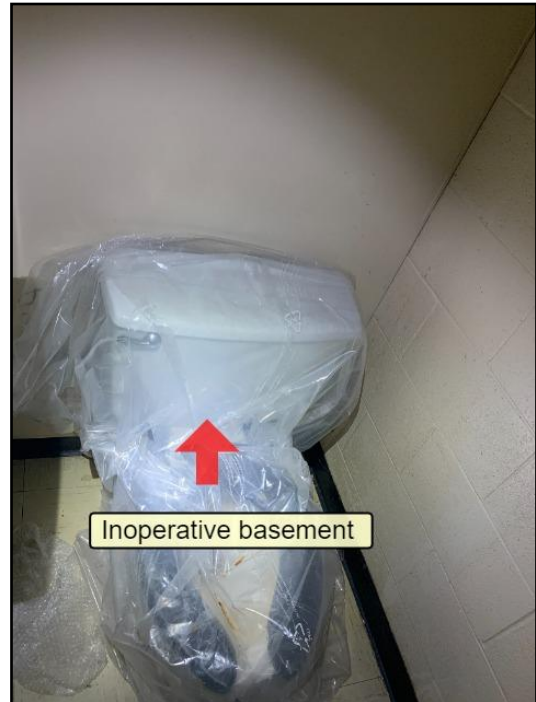
49. Inoperative basement

44. Condition: • Inoperative

Task: Replace

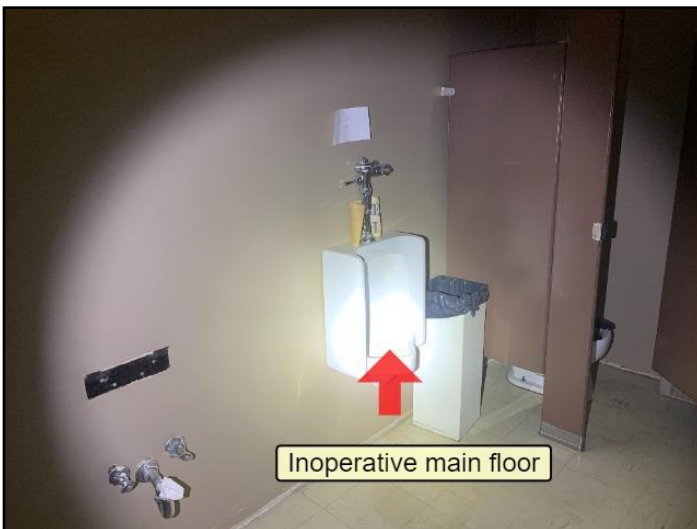
50. Inoperative main floor

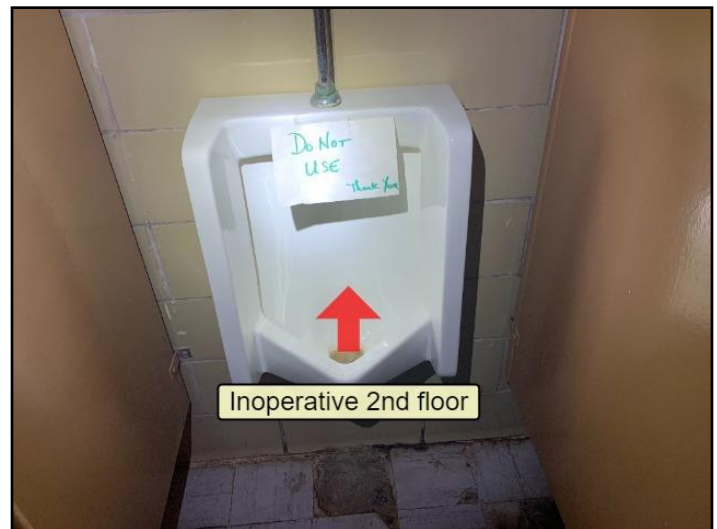
51. Inoperative 2nd floor

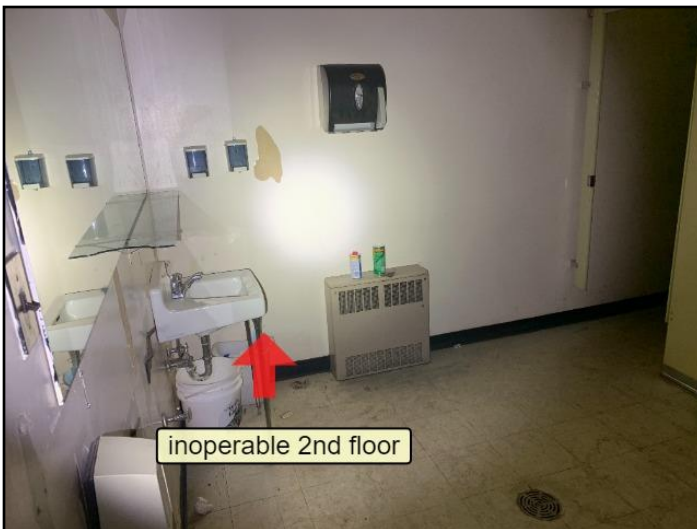
45. Condition: • Inoperable

52. Inoperable 2nd floor

Task: Replace

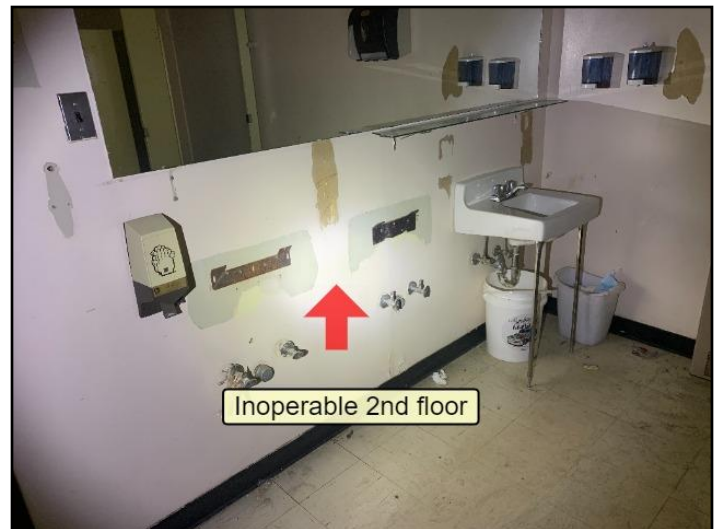
53. Inoperable 2nd floor

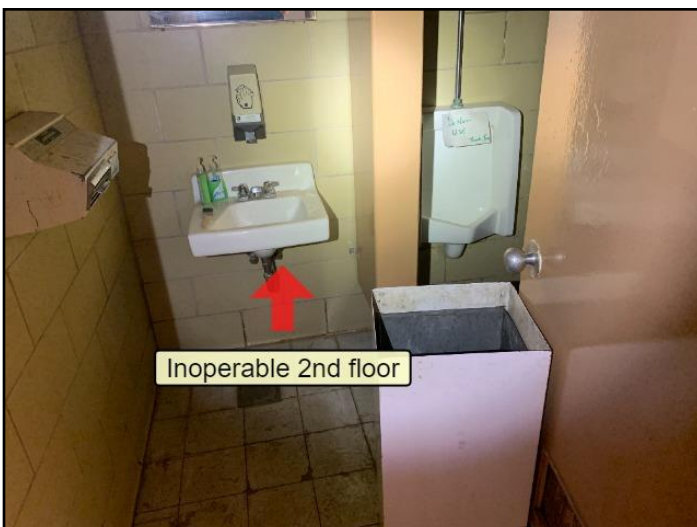
54. Inoperable 2nd floor

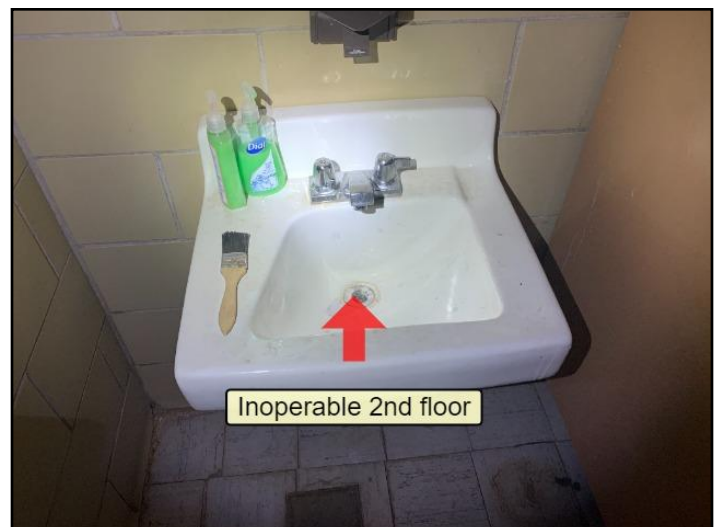
55. Inoperable 2nd floor

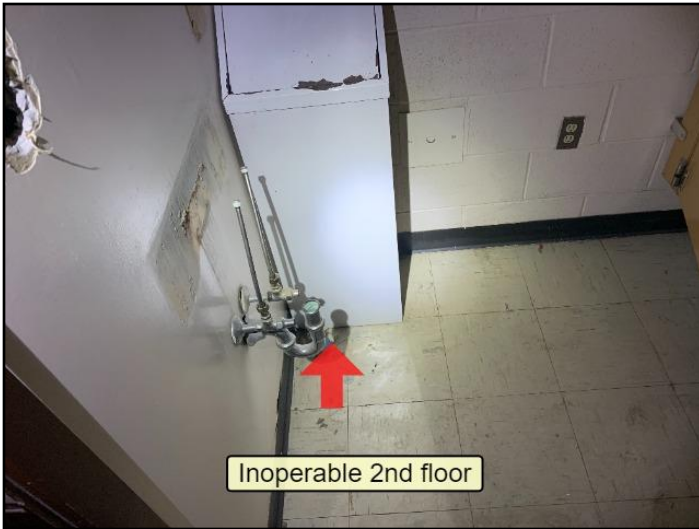
56. Inoperable 2nd floor

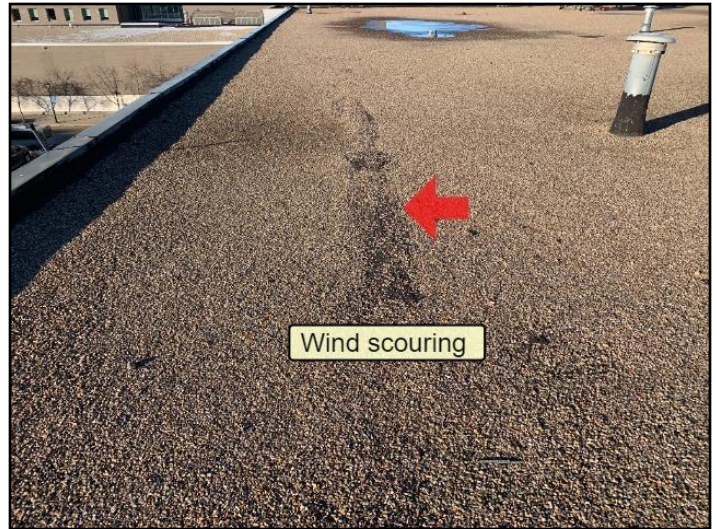
69. *Wind scouring*

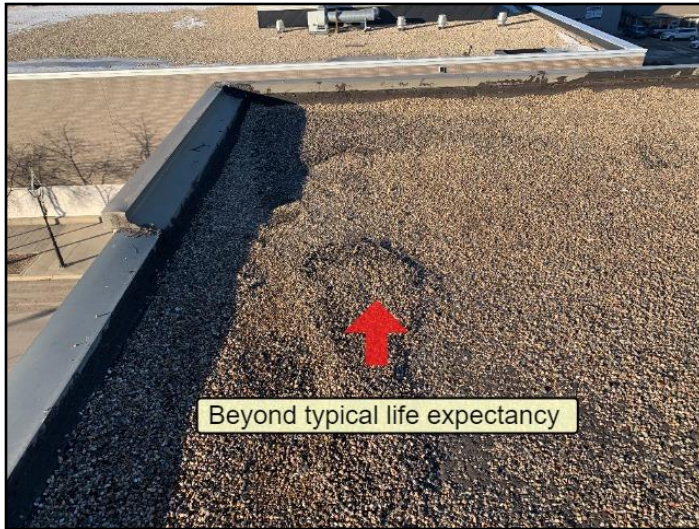
72. Beyond typical life expectancy

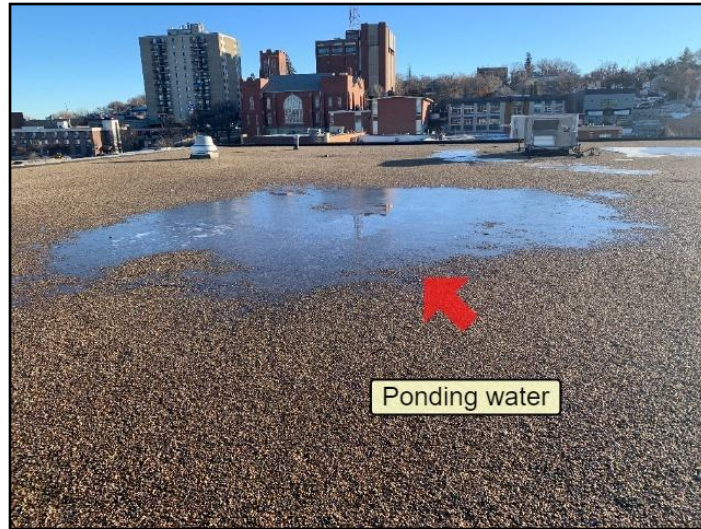
76. Ponding water

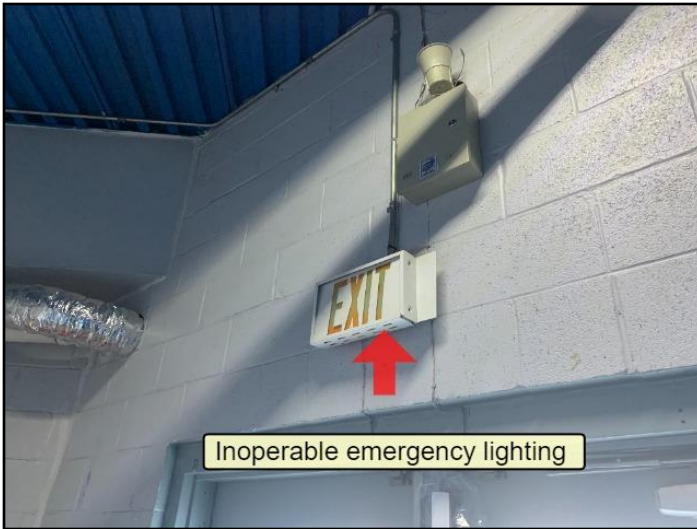
103. Inoperable emergency lighting

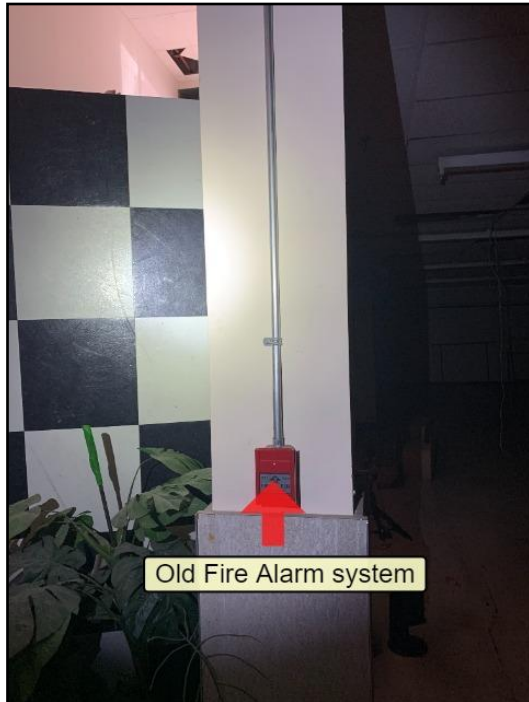
106. Old Fire Alarm system

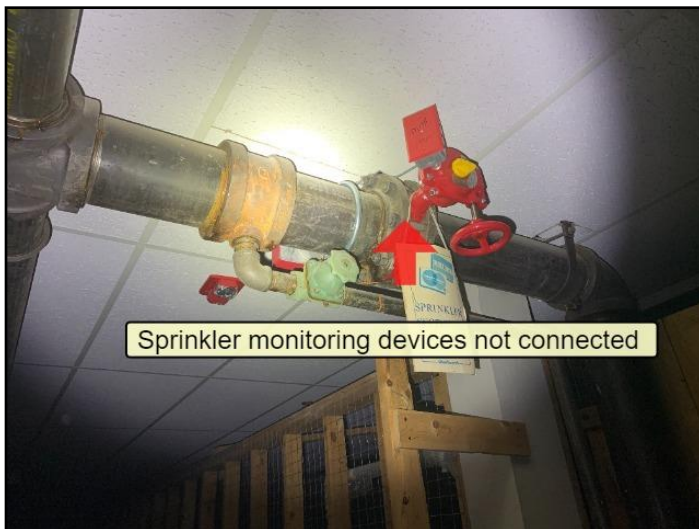
108. Sprinkler monitoring devices not connected

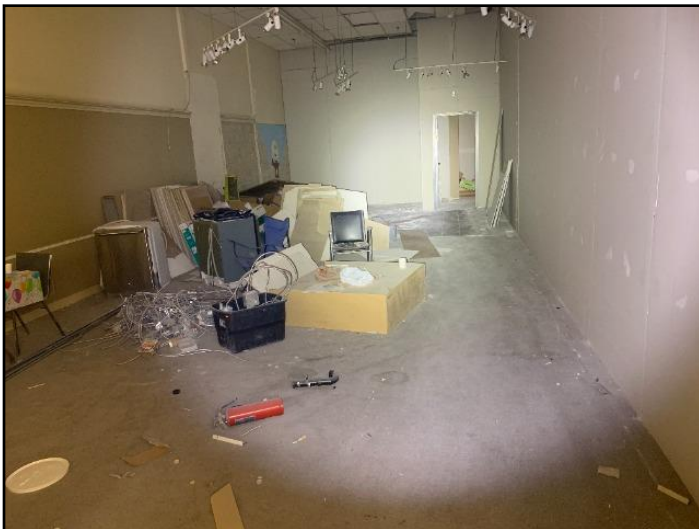
110. Example of main floor store area

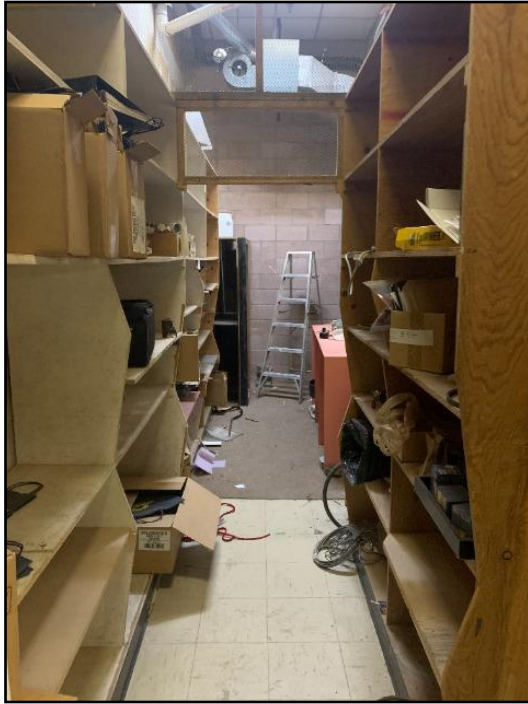
112. Example of main floor store area

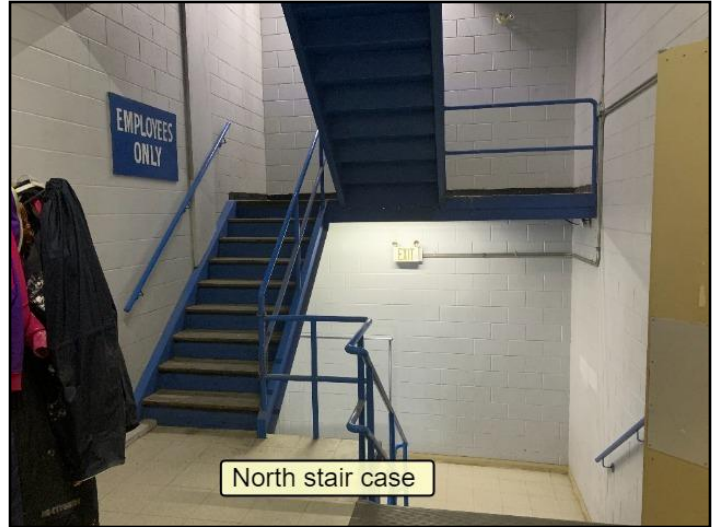
113. Concrete and steel

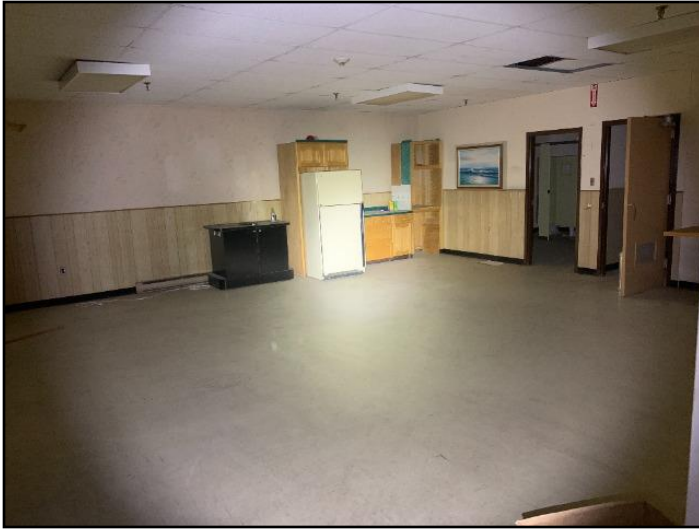
116. Example of 2nd floor office area

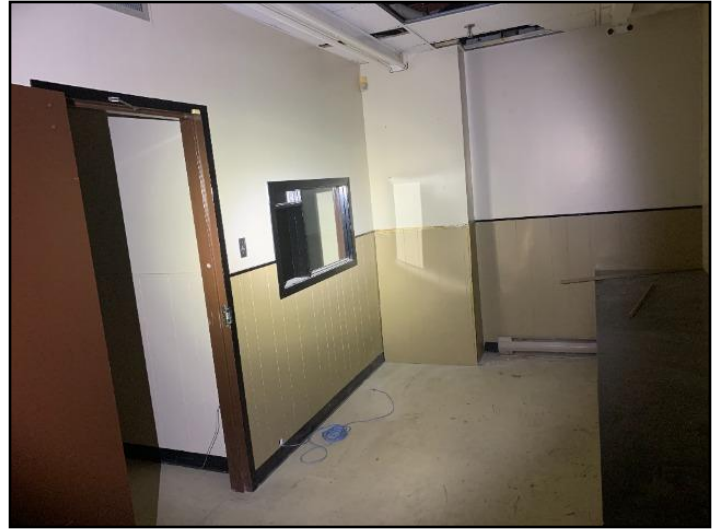
117. Example of 2nd floor office area

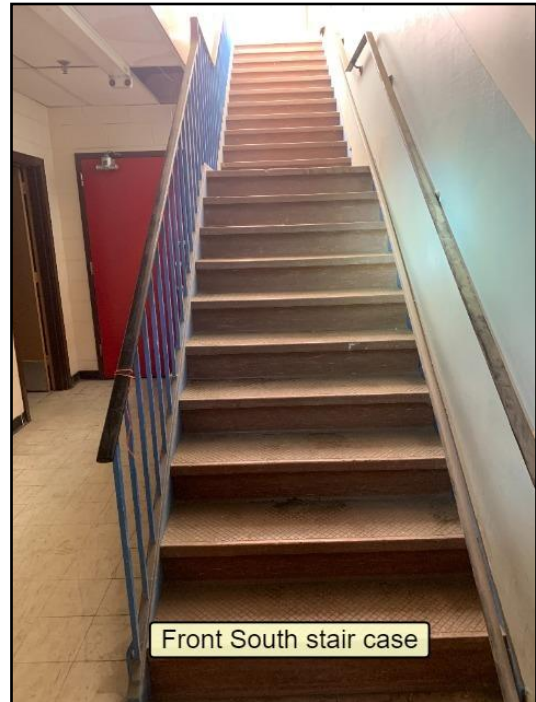
121. Concrete and steel

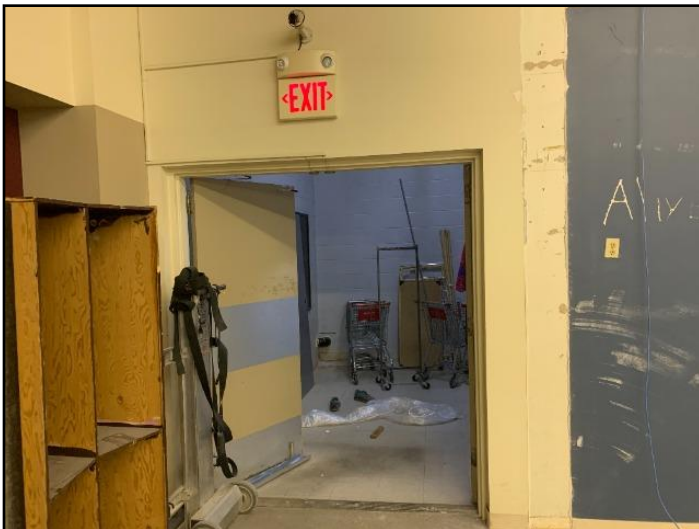
122. Example Emergency light battery pack

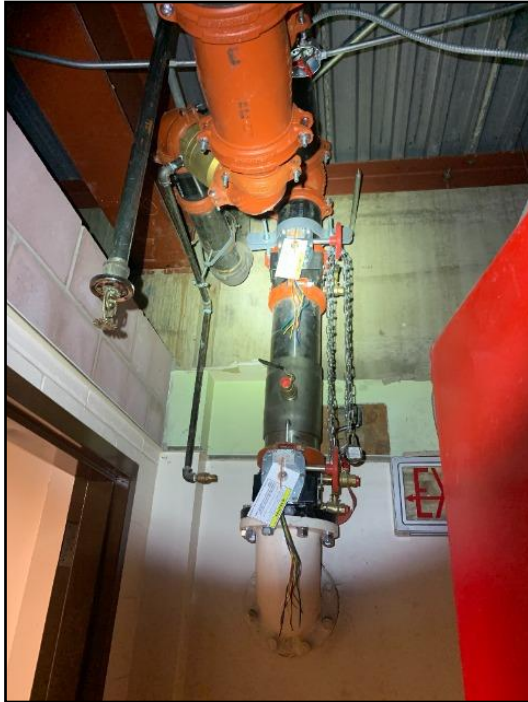
124. Example main fire protection sprinkler pipe

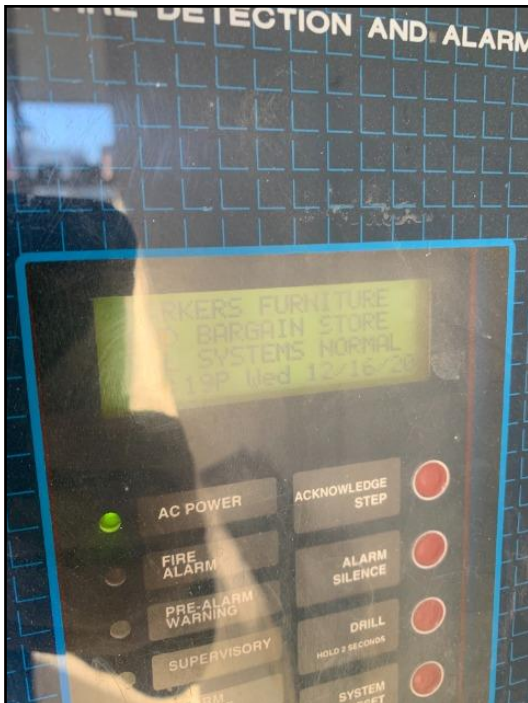
126. Example Fire Alarm Panel

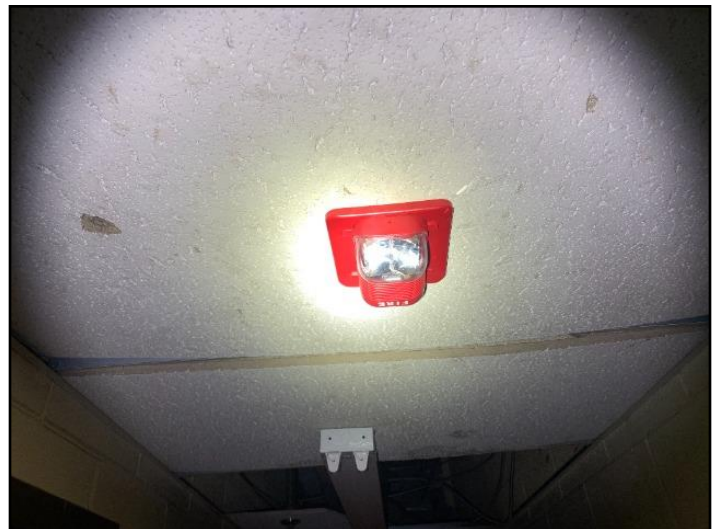
127. Example Fire Alarm Horn/strobe

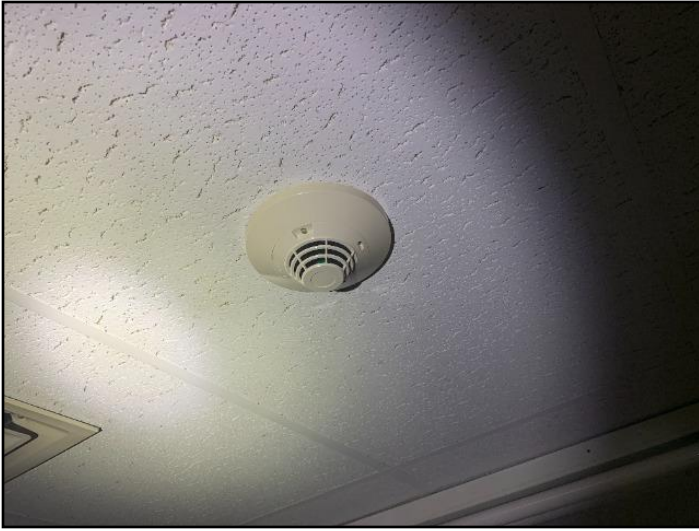
128. Example Fire Alarm smoke detector

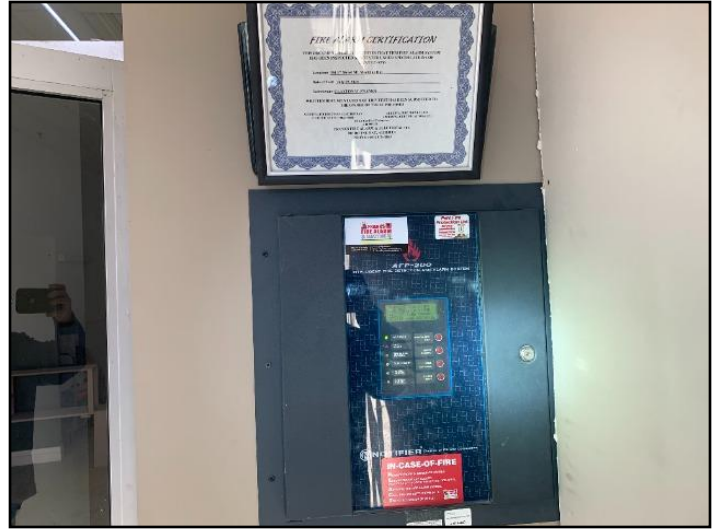
129. Example Fire Alarm verification report posted

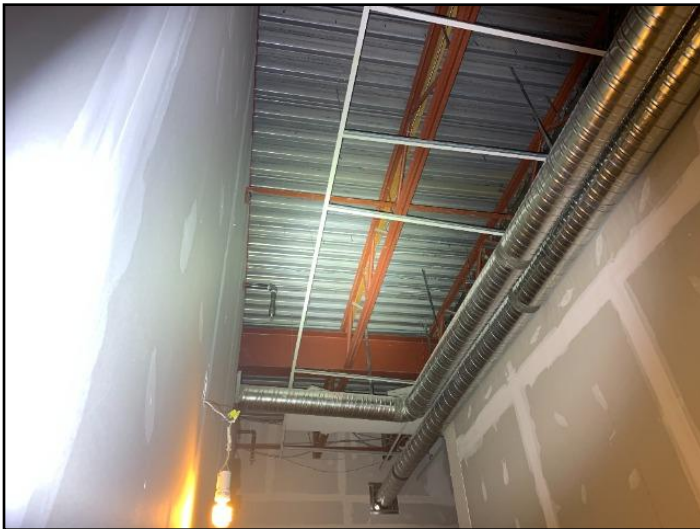
135. Example supported by open web steel joists

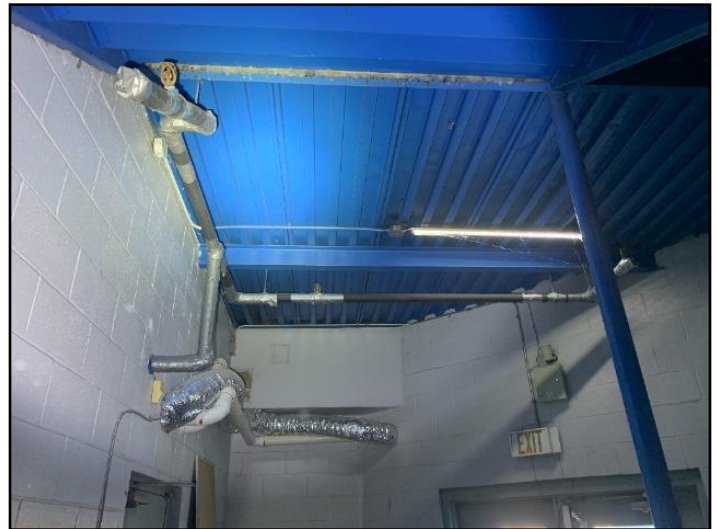
136. Example supported by steel beams and columns

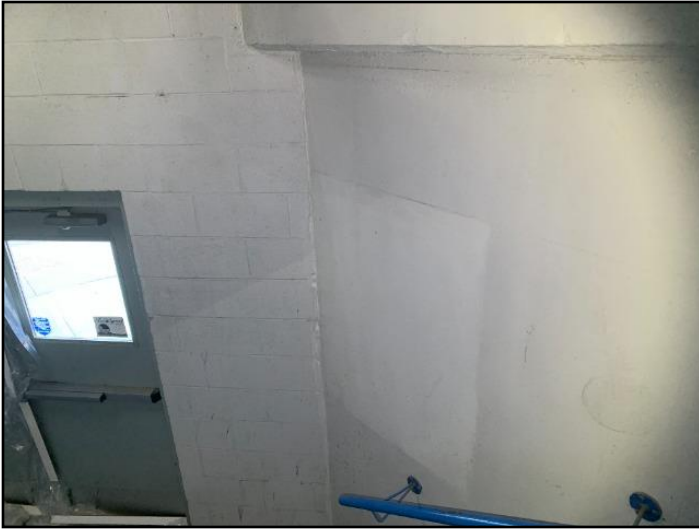
137. Example poured-concrete and cinder block

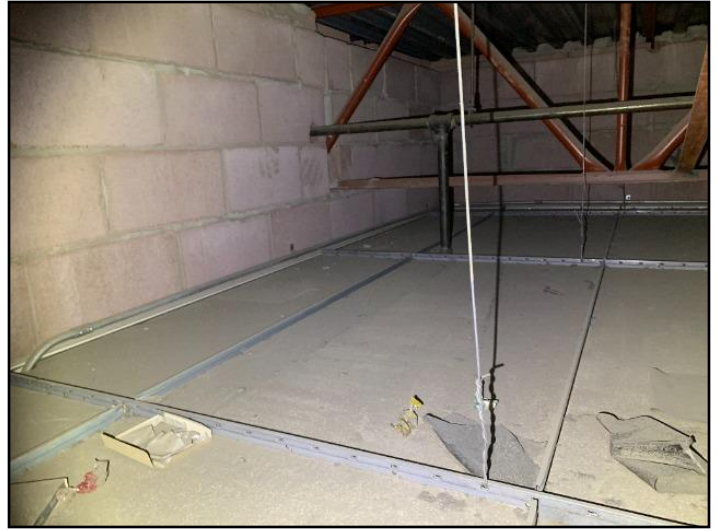
138. Example masonry walls

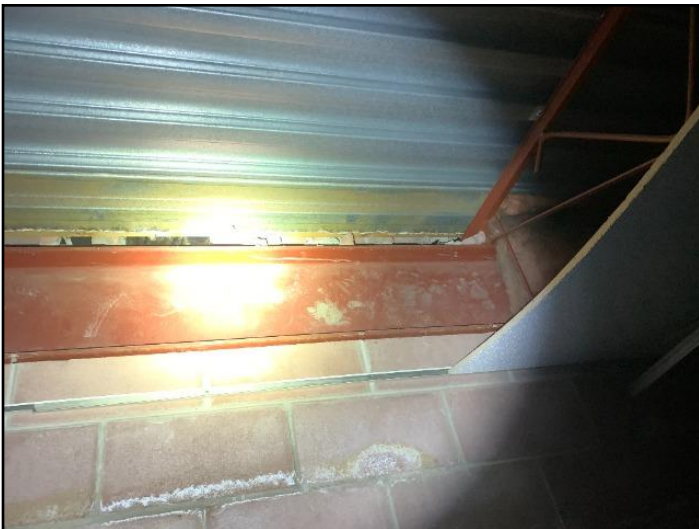
139. Example supported by exterior walls

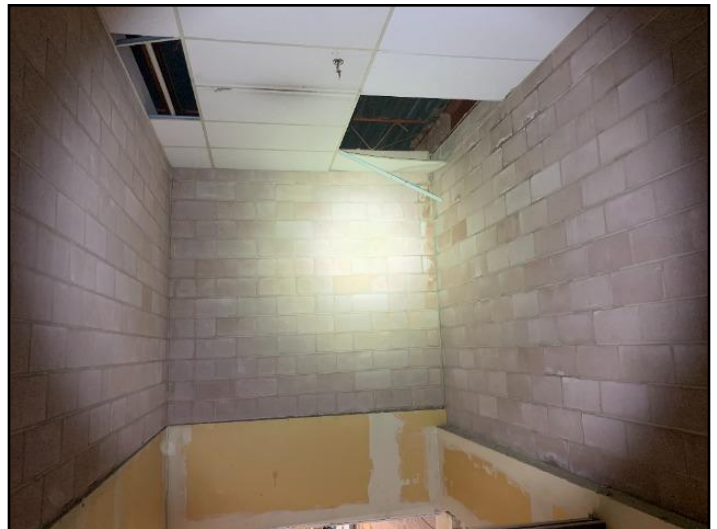
140. Example masonry walls

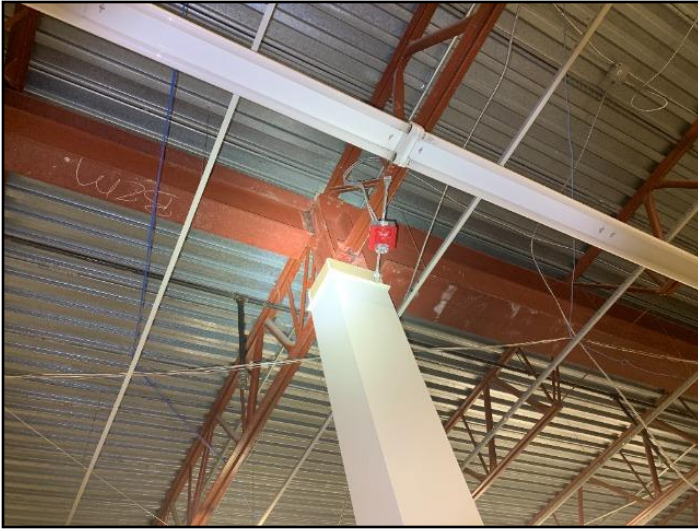
141. Example supported steel beams and columns

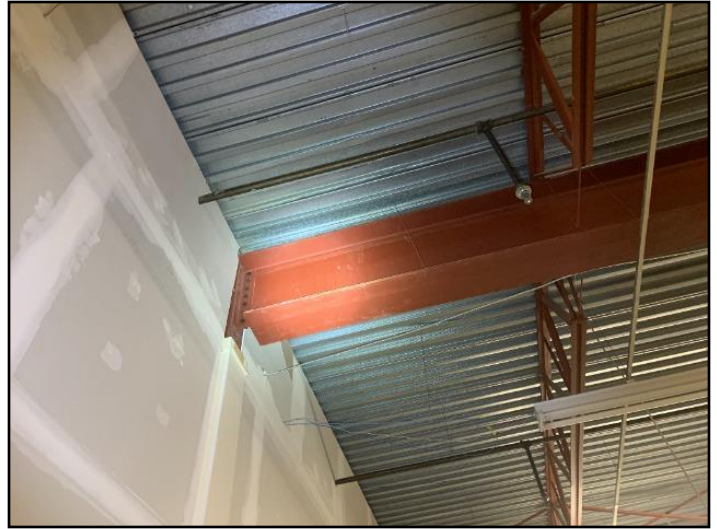
142. Example steel beams supporting steel deck

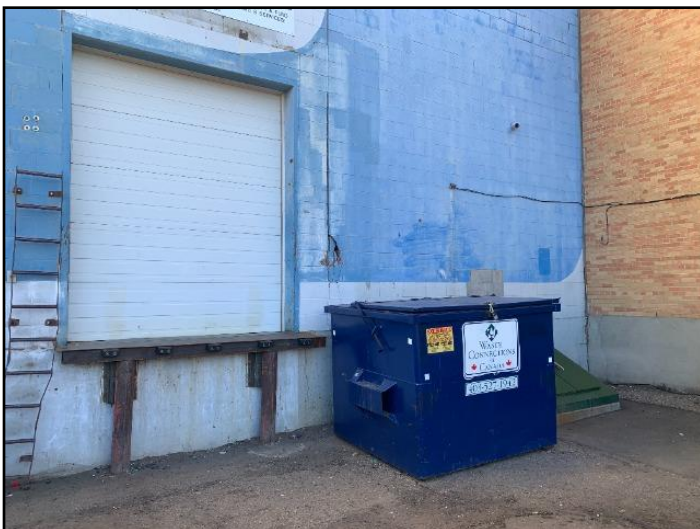
153. Example West loading dock

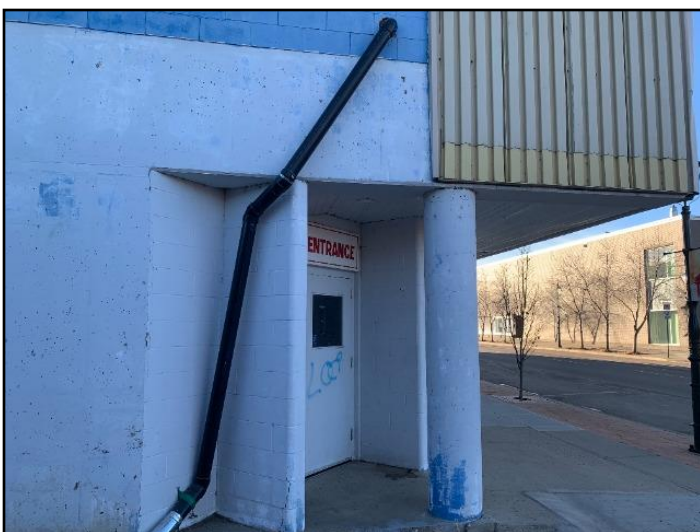
155. Example North exit back door

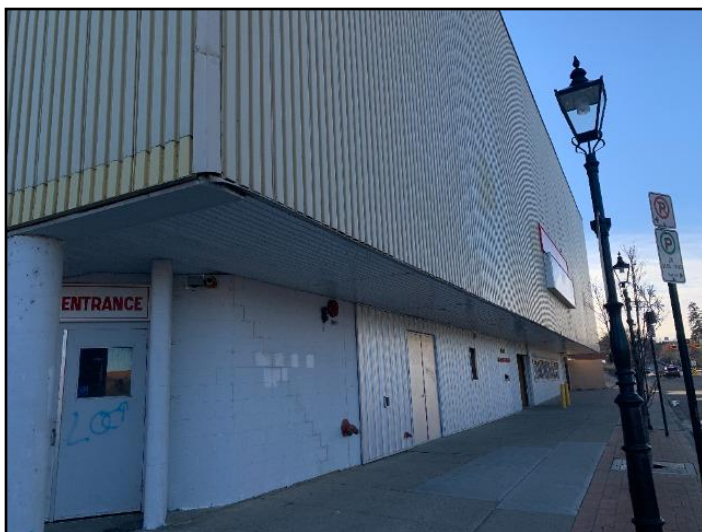
157. Example North side

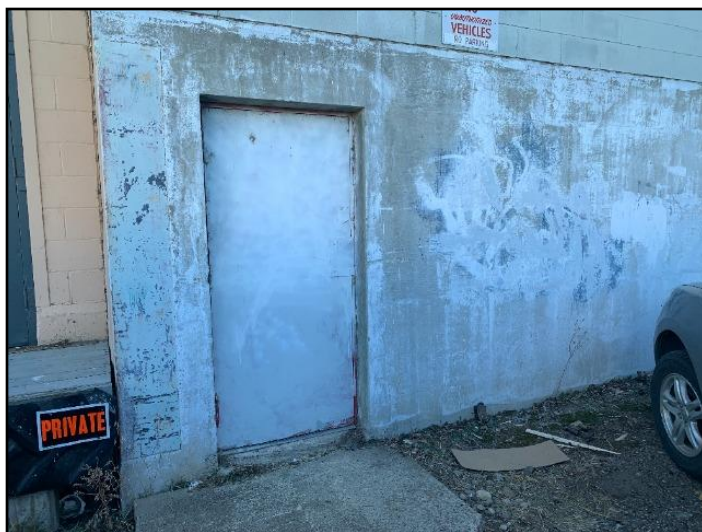
158. Example North fire exit

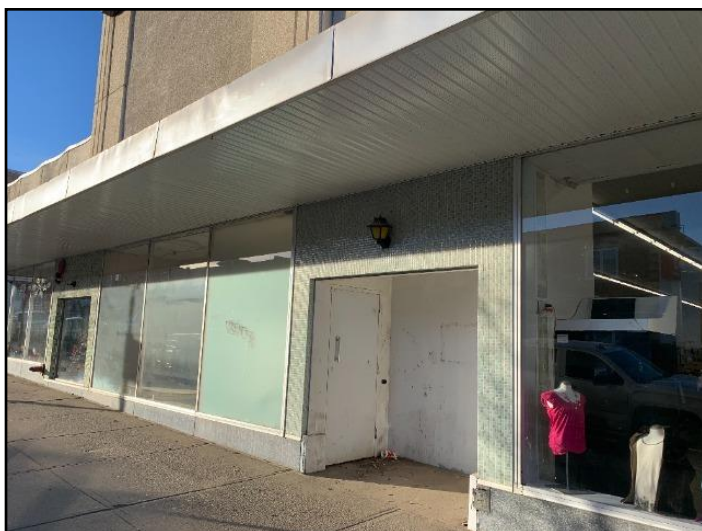
159. Example South side Front

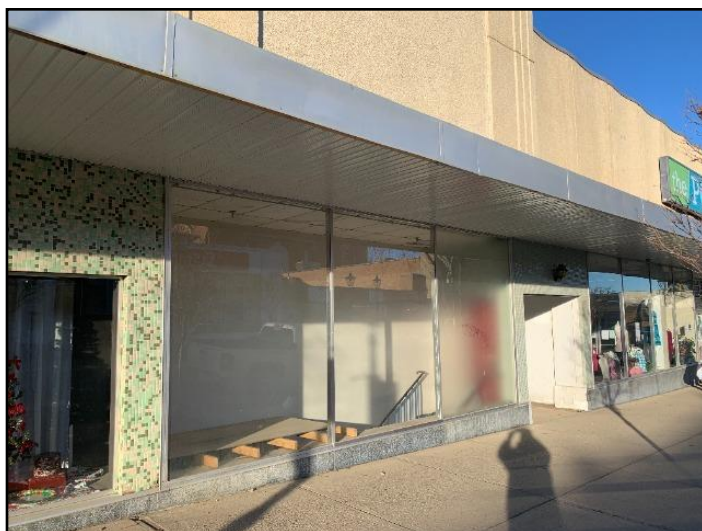
160. Example South side front
