# YOUR Inspection Report

75 Sample Crt  
Pittsburgh, PA 15149

Friday, May 22, 2015

RE: Report No. 1498, v.4  
75 Sample Crt  
Pittsburgh, PA  
15149

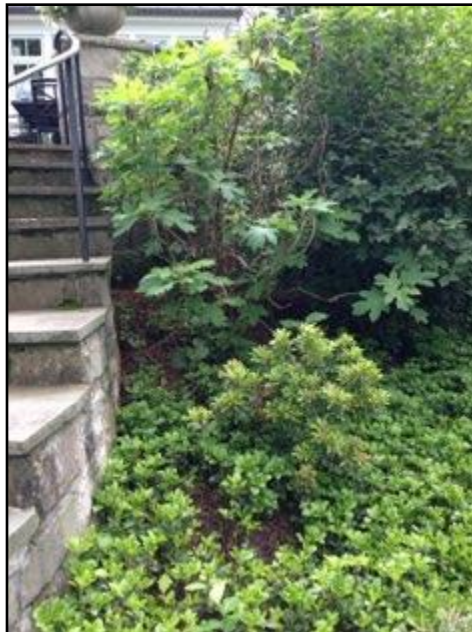
Limited visibility of the short rear retaining wall due to vegetation/ landscaping.

*Vines/shrubs/trees against wall*

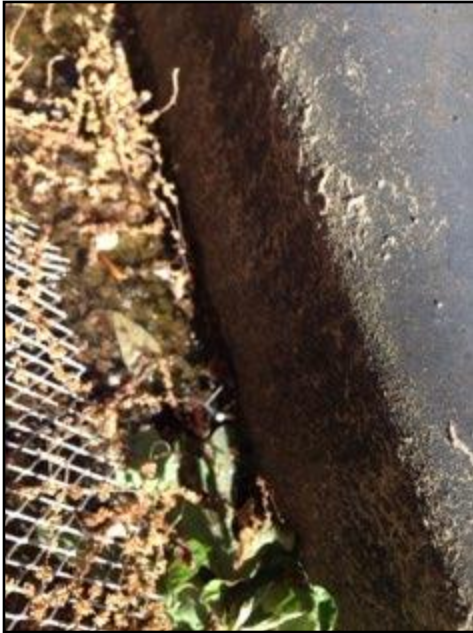
#### 3. Condition: • Clogged

The rear gutters were clogged at the time of the inspection (see pictures). Improve/clean ASAP and as part of regular maintenance to ensure proper rain water drainage in order to prevent water damage to finished areas and/or structure. It is highly recommended to have the entire gutter system cleaned/ maintained on a yearly basis, due to the abundance of mature trees around the property.

*Clogged*

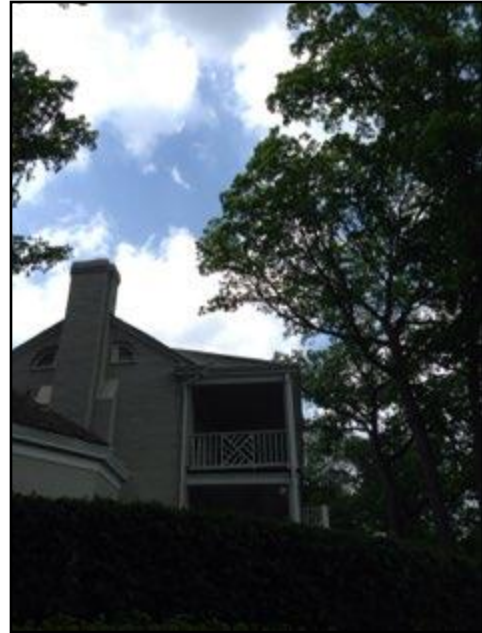
*Trees overhanging roof*

2. • Just for your information: it is recommended to keep all overhanging tree's trimmed away from the house. Also, to have the gutters cleaned and maintained yearly to ensure that the rain removal system is operating as intended. Another suggestion, keep all exterior wood and metal painted with a quality exterior paint to prevent premature deterioration as part of regular maintenance.

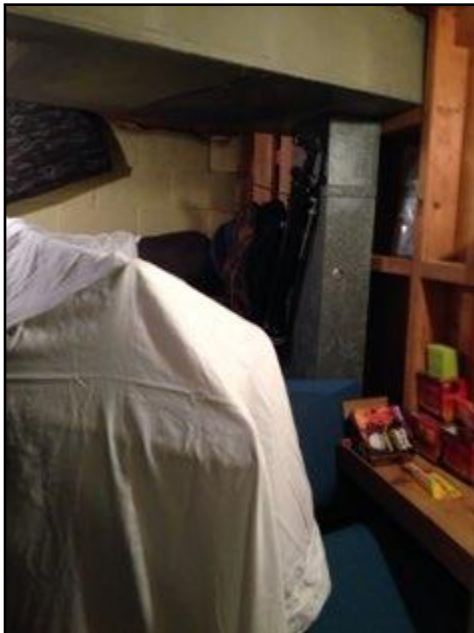
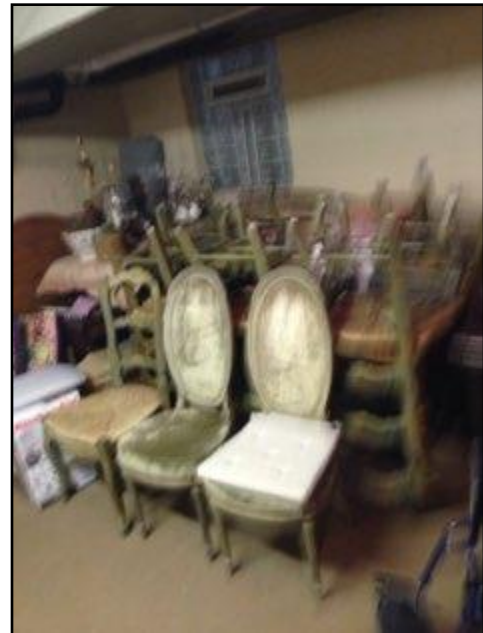
Storage in the basement limited visibility of the structure/ foundation in areas.

*Storage*

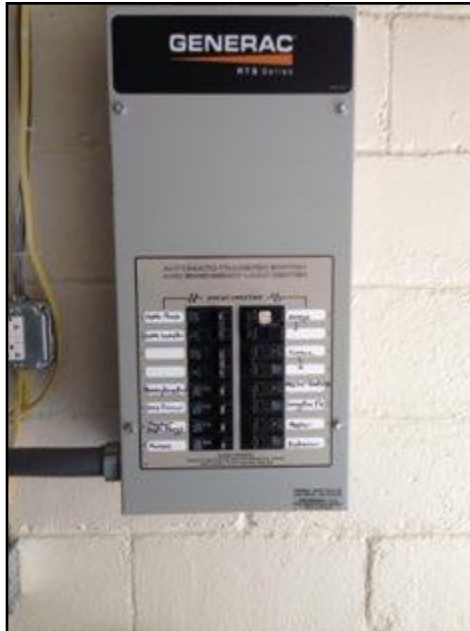
**Inspection limited/prevented by:** • Whole house generators are outside the scope of this home inspection. Please consult with the current owner on use and service information.

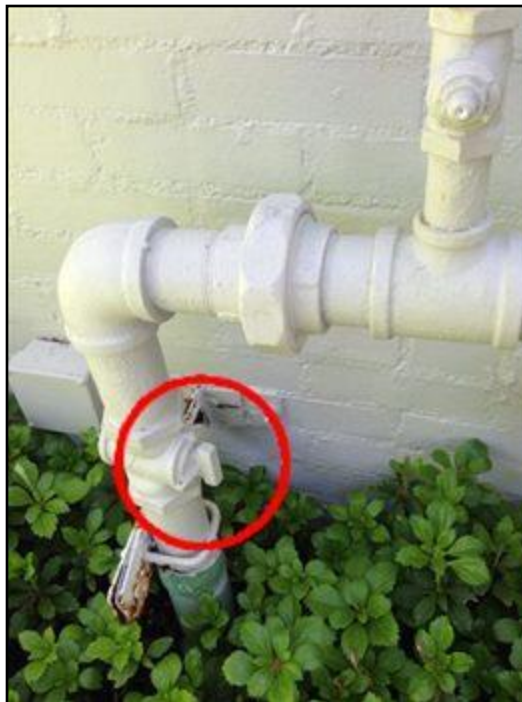
*Exterior wall/main gas shutoff*

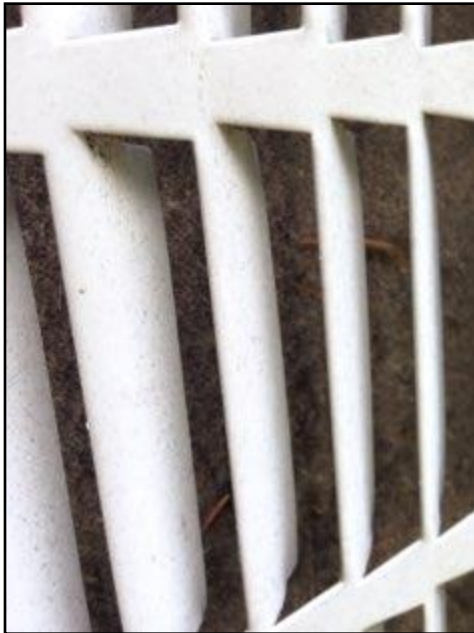
12. Condition: • Dirty

Dirty

**Time:** Regular maintenance

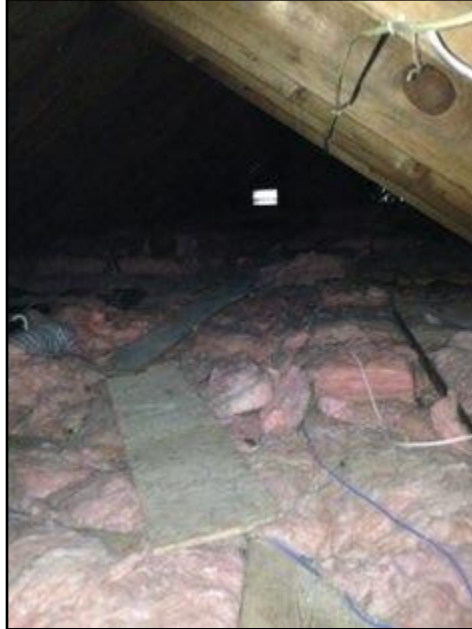
**Attic/roof insulation amount/value:** • R-30

*R-30*

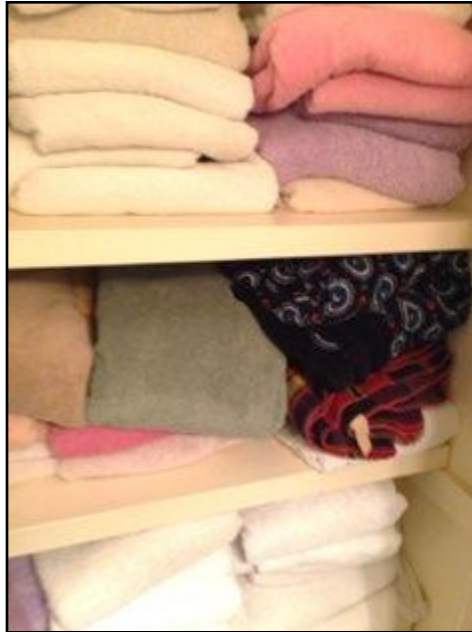
- Storage/furnishings
- Storage in closets/cupboards

*Storage in closets/cupboards*

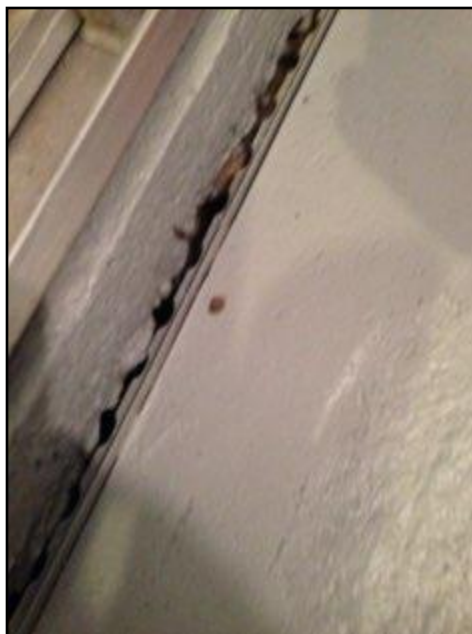
**20. •** Evidence of interior french drains at cottage garage and the right side main house garage. Interior french drains collect excessive water and divert it away from the house.

Note: No issues were observed with this system.

**Location:** Cottage garage/ main house garage

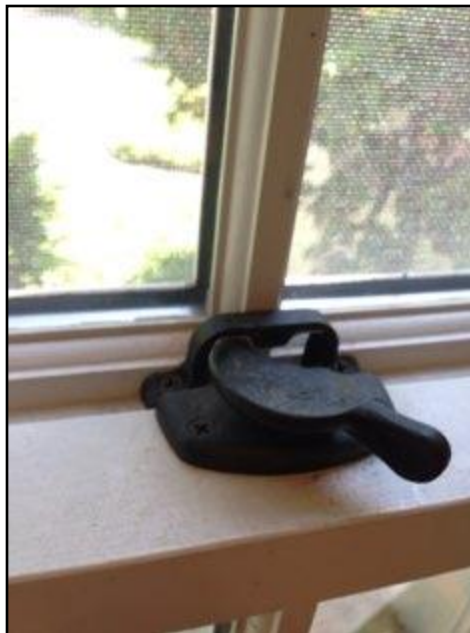
*Inoperable*

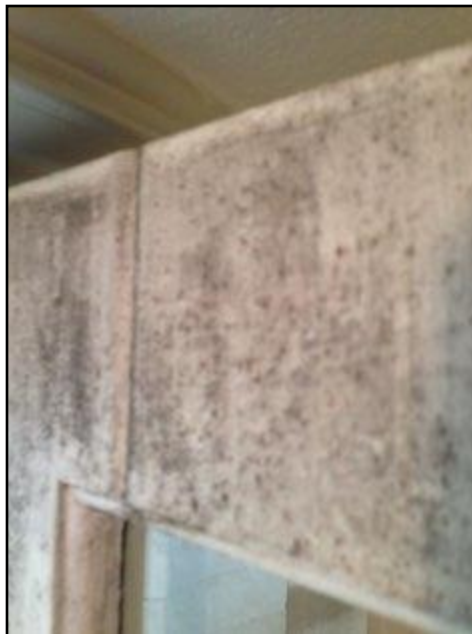
*Mold*

**Task:** Further evaluation if concerned
