INSPECTION REPORT

For the Property at:
8 KENYON ROAD
VERNON, BC V1H 2C6

Prepared for: R G
Inspection Date: Friday, September 20, 2019
Prepared by: Matt Bramall

Report No. 1021, v.3

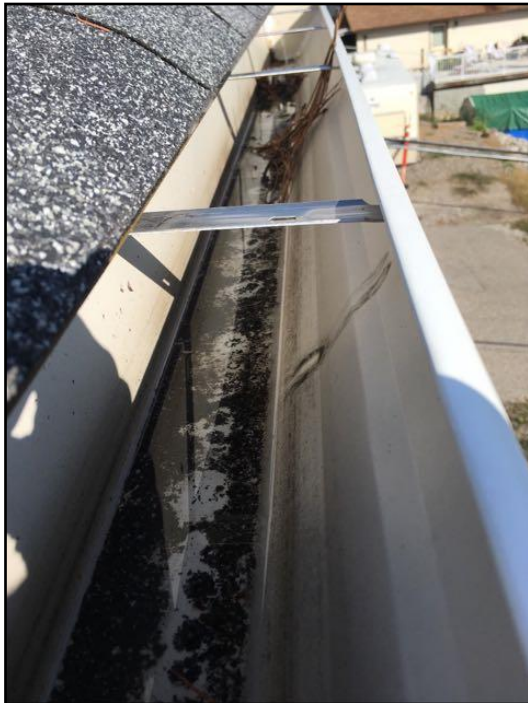
The asphalt shingles were recently installed, and have lost a normal amount of granules for a newly installed roof. The gutters also have accumulated some leaves and needles at this time. Clean gutters seasonally to ensure proper drainage and to prevent overflows. Overflowing gutters can damage the fascia and structure below.

Dirty/debris

Task: Clean

Time: Regular maintenance

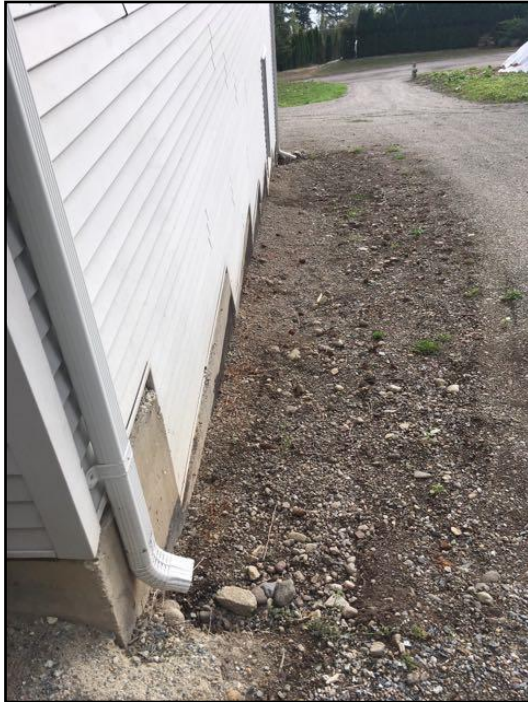
Condition: • [Should discharge 6 feet from building](#)

Should discharge 6 feet from building

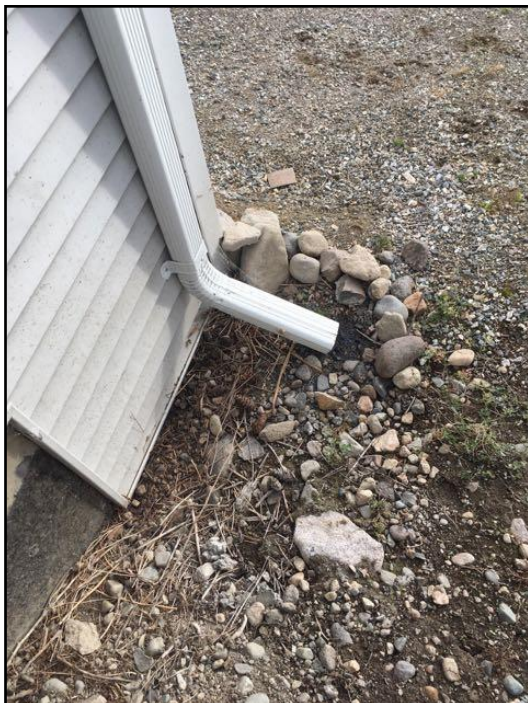
Should discharge 6 feet from building

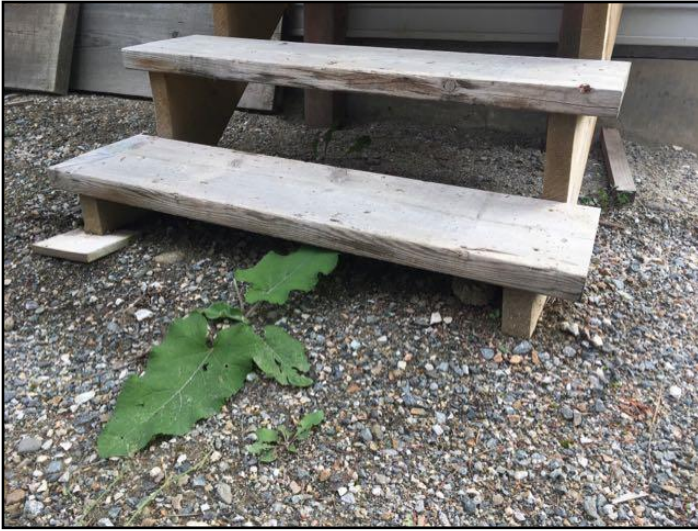
Condition: • [Wood/soil contact](#)

Wood/soil contact

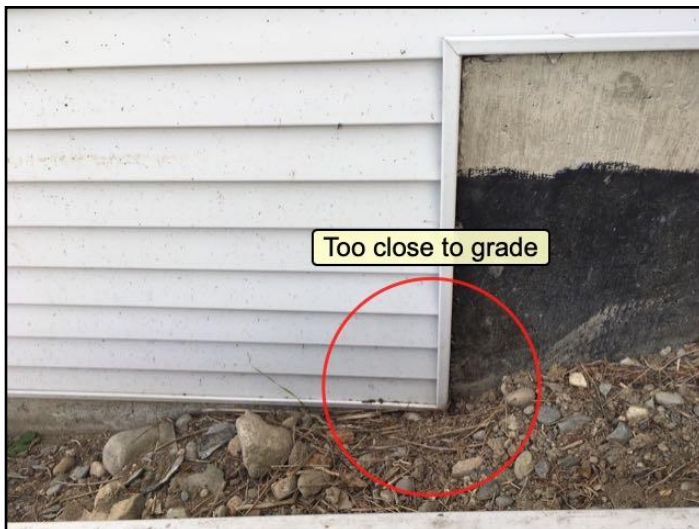
The siding which is covering the wood framed walls along the north and south sides of the home is too close to grade. There should be a minimum of 8" of clearance from the ground to the wood framing. This is particularly concerning with this home, as the above-grade downspouts uphill of these areas are directing a lot of water up against the foundation wall.

Too close to grade or wood/soil contact

Task: Increase clearance from ground to wood framing, slope ground away from structure.

Time: As soon as possible

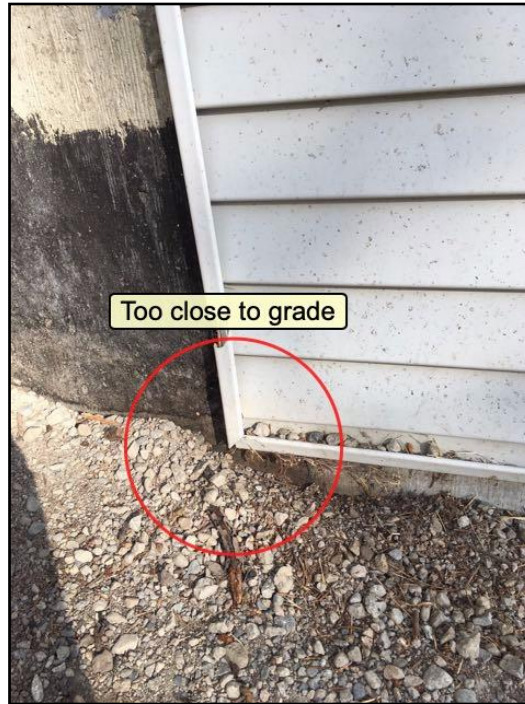
Too close to grade or wood/soil contact

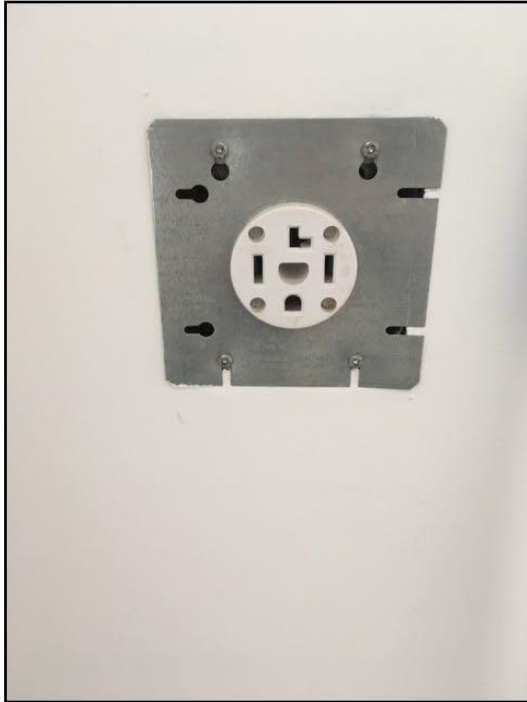
Power was turned off to the dryer outlet and the range.

Power was off in some areas

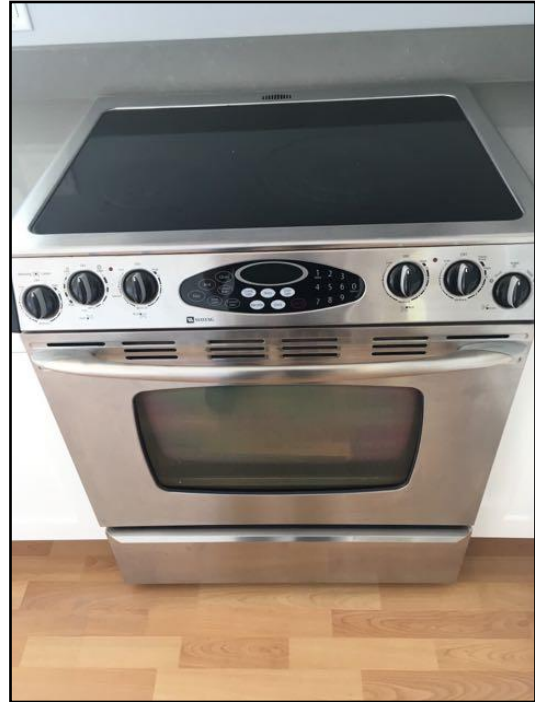
Power was off in some areas

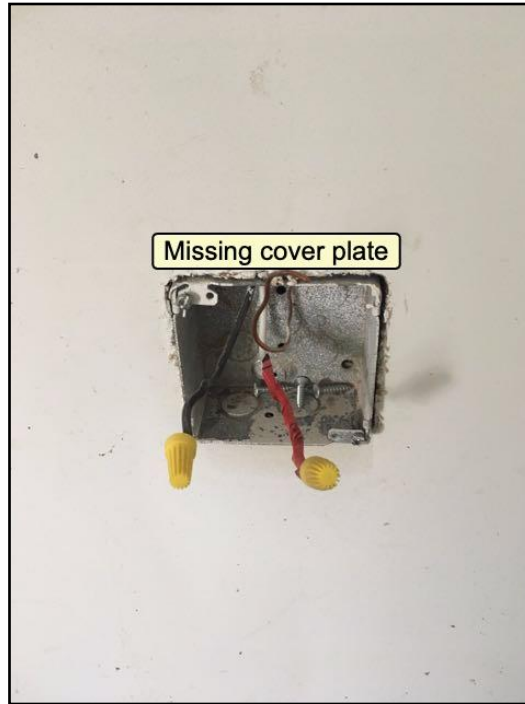
Condition: • [Exposed on walls or ceilings](#)

Exposed on walls or ceilings

Time: Immediate

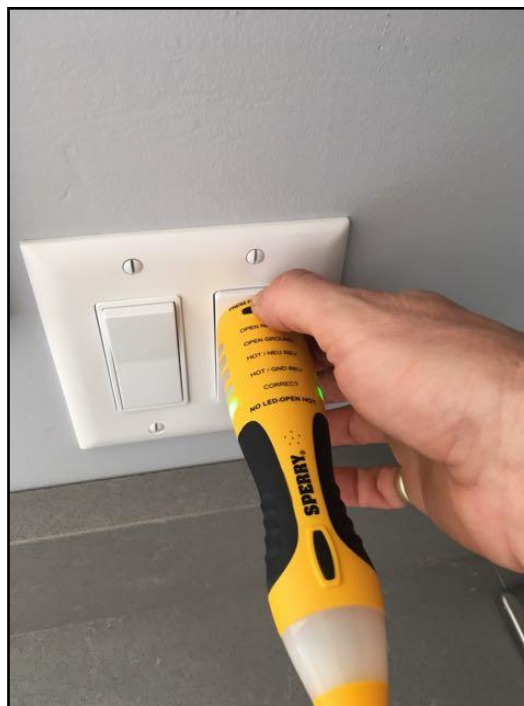
No GFCI/GFI (Ground Fault Circuit...

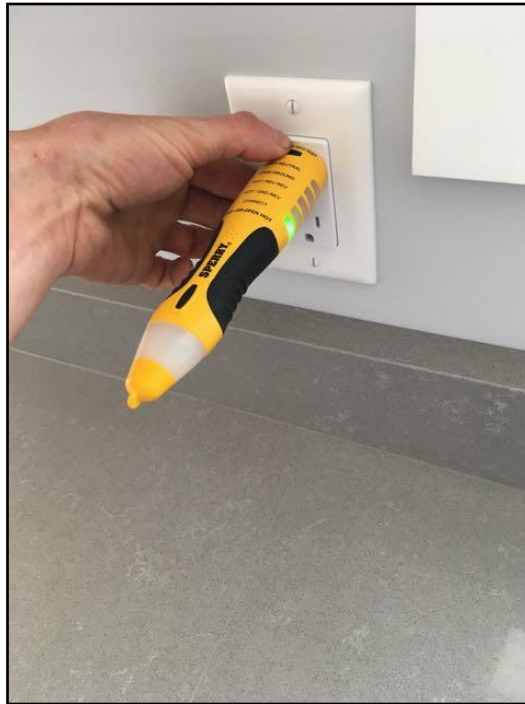
Condition: • [No GFCI/GFI \(Ground Fault Circuit Interrupter\)](#)

the GFCI circuitry within the outlet checks constantly for a difference between the current in the black and white wires
if there is a difference of at least 5 milliamps, there is a current leak and the GFCI shuts off the outlet and all outlets downstream

No GFCI/GFI (Ground Fault Circuit...

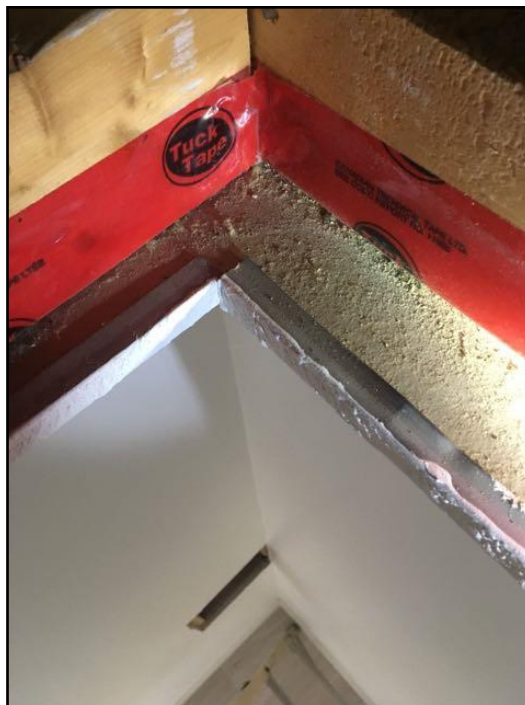
Condition: • [Not weatherstripped](#)

Implication(s): Chance of condensation damage to finishes and/or structure | Increased heating and cooling costs

Not weatherstripped

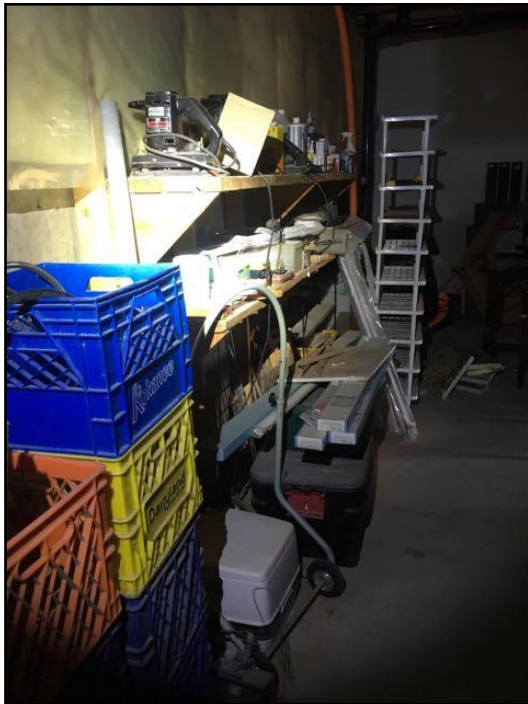
Inspection of some areas of the interior walls on the perimeter of the home were not able to be inspected due to storage.

Storage/furnishings

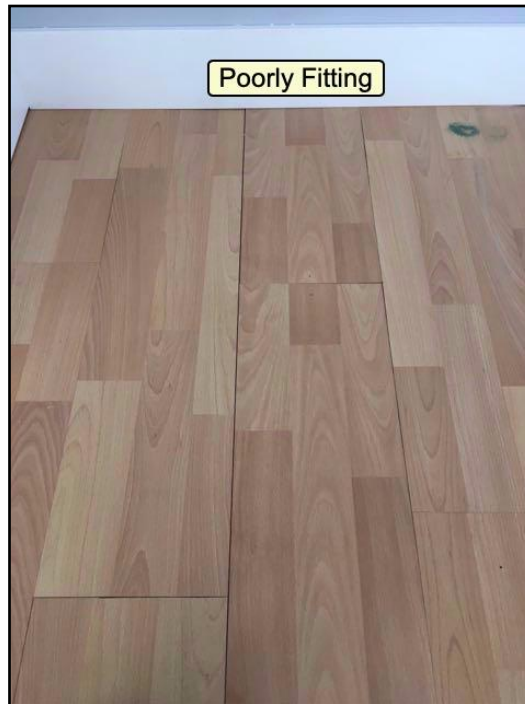
Laminate flooring not tight

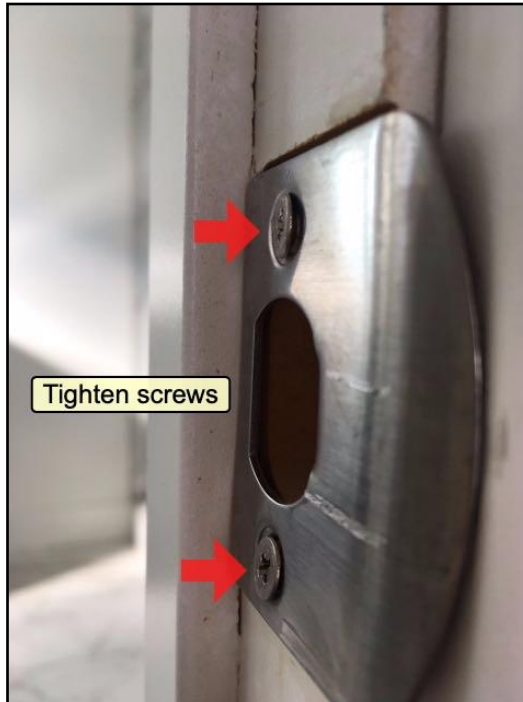
Condition: • Binds

Binds

Task: Tighten screws until they are recessed into strike plate

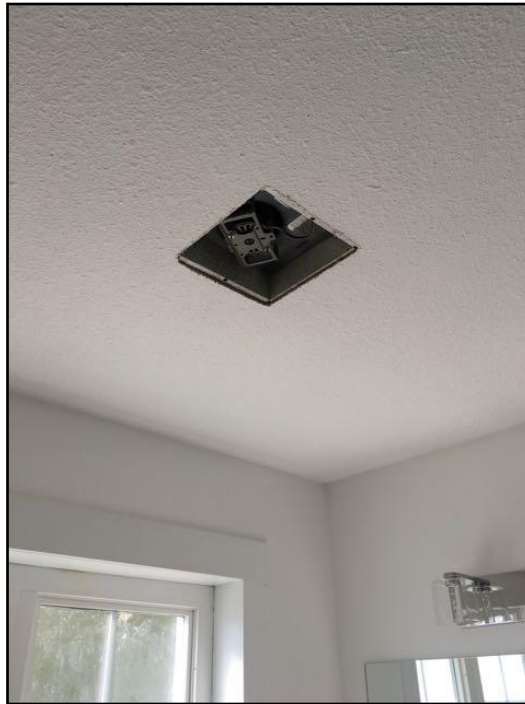
Master bathroom fan is noisy and missing it's cover.

Noisy

Task: Repair or replace

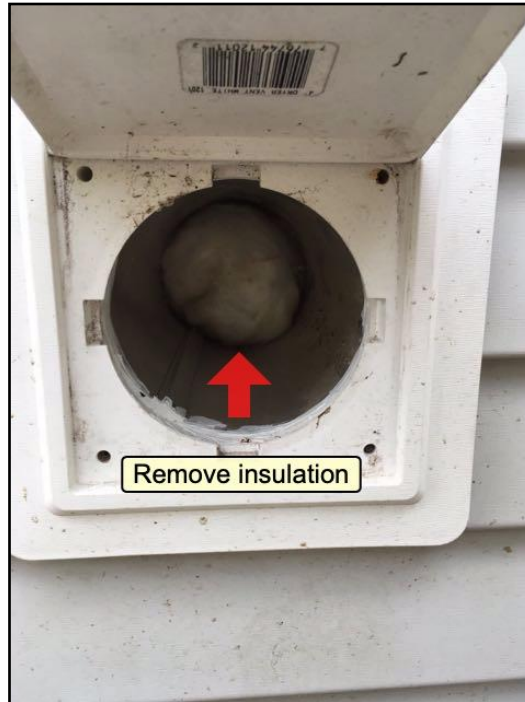
Dryer vent to outside

Condition: • There is currently no dryer installed in the home. Ensure when connecting dryer venting to the exterior wall vent pipe that the insulation is removed.

Implication(s): Poor clothes drying, increased energy consumption, fire hazard.
