INSPECTION REPORT

For the Property at:
1234 NEW HOME
SE WISCONSIN, WI

Prepared for: EXAMPLE REPORT
Inspection Date: Friday, December 11, 2020
Prepared by: David Gross

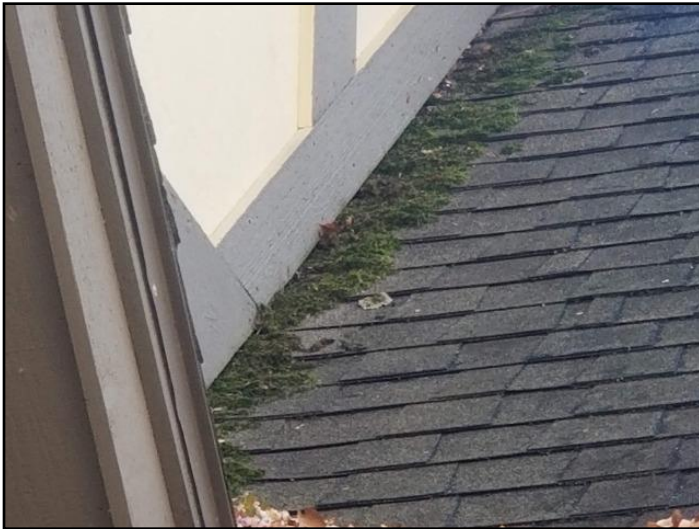
1. Condition: • Organic growth on north side of roof. Clean with appropriate cleaners to extend roof life

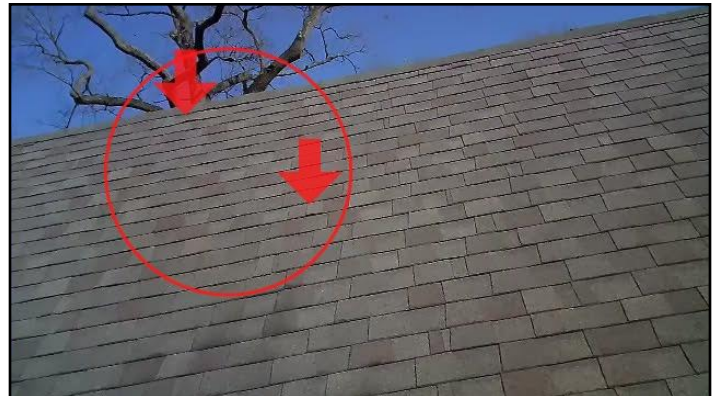
6. Nail Pop Have roofer or handyman correct...

3. Condition: • Nail Pop Have roofer or handyman correct nail prior to having it back out through the shingle. Noted various nail pops on roof. Have handyman or roofer repair as needed.

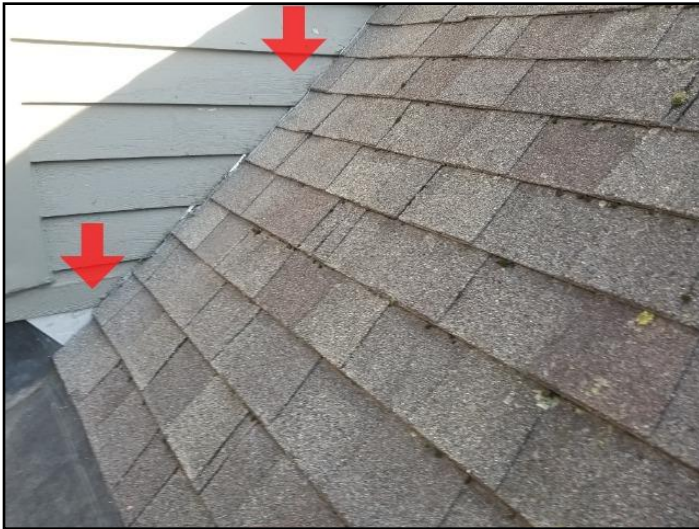
9. Siding not cut back

5. Condition: • Siding not cut back

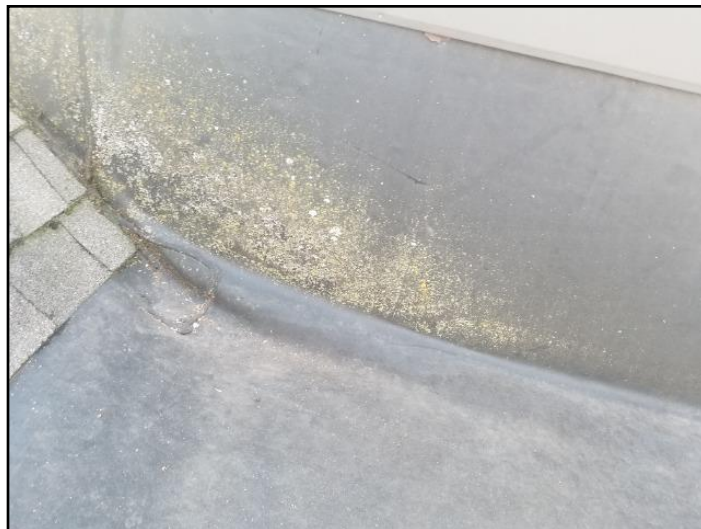
17.

8. Condition: • Clean roofs off of organic growth to extend life of roof.

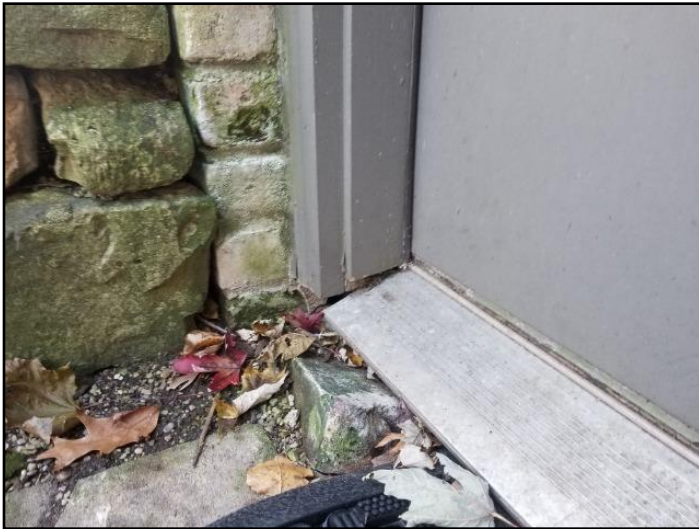
38.

20. Condition: • Rear door to storage room has a loose sill. Support to prevent further damage. Contact reputable contractor or handyman for options.

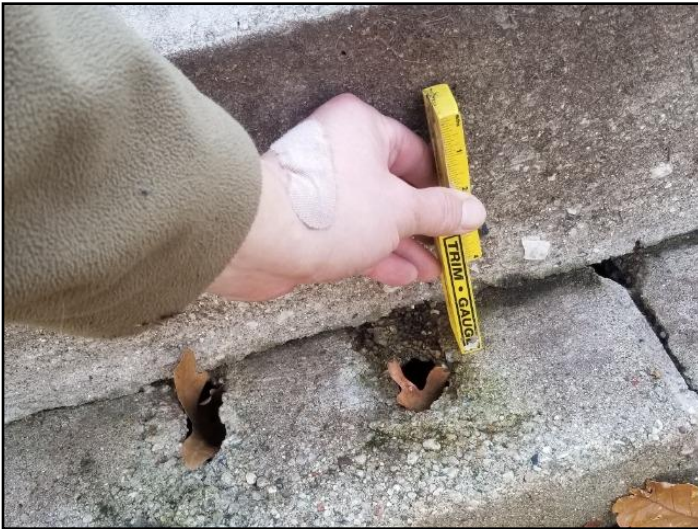
21. Condition: • Stair rise too big or not uniform

40. Stair rise too big or not uniform

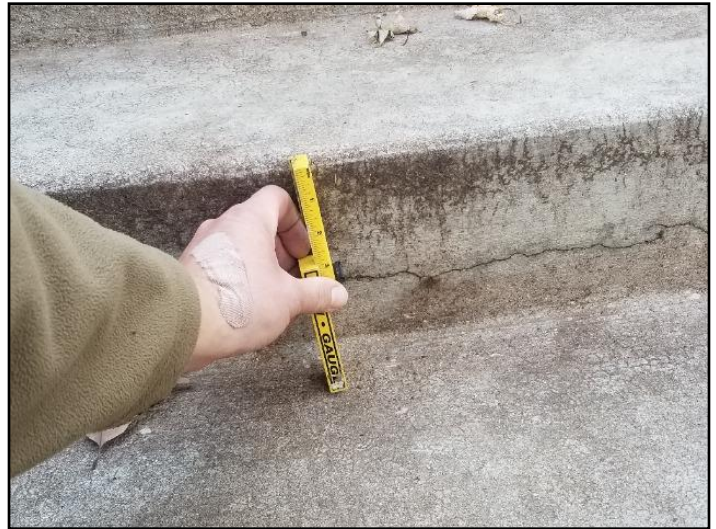
41. Stair rise too big or not uniform

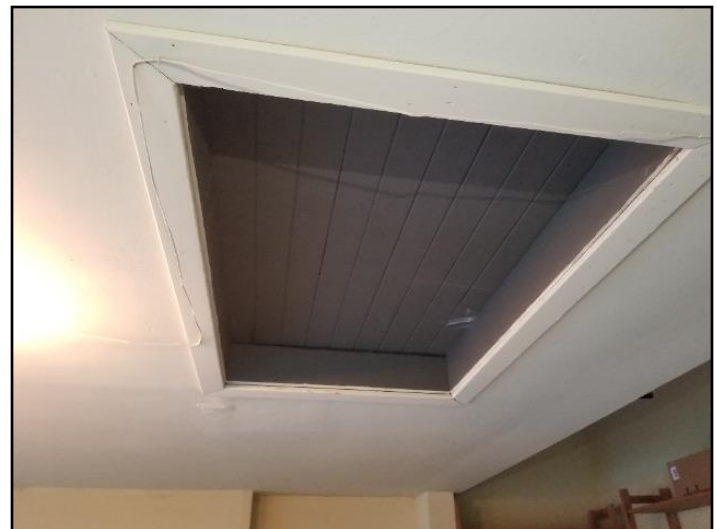
25. Condition: • Not fireproof

45. Not fireproof

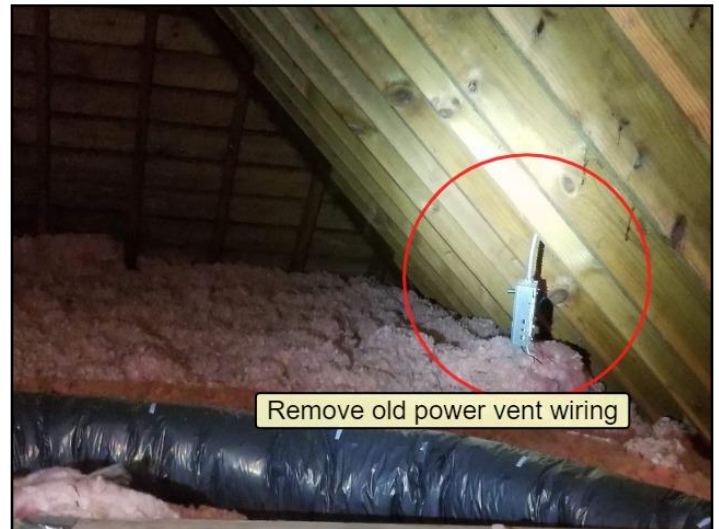
32. Condition: • Exposed in attics

55. Exposed in attics

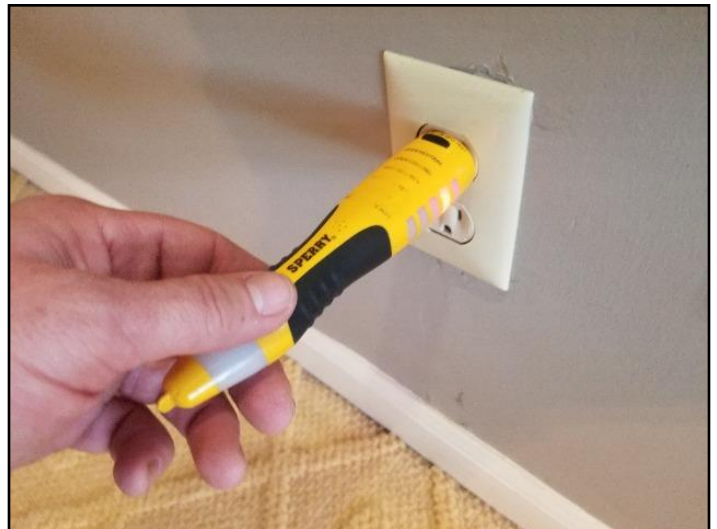
58. Ungrounded

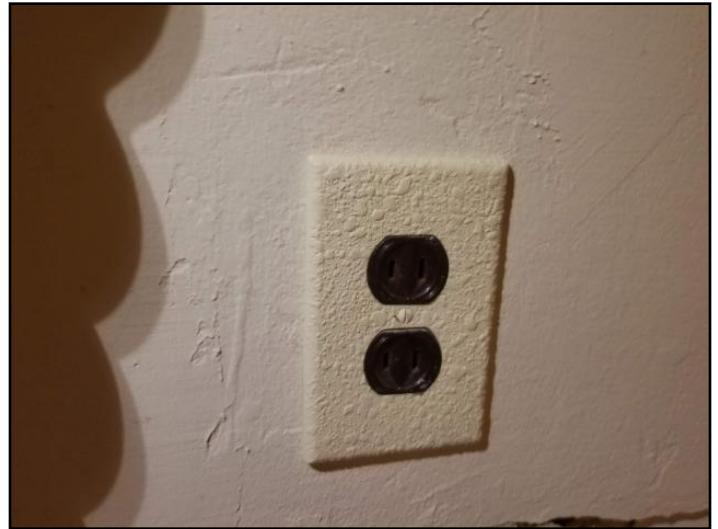
60. Ungrounded

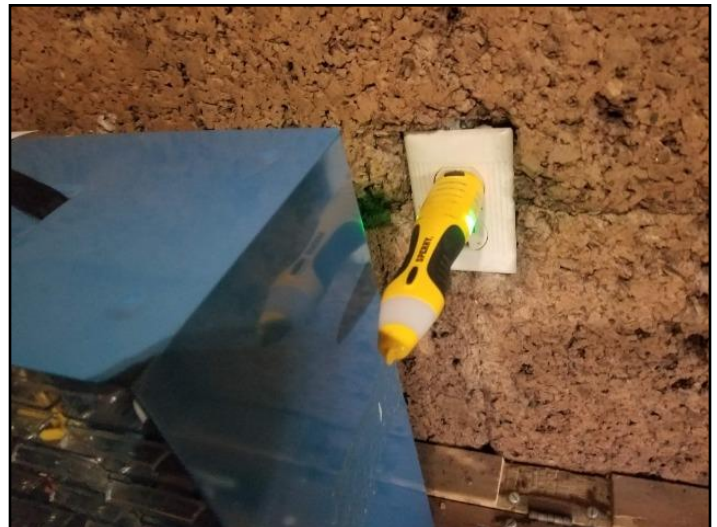
63. GFCI/GFI needed (Ground Fault Circuit...

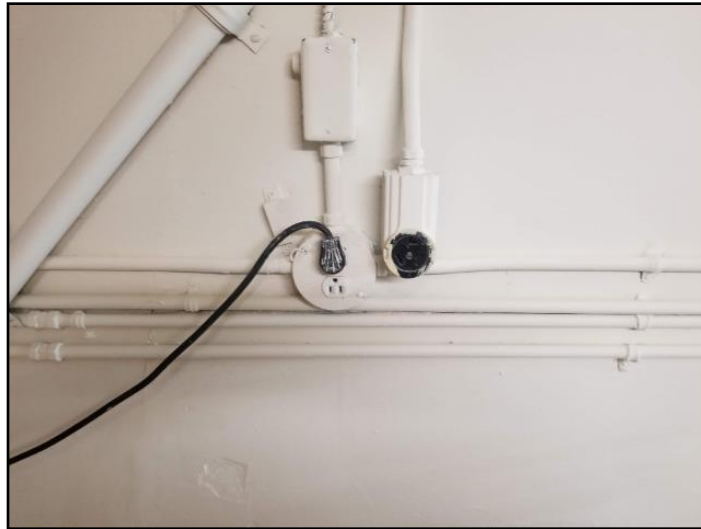
64. GFCI/GFI needed (Ground Fault Circuit...

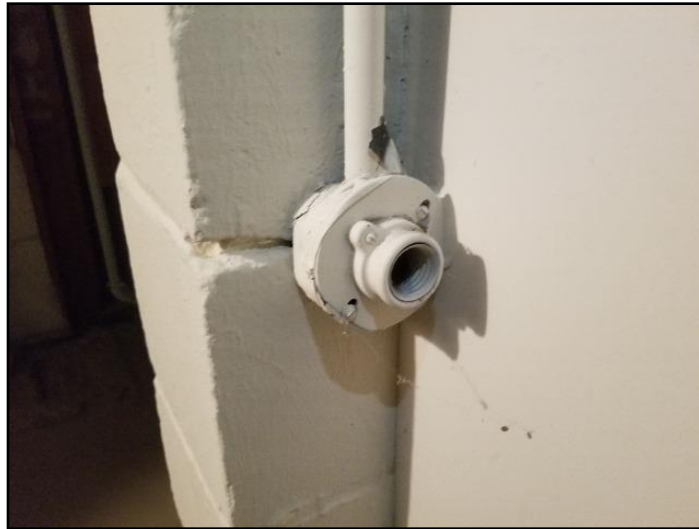
67. Obsolete

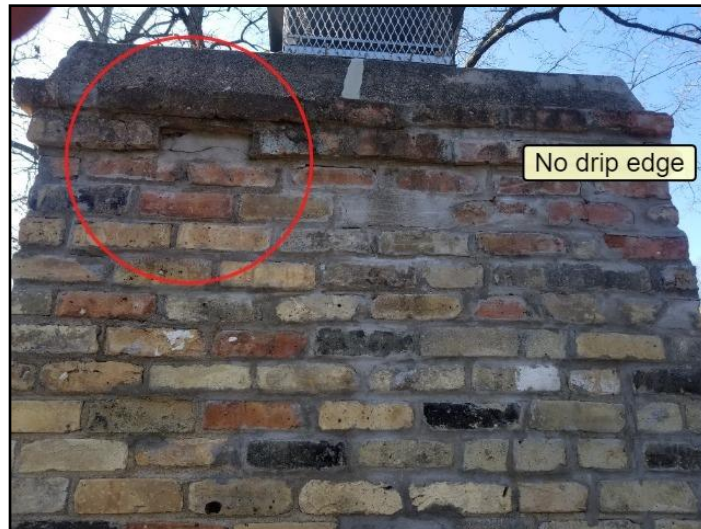
69. No drip edge

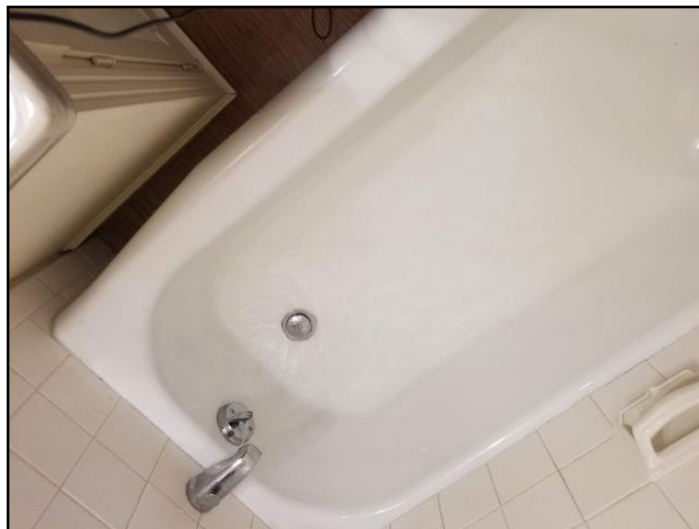
77. Slow drain

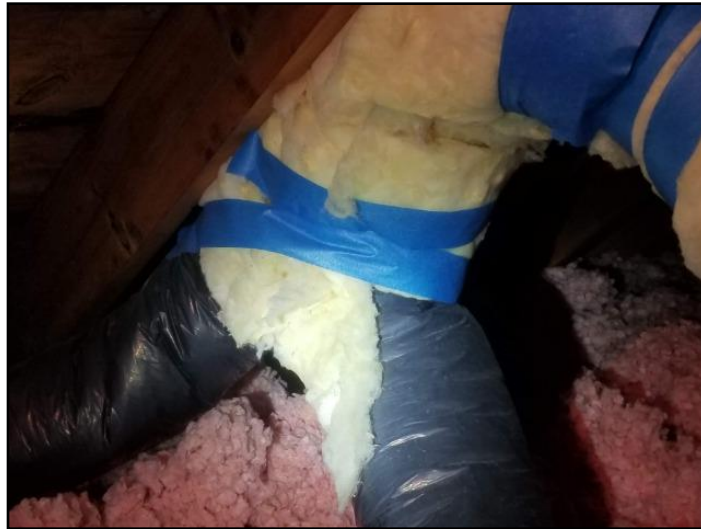
80. Multiple ducts are combined to a single...

61. Condition: • Multiple ducts are combined to a single termination. Each vent should have it's own termination point on the exterior of the house

Task: Repair or replace
