## Horizon Home Inspectors Sample Report Hilton Head Island, SC 29928

**INSPECTION DATE:**  
Wednesday, January 2, 2019

RE: Report No. 5190, v.3  
Horizon Home Inspectors Sample Report  
Hilton Head Island, SC  
29928

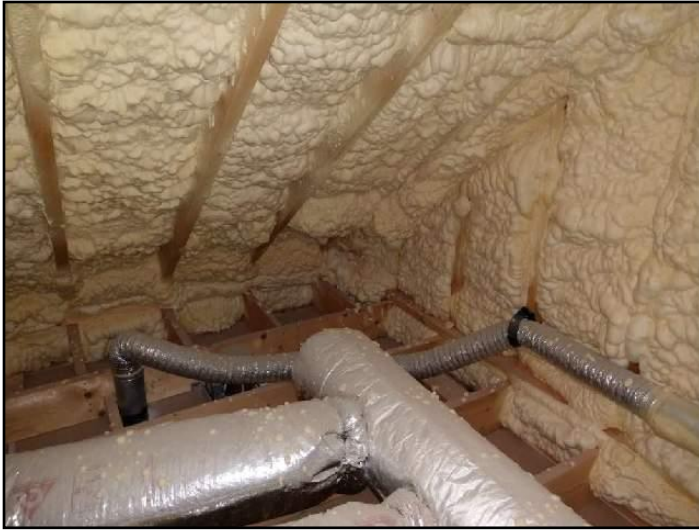
54. Access limited by insulation

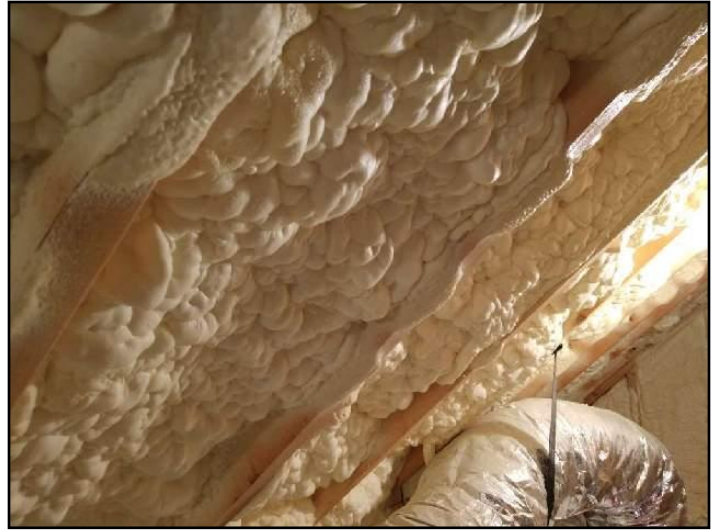
55. Attic access limited by insulation. The...

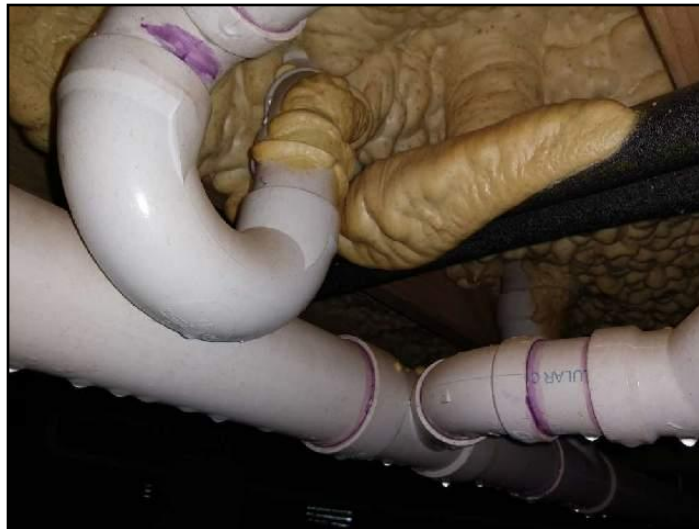
**Crawlspace:** • foam insulation obstructs observation of the penetrations such as plumbing supply and drains.

56. Foam insulation-obstruction

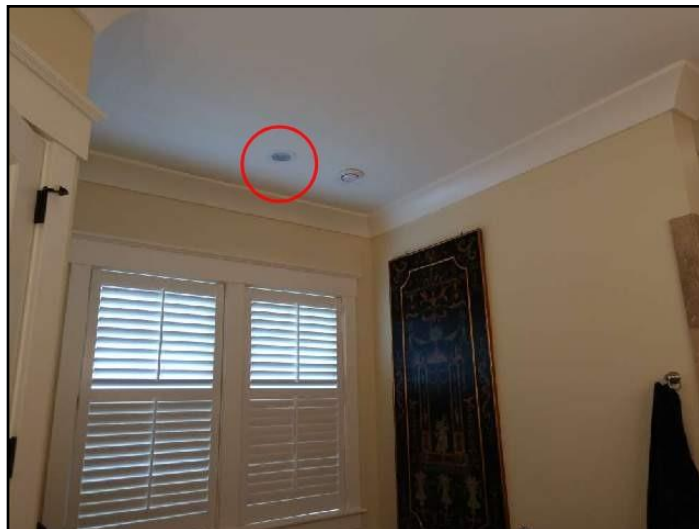
57. Inoperative

**Task:** Request disclosure or documentation

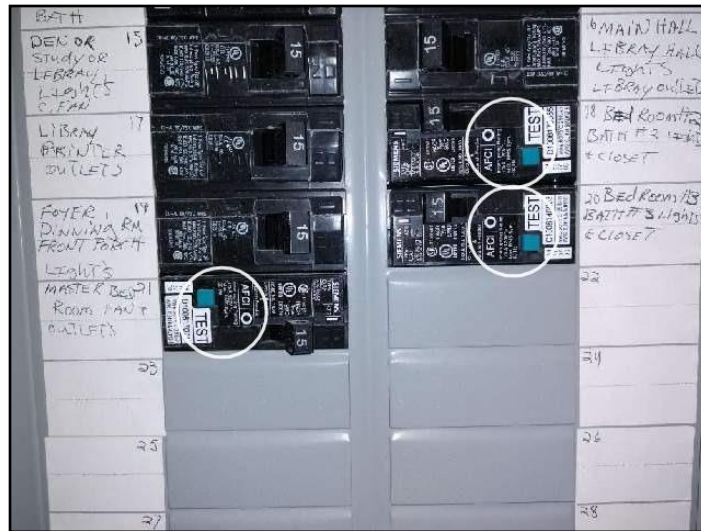
70. Arc fault breakers not tested

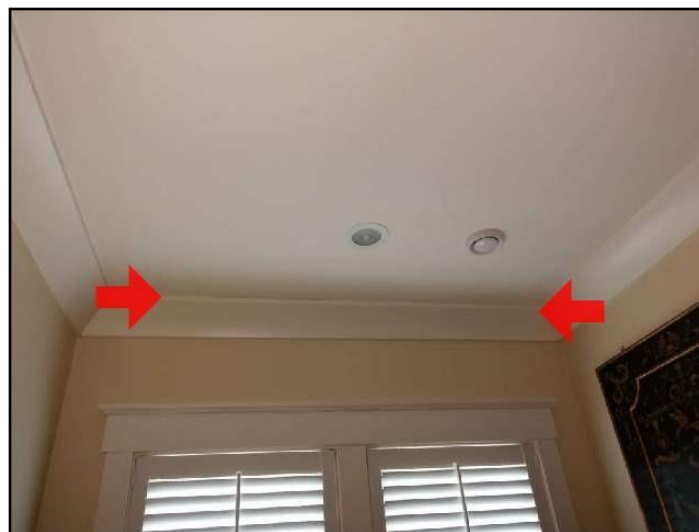
102. Typical flaws

**19. Condition:** • [Typical flaws](#)

**Task:** Repair recommended

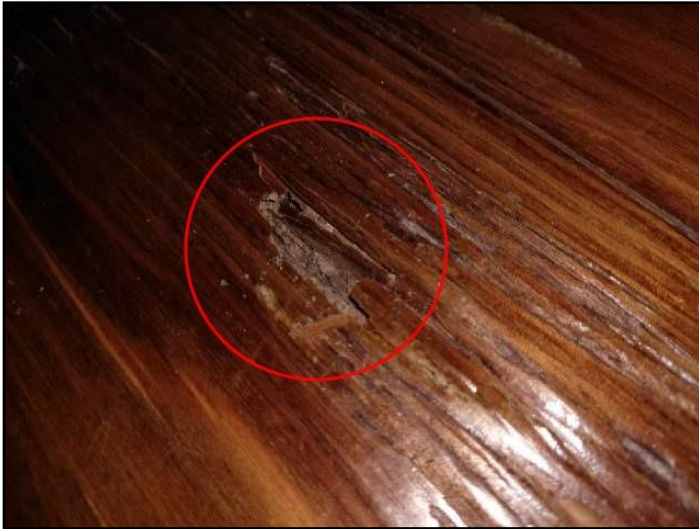
103. Close-up

**20. Condition:** • Insect damage to Floor boards. This damage is near and above the insect activity noted in the crawlspace

**Implication(s):** Insect penetration/Damage

**Task:** Evaluation by a qualified technician or contractor.

**Time:** Prior to closing

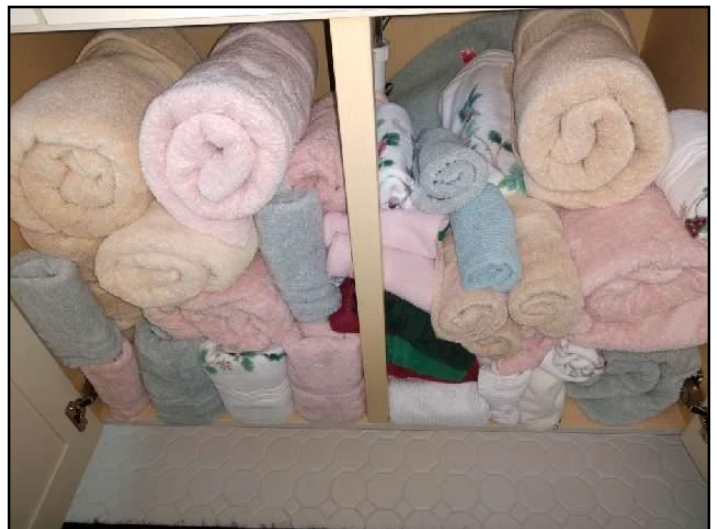
120. Storage in closets and cabinets / cupboards

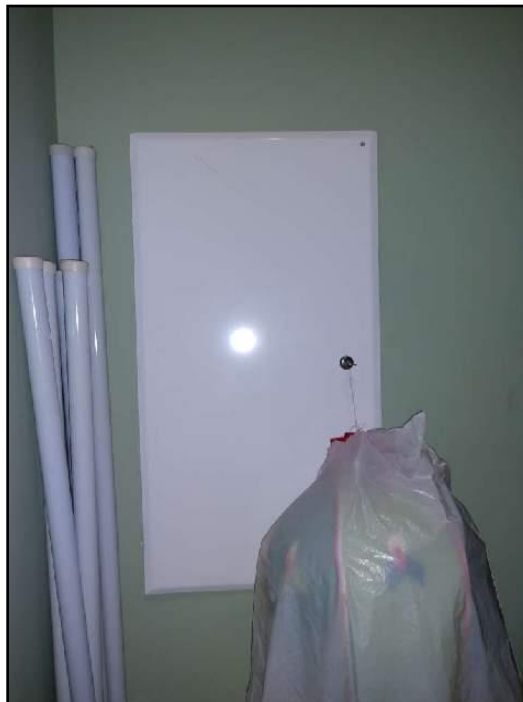
**121.** *Structured wiring panel was not inspected*

If you questions about the configuration and function of this panel you should contact a qualified technician prior to closing.
