# INSPECTION REPORT

1234 Sample Street, Calgary  
AB S1M P1E

**Dettexx Enterprises**

October 18, 2019

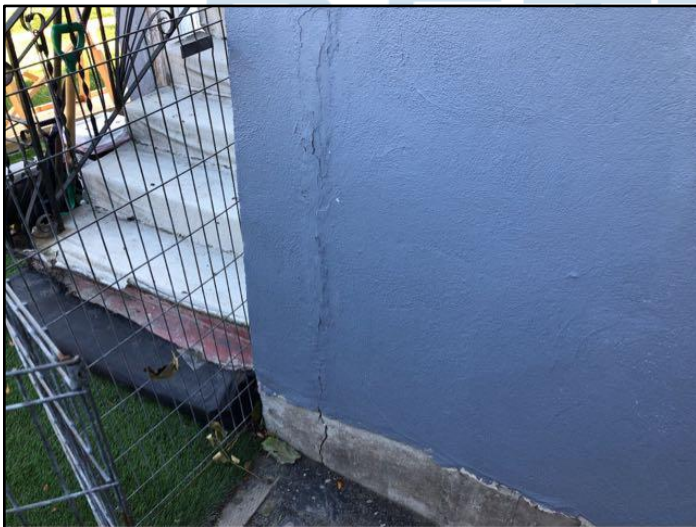
Cracked

**Task:** Correction by qualified contractor

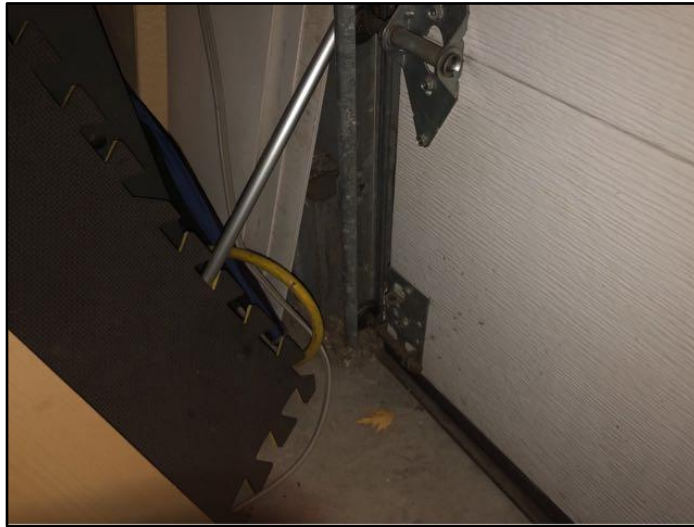
Sensors poorly located

**Notes:** No sensors on this door - safety issue - not to current standards**Implications:** Physical injury**Location:** First Floor Garage**Task:** Provide**Time:** Immediate

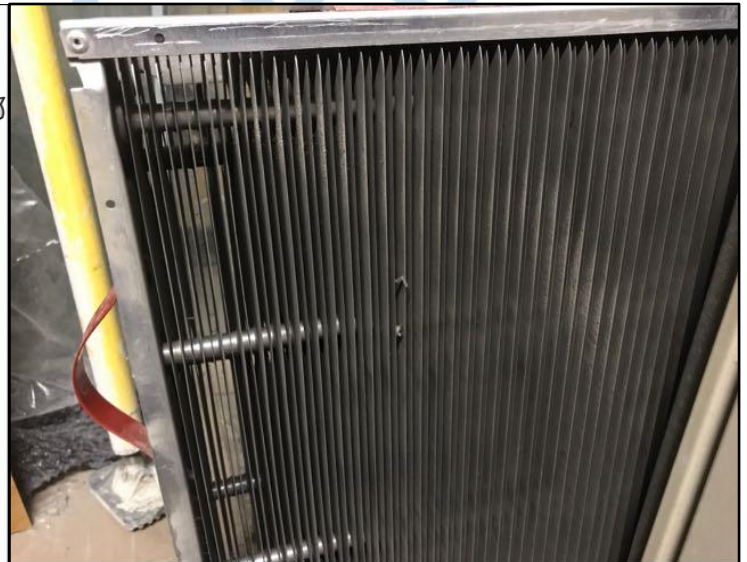
### Dirty

### Electronic air cleaner problems

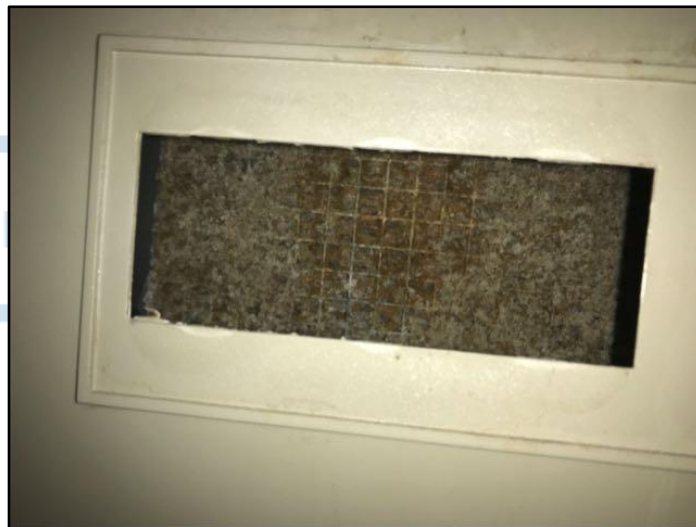
[Clogged pad, mesh or nozzle](#)

**Implications:** Equipment not operating properly

**Task:** Clean
