INSPECTION REPORT

XXXXXXXXXX
ANYWHERE, OK

Inspection Date: Tuesday, June 26, 2018

RE: Report No. 1004, v.4

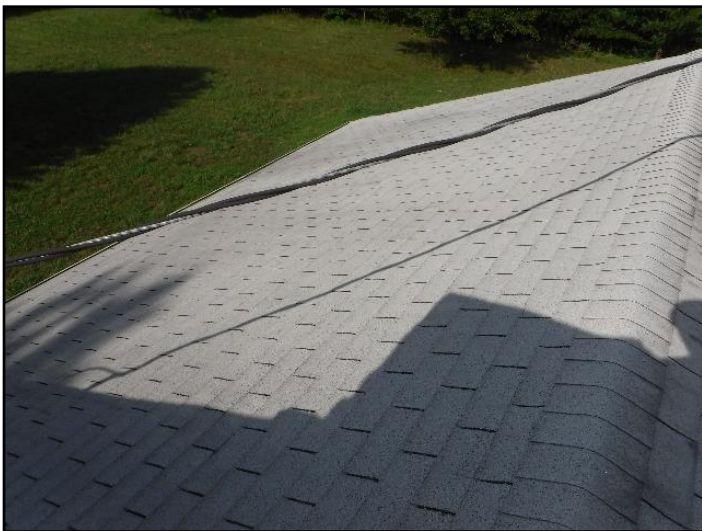
The asphalt shingles on the roof are 3 tab...

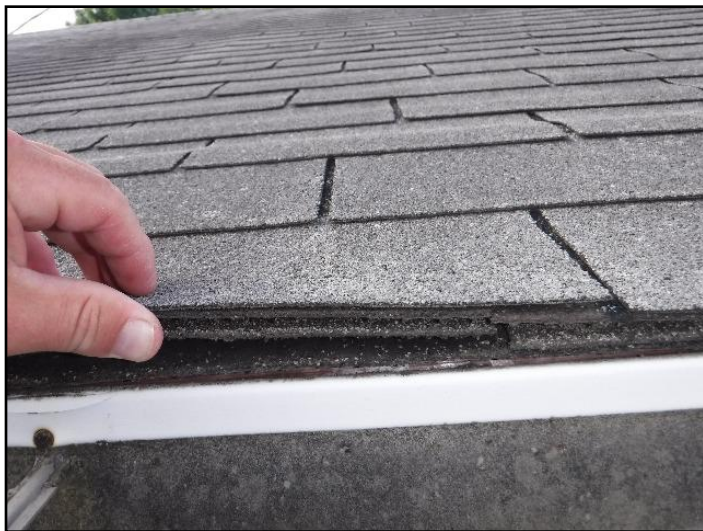
The asphalt shingles on the roof are 3 tab...

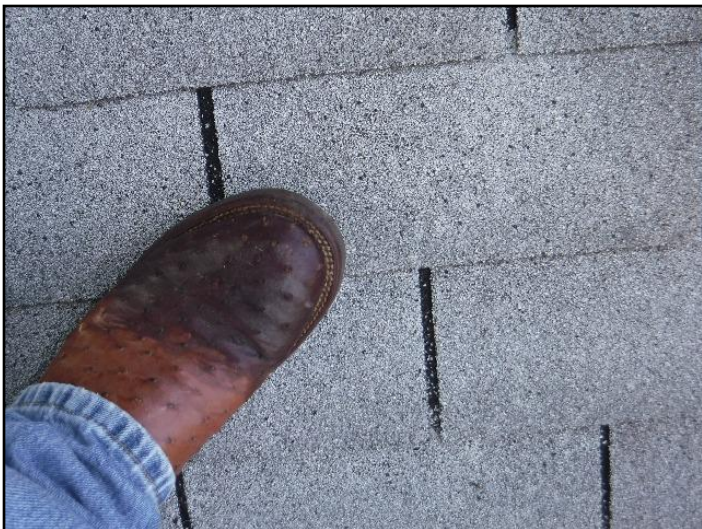
The asphalt shingles on the roof are 3 tab...

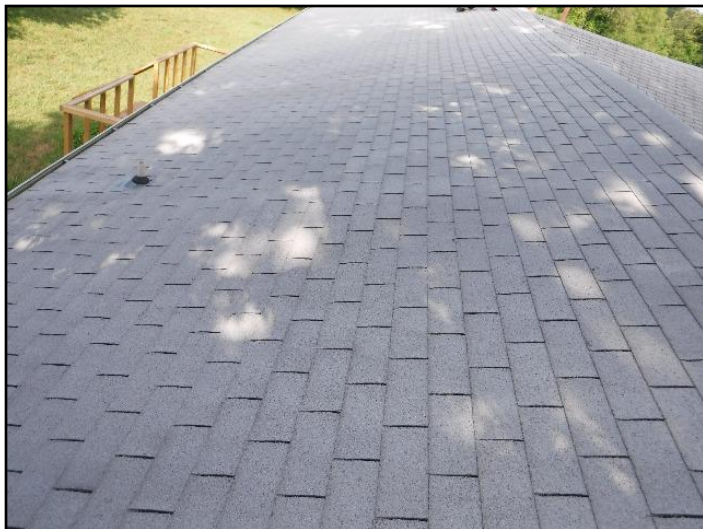
The asphalt shingles on the roof are 3 tab...

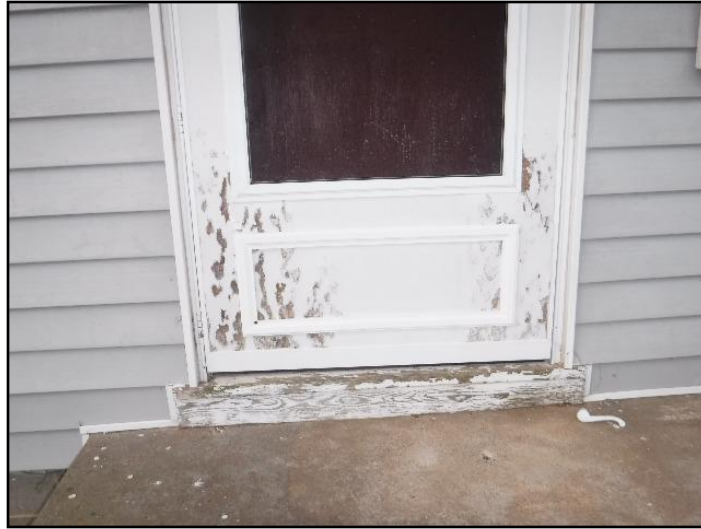
13. Condition: • [Delaminated](#)

Task: Monitor and repair as needed
