# INSPECTION REPORT

For the Property at:  
**123 YOUR STREET**  
NEW ORLEANS, LA

Prepared for: SAMPLE REPORT  
Inspection Date: Tuesday, April 25, 2023  
Prepared by: Turk Schexnayder LHI Lic.10679

RE: Report No. 2508, v.4  
123 Your Street  
New Orleans, LA

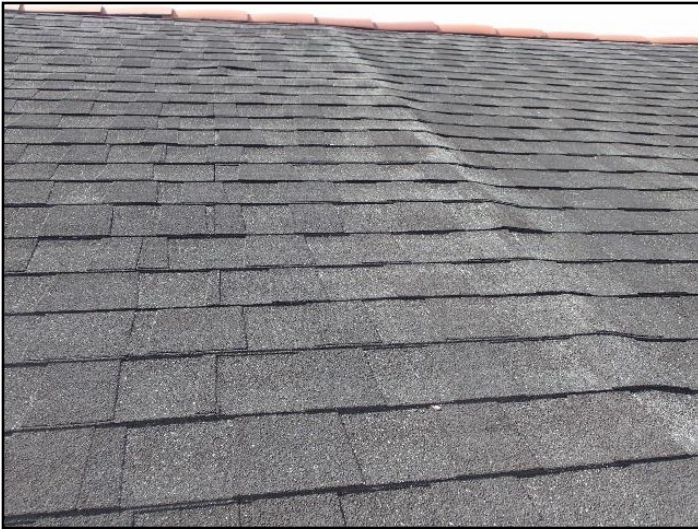
All deficiencies may not be mentioned or pictured. The following items were noted to support my opinion for further evaluation. The roof appears to be approximately 15-20 years old with fungal staining on north side and loose granules on south side. Torn shingles, raised fasteners, satellite dish on roof and no visible flashing at gable wall and roof with no spacing of siding over roof. Turbine installed at improper angle. Raised areas noted at rafter at addition and curling noted toward front. Staining on roof decking and ceilings also noted. In my opinion, based on the age, and condition of the roof, replacement is recommended over repairs.

2. Raised area at ridge

**1. Condition:** • Consider a more detailed evaluation of the roof system by a qualified roofer. This should include recommendations and cost estimates.

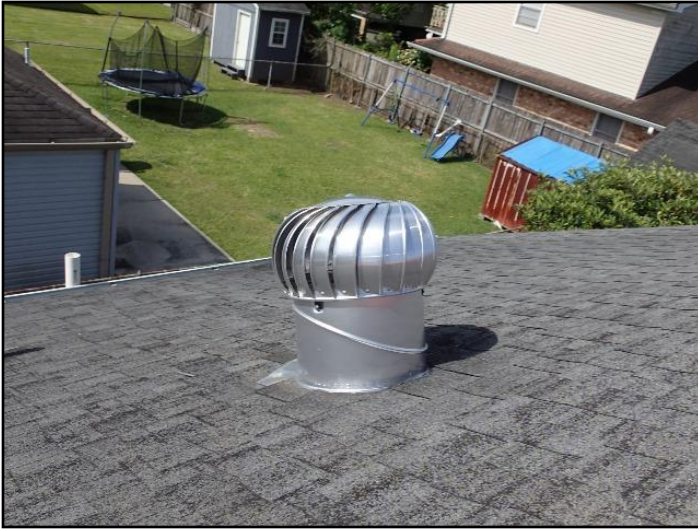
6. Installed at incorrect angle

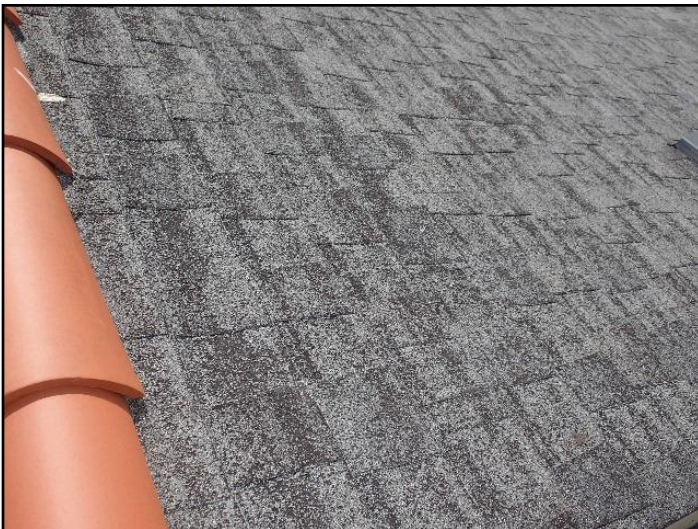
8. Granule loss

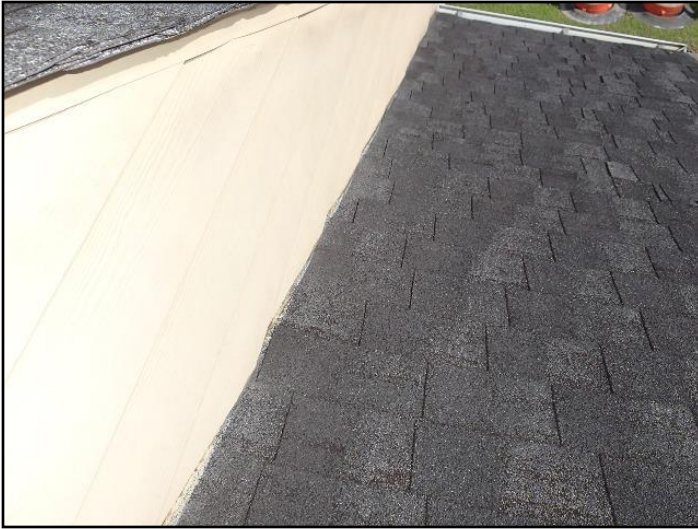
10. No visible flashing and no spacing

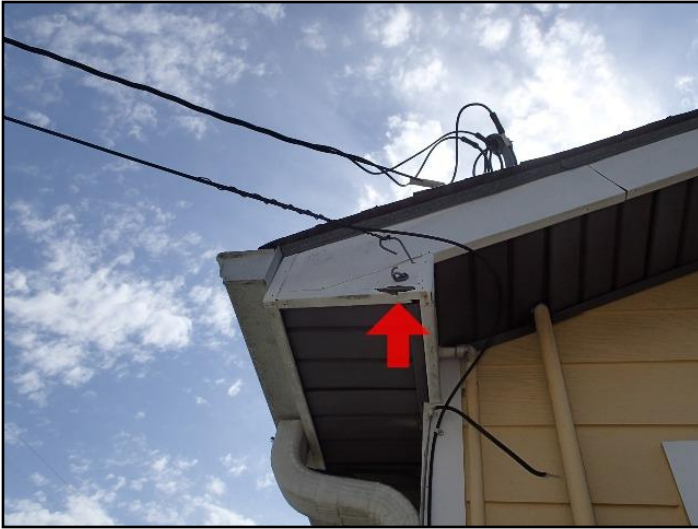
**7. Condition:** • Open seams in siding

24. Open seams in siding

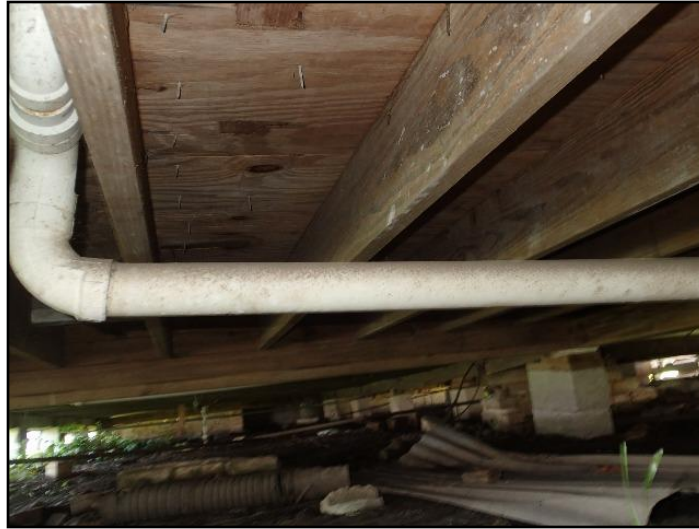
31. Low height clearance and debris limited...

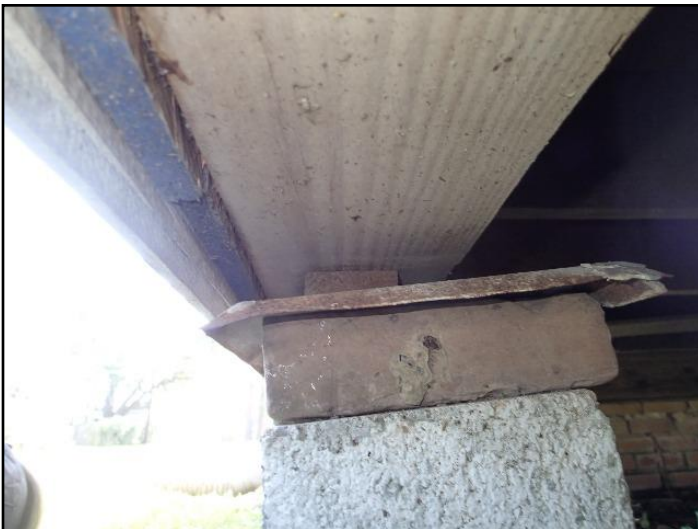
Damaged piers noted; Leaning pier with poor support or poor bearing; Crack in CMU block pier; Ledger board for porch not connected properly; Front sill appeared twisted and had poor bearing; Poor bearing below joint on center beam; Missing pier & leaning pier with poor support; No bearing on pier below right side door; Leaning pier below bounce beam; Missing mortar on brick infill below front wall was also noted.

38. Poor bearing

**Task:** Further evaluation is recommended. Evaluation should include a scope of work and cost estimates.

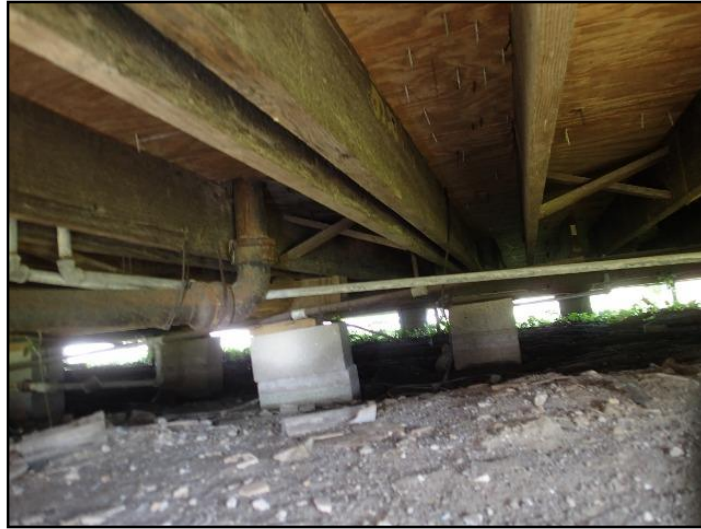
**44.** *Leaning pier below bounce beam*

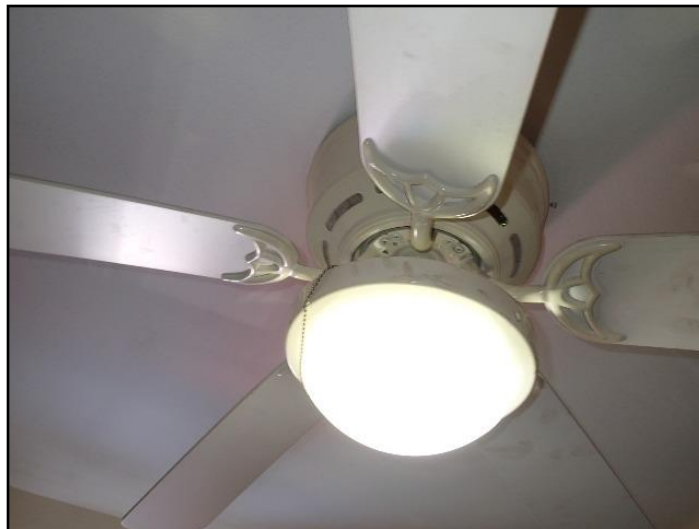
56. Ceiling fan problems

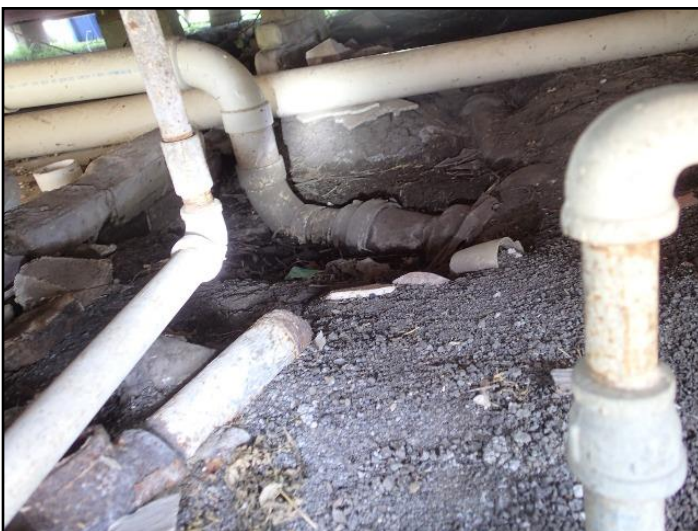
73. Wet area at connection

**Task:** Further evaluation

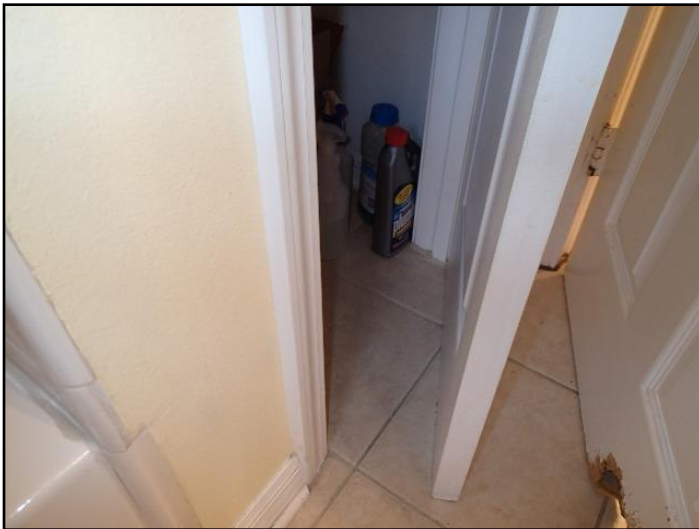
89. *Binds*

**Task:** Adjust

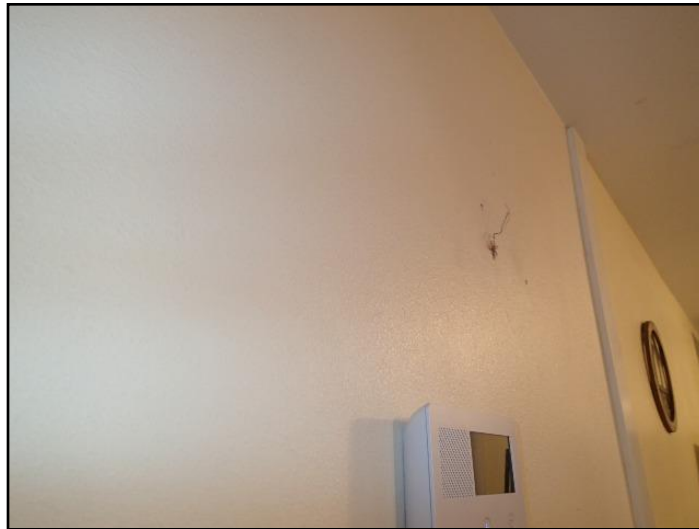
removed. This is an observation only.

**93.** *Wires coming out of wall.*
