# Your Inspection Report

103 Longwater Chase  
Markham, ON L3R 4A9

Wednesday, August 19, 2026

RE: Report No. 11106  
103 Longwater Chase  
Markham, ON  
L3R 4A9

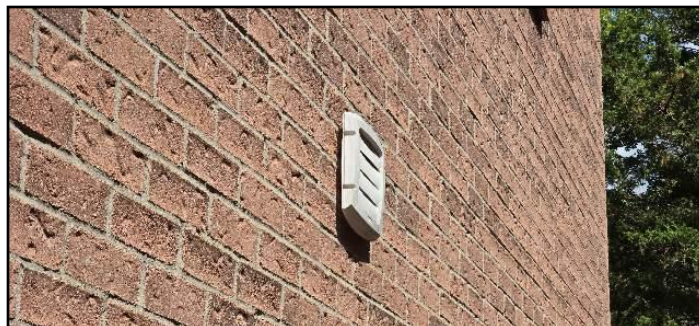
9.

## WALLS \ Vent (fan, clothes dryer, etc.)

**Task:** Correct

**Time:** As soon as practical

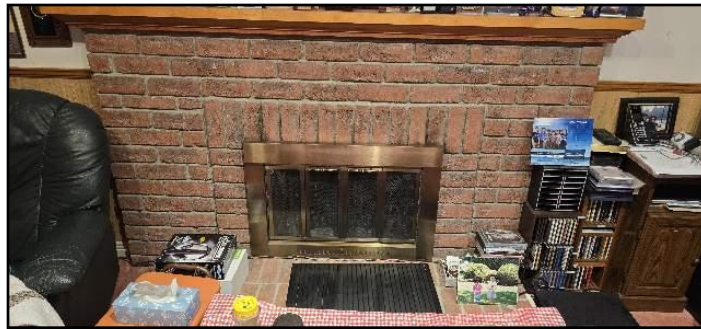
79.

• [Wood-burning fireplace](#)

WETT certify before use

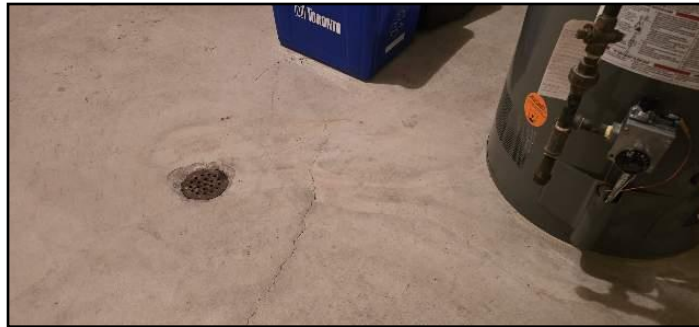
87.

**Floor drain location:**

- Near water heater

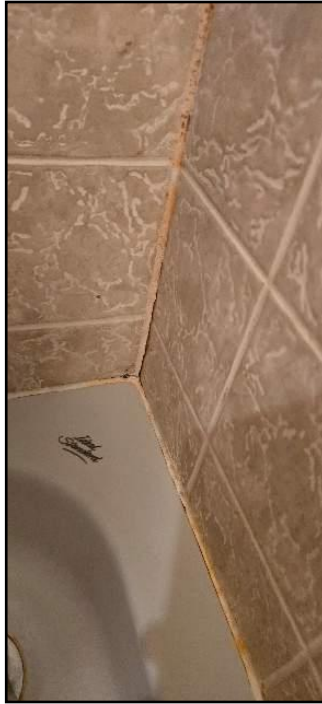
88.

**Condition:** • Ongoing regular maintenance is needed for grout, caulking in showers, sinks and bath tub areas. It is strongly recommended that the grout and caulking materials be inspected once a year for deterioration and to be repaired or replaced as needed.

**Task:** Repair/seal

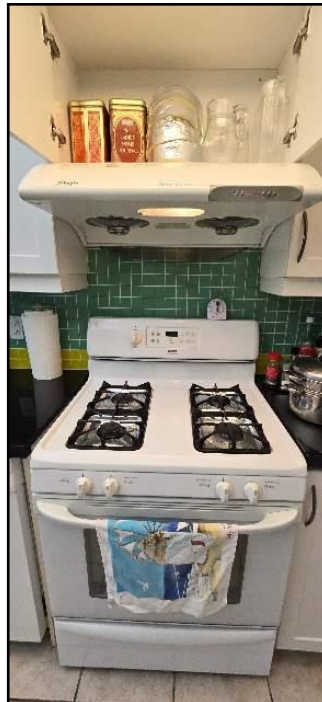
89.

**Kitchen ventilation:**

• Range hood
