YOUR Inspection Report

Sample Home
My Town, ON

Monday, June 10, 2013

Rick Clayton CMI RHI WRT AMRT

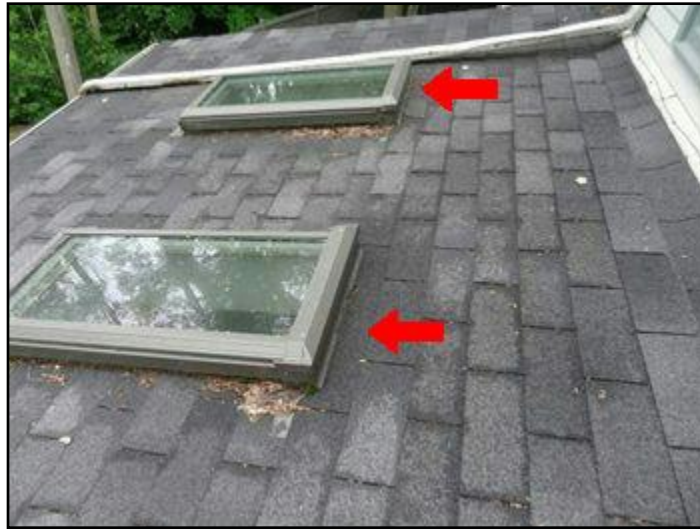
Condition: • Wrong, incomplete flashings

flashing at top of skylight is incomplete. New curb has been installed on upper sky lights but is missing on lower skylight. monitor for leakage. no moisture found during inspection. repairs and replacement of shingles noted in skylight areas.

proper installation of skylight.

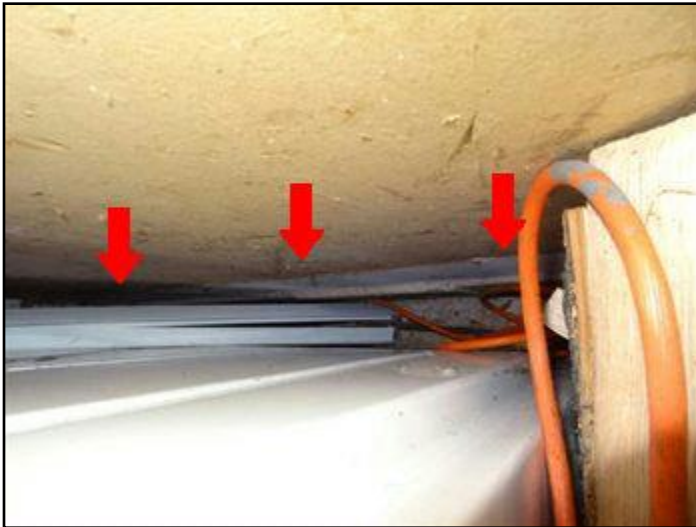
EXTERIOR GLASS/WINDOWS \ Glass (glazing)

Condition: • Lost seal on double or triple glazing
seal lost on skylight, replace and needed

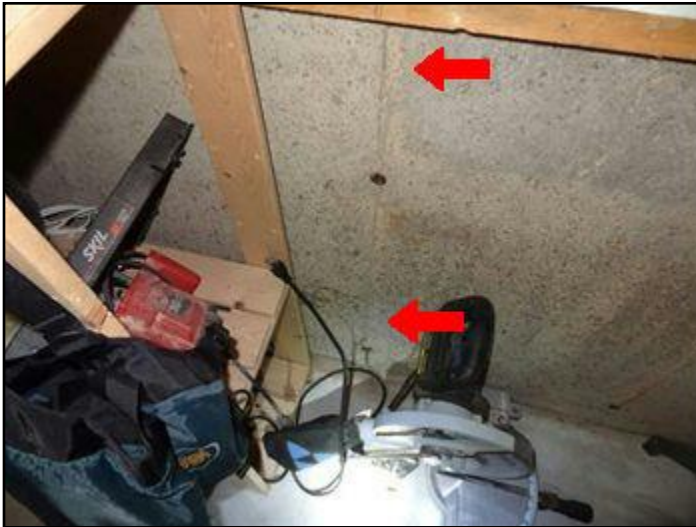
Condition: • Cracked

signs of past leakage noted at rear of the home, cracks below windows and at connection to well. monitor and correct as needed

Implication(s): Chance of water damage to contents, finishes and/or structure | Weakened structure

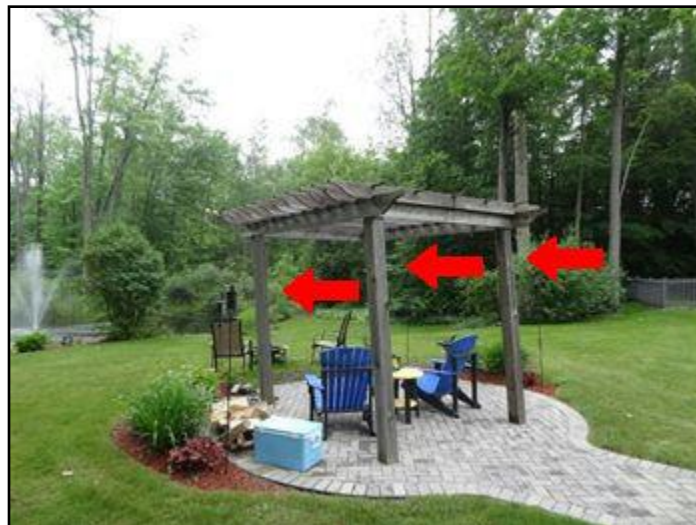
Condition: • Leaning

correct structure, loose and leaning.

Task: Correct

Time: Immediate

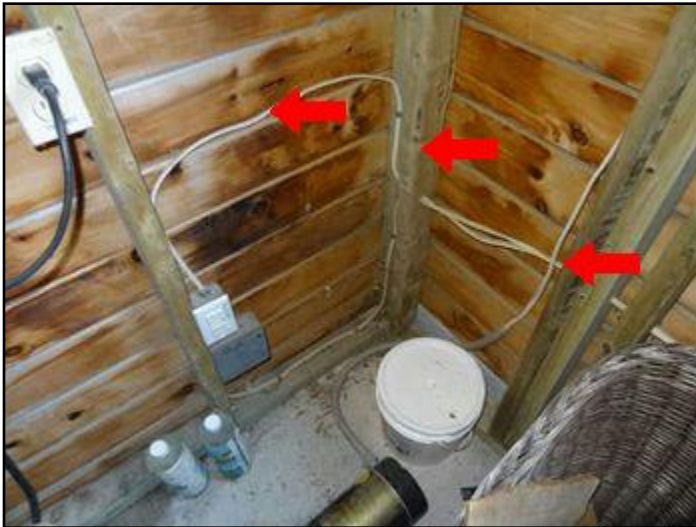
DISTRIBUTION SYSTEM \ Wiring - damaged or exposed

Condition: • Exposed on walls or ceilings

Protect wiring from possible damage.

Task: Protect

Time: Immediate

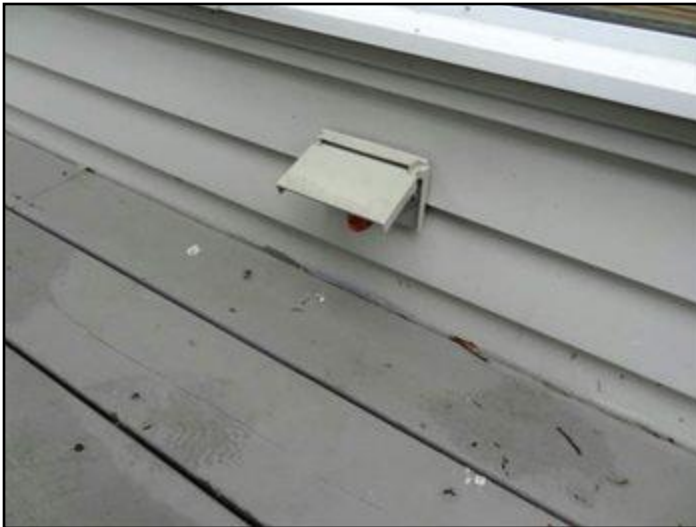
DISTRIBUTION SYSTEM \ Outlets (receptacles)

Condition: • Inoperative

outlets have no power, correct, source not found.

Task: Further evaluation

Time: When necessary

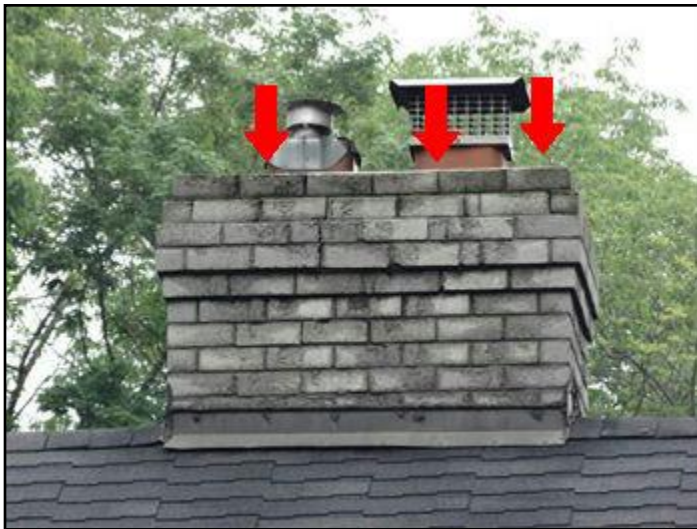
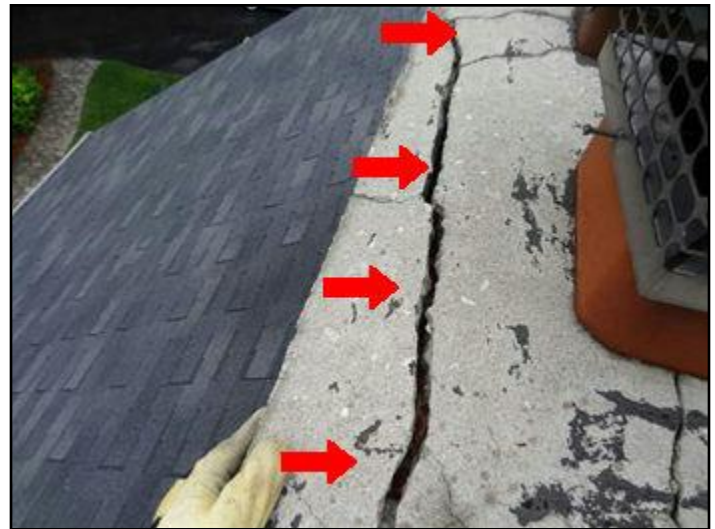
Condition: • Cracked

Implication(s): Chance of water damage to contents, finishes and/or structure | Shortened life expectancy of material

Seal Chimney cap to prevent leakage,

Time: Less than 1 year

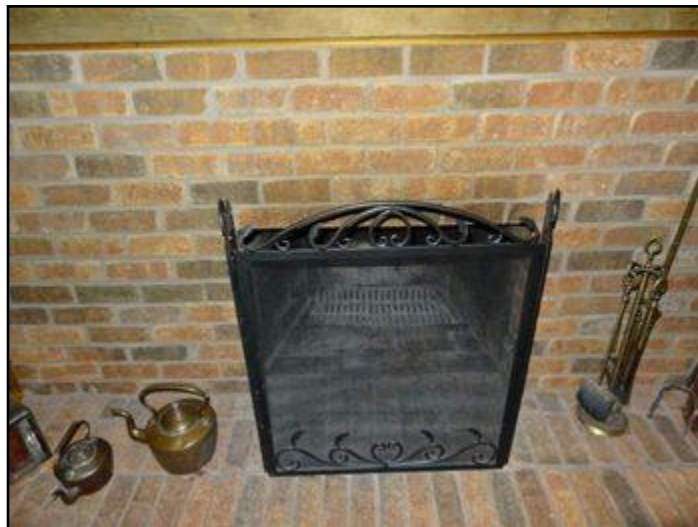
FIREPLACE \ General

Condition: • Inspect chimney, and sweep, if needed before using
Clean and provide WETT inspection prior to use.

Implication(s): Fire hazard

Task: Provide

Time: When necessary

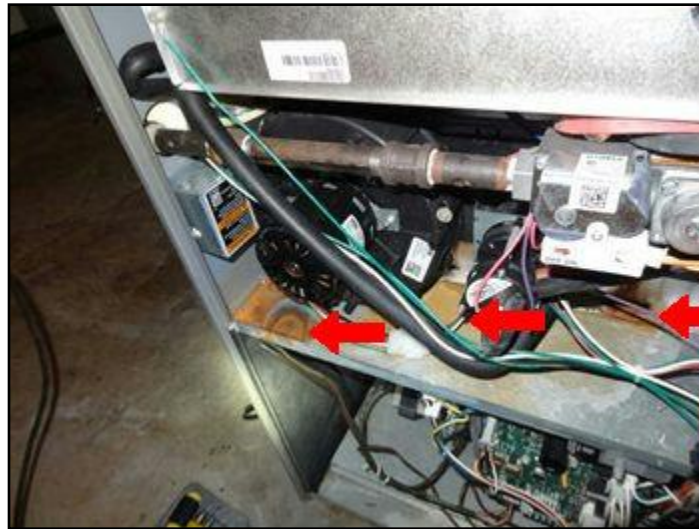
AIR CONDITIONING \ Condensate system

Condition: • Pan leaking

condensation leak noted at furnace. correct.

Implication(s): Chance of water damage to contents, finishes and/or structure | Damage to equipment

Task: Correct

Time: Immediate

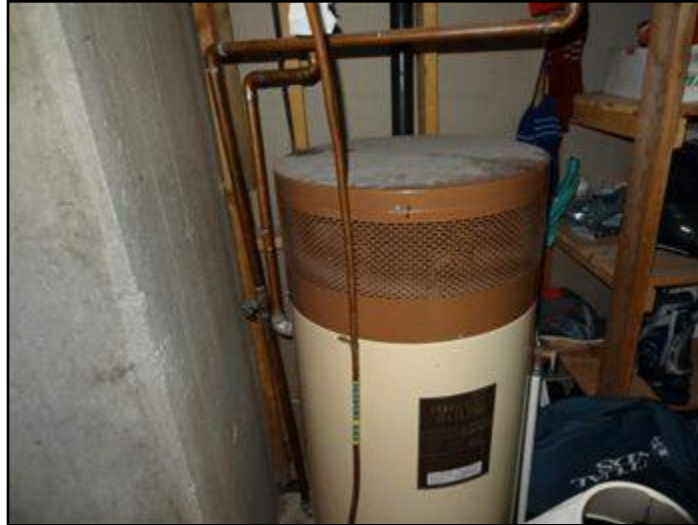
Condition: • Near end of life expectancy

Task: Replace

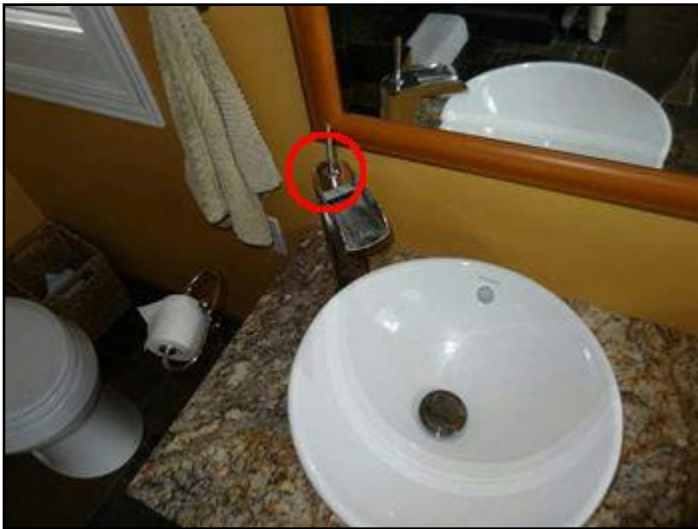
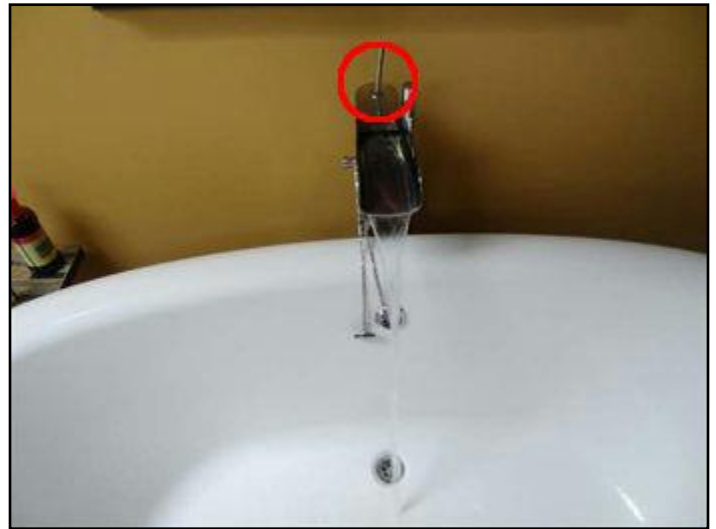
Condition: • Hot and cold reversed
correct, hot and cold are reversed.

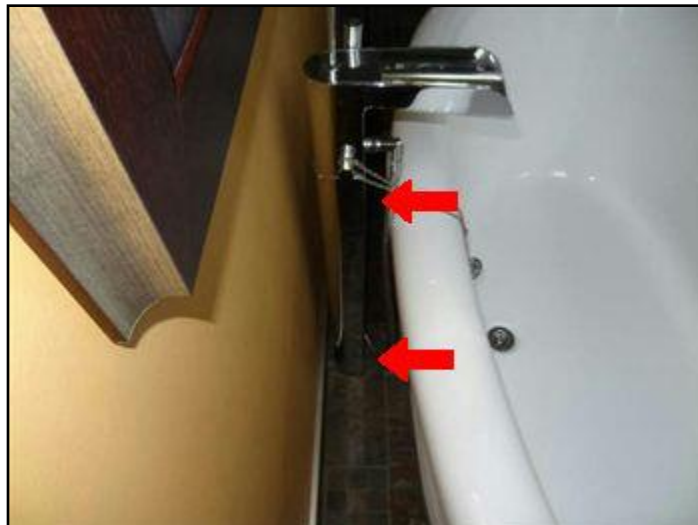
Condition: • Loose

properly secure faucet, loose

Task: Correct

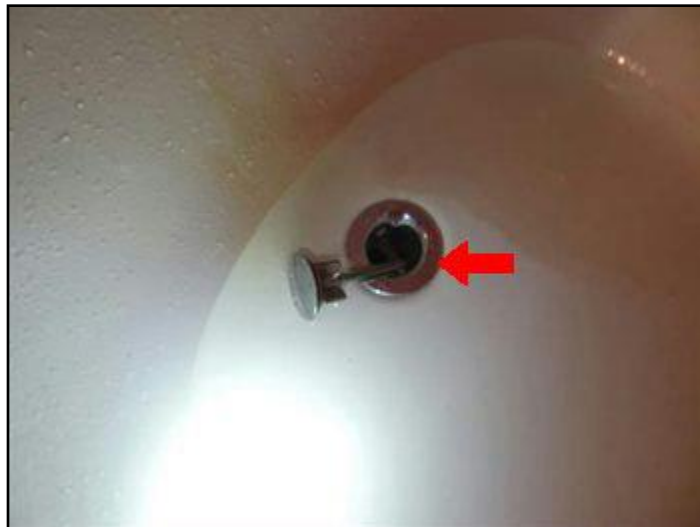
Condition: • Drain stop ineffective
repair drain stop as needed

Task: Correct

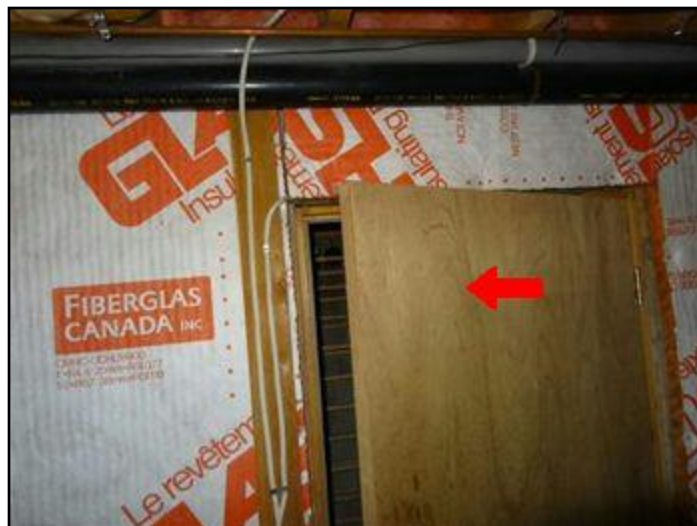
Condition: • Replace cold room door with insulated exterior type door

Task: Replace

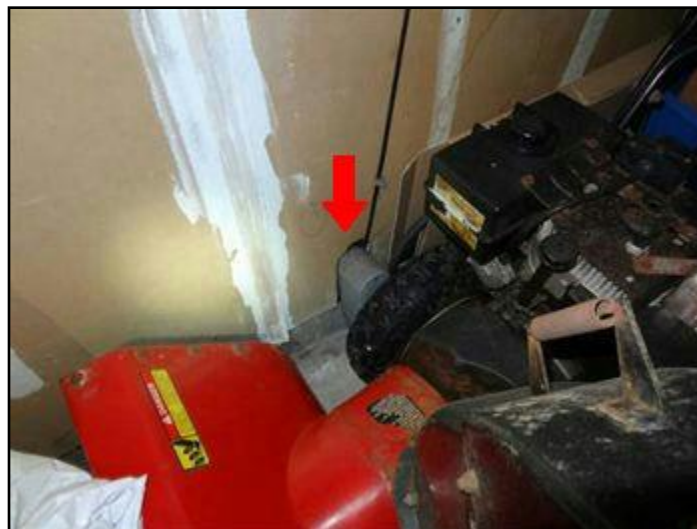
Condition: • Not gastight

Implication(s): Hazardous combustion products entering home

Task: Correct
