#### FOR THE PROPERTY AT:

123 Sample Address Virginia Beach, VA 23455

Friday, June 9, 2017

RE: Report No. 1319, v.5 123 Sample Address Virginia Beach, VA 23455

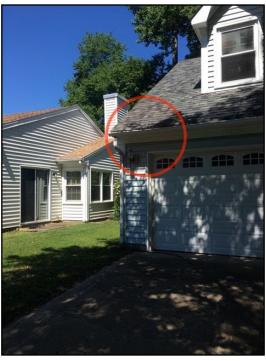
2. Loose

Condition: • Loose

Location: Front Left First floor Exterior

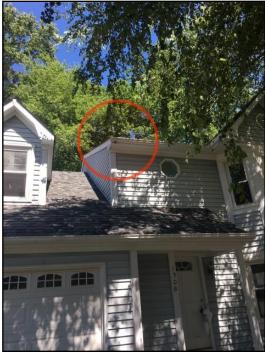
4. Missing

Condition: • Missing

Implication(s): Chance of water damage to contents, finishes and/or structure

Task: Repair or replace

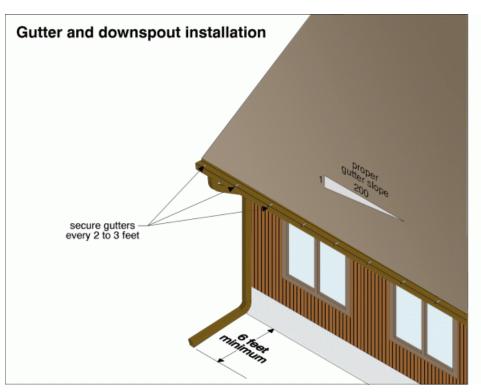
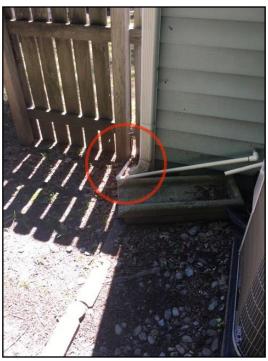
5. Should discharge 6 feet from building

Condition: • Should discharge 6 feet from building

Implication(s): Chance of water damage to contents, finishes and/or structure

Location: Throughout Exterior

Task: Improve

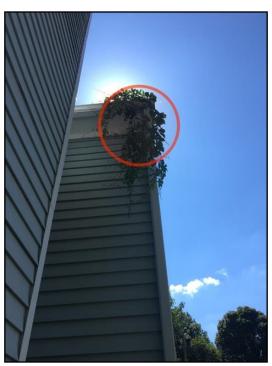
12. Vines on building

Condition: • Vines on building

Implication(s): Chance of pests entering building | Chance of damage to finishes

**Location**: Left Side Exterior **Task**: Repair or replace

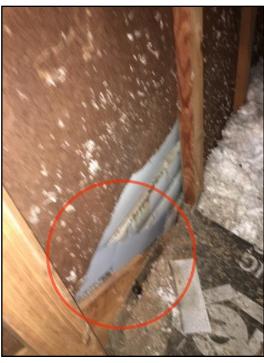
14.

Condition: • Appears there have been prior repairs to replace flashing

Location: Rear Left Attic

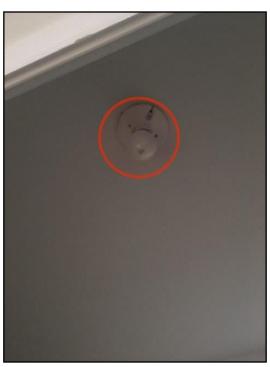
20. Inoperative

Condition: • Inoperative Possibly bulb burned out

Implication(s): Inadequate lighting

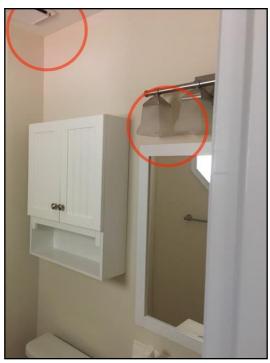
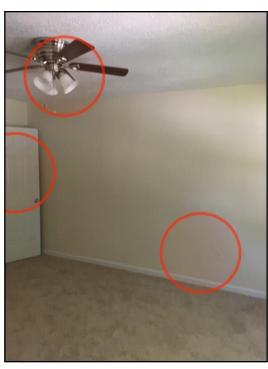
# **DISTRIBUTION SYSTEM \ Outlets (receptacles)**

Condition: • No power in bedroom or master bathroom. Have extractor fan checked too

Location: Front Right Second Floor Bedroom

Task: Further evaluation

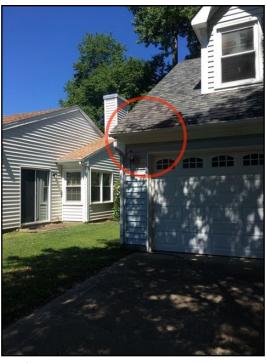
49. Loose

2. Condition: • Loose

Task: Repair or replace

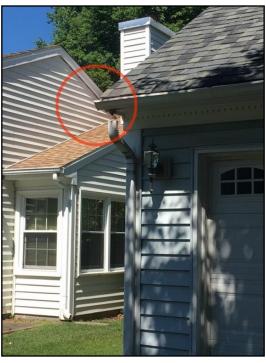
50. Loose connections

#### **ROOF DRAINAGE \ Downspouts**

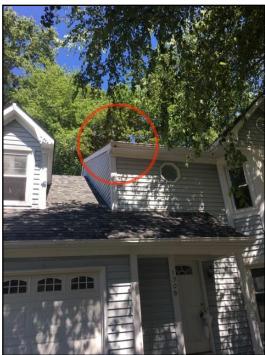
51. Missing

4. Condition: • Missing

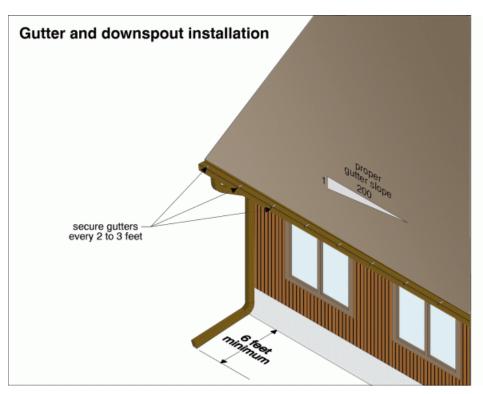
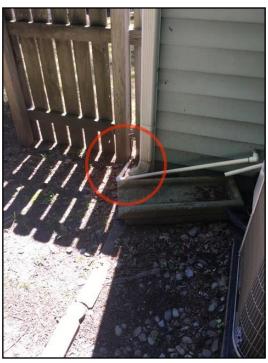
52. Should discharge 6 feet from building

**5. Condition:** • Should discharge 6 feet from building Implication(s): Chance of water damage to contents, finishes and/or structure

**Location**: Throughout Exterior

Task: Improve

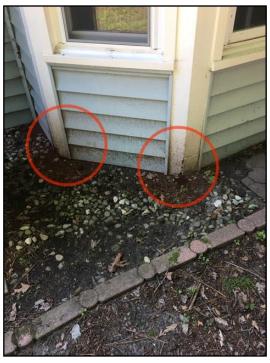
**53.** Rot

#### WALLS \ Trim

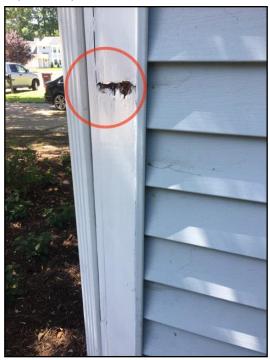
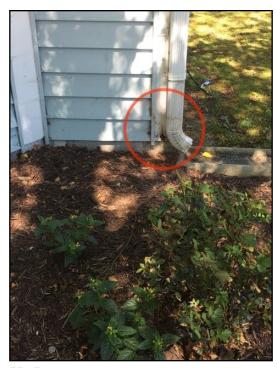
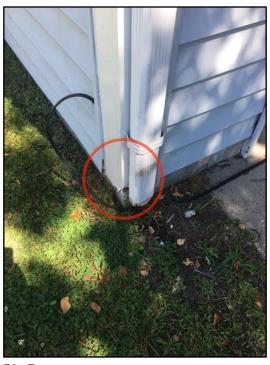
**54.** Rot

7. Condition: • Rot

Location: Front Left and Right Corners Exterior

Task: Repair or replace

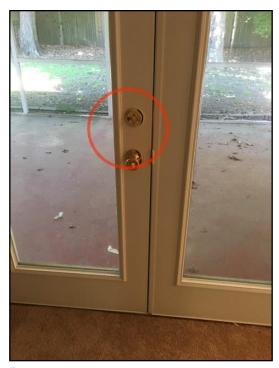
57.

8. Condition: • Bolt lock does not work Location: Rear First Floor Exterior

Task: Repair or replace

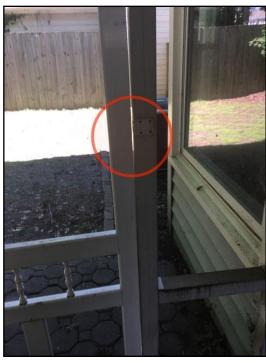
9. Condition: • Inoperable

Screen door hinges missing

Implication(s): Chance of damage to finishes and structure

58. Inoperable

**Location**: Rear Exterior **Task**: Repair or replace

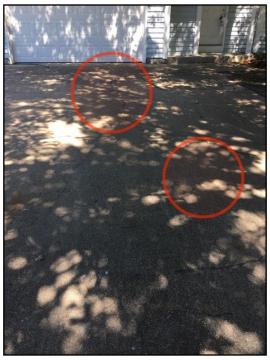
**11. Condition:** • Cracks in concrete driveway need to be sealed/repaired to prevent further moisture penetration/damage. Task: Needs Sealing/Caulking

60. Cracks in concrete driveway need to be...

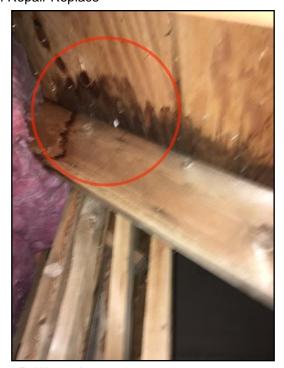
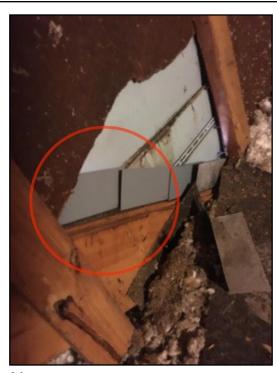
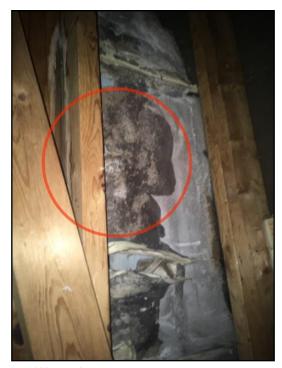
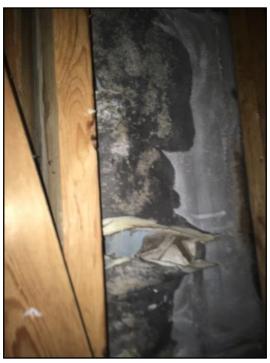
13. Condition: • Water damageWater stain on sheathing and drywall at chimneyLocation: Left Side Second Floor in attic at chimneyTask: Repair Replace

65. Water damage

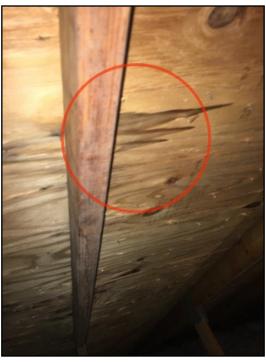
14. Condition: • Water stains Small water stain right of pipe stack Implication(s): Material deterioration

68. Water stains

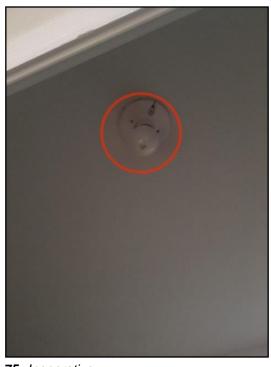
**16. Condition:** • Inoperative Possibly bulb burned out

Implication(s): Inadequate lighting

Location: Right Side Second Floor Bedroom closet

75. Inoperative

Task: Repair or replace

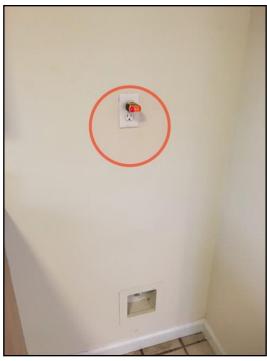
19. Condition: • Reversed polarity

Implication(s): Electric shock Location: Rear Right Kitchen Task: Repair or replace

79. Reversed polarity

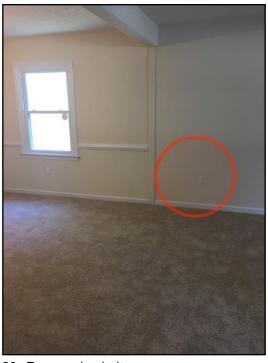
20. Condition: • Reversed polarity

80. Reversed polarity

Task: Repair or replace

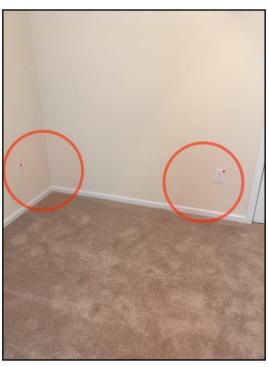
**21. Condition:** • Reversed polarity

81. Reversed polarity

Task: Repair or replace

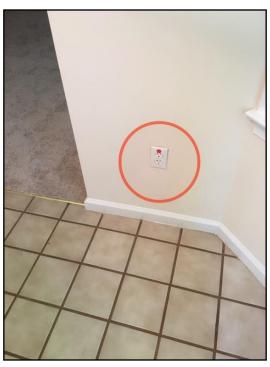
22. Condition: • Ungrounded

82. Ungrounded

Task: Repair or replace

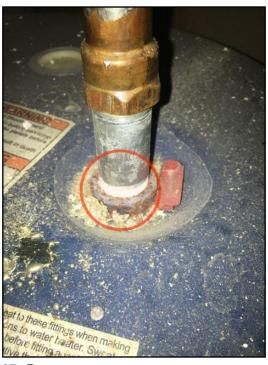
29. Condition: • Rust Implication(s): Leakage

**97.** Rust

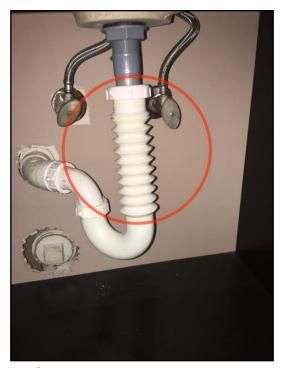
98. Corrugated piping is not ridged nor...

Task: Repair or replace

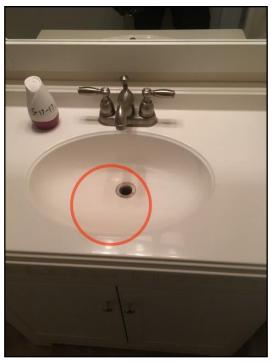
31. Condition: • Drain stop missing Implication(s): Reduced operability **Location**: Second Floor Bathroom

99. Drain stop missing

Task: Repair or replace

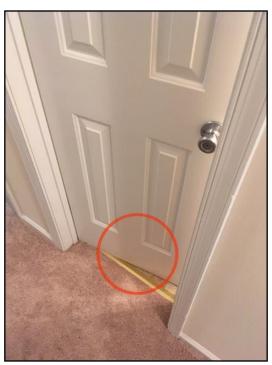
36. Condition: • Stiff

**107.** Stiff

Task: Repair or replace

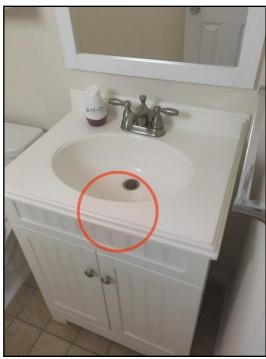
37. Condition: • Loose or missing pieces

Loose

**108.** Loose or missing pieces

Task: Repair or replace

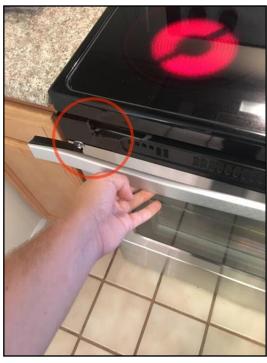
39. Condition: • Handle defective

109. Handle defective

Location: Kitchen Task: Repair or replace

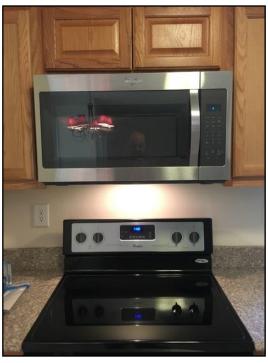
110.

**40. Condition:** • Recirculating fan is noisy Location: Rear Right First Floor Kitchen

Task: Repair or replace

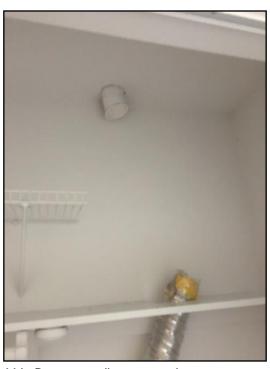
41. Condition: • Dryer vent disconnected

Implication(s): Chance of damage to finishes and structure | Equipment not operating properly | Fire hazard | Odors,

111. Dryer vent disconnected

Task: Repair or replace
