Your Inspection Report

XXX Sample street
Calgary, AB

INSPECTION DATE:
Tuesday, March 11, 2008

Hawkeye Property Services
426 21 ave NE
Calgary, AB T2E 1S6

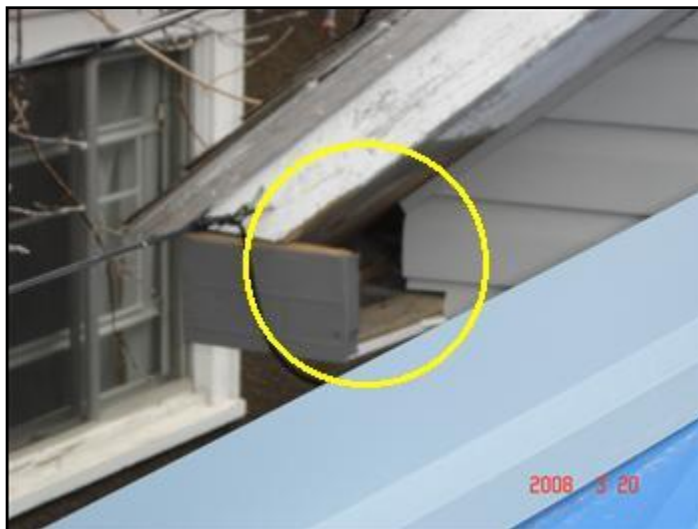
1.

SLOPED ROOFING \ Asphalt shingles

Condition: • [Damage](#)

one spot of burn though

Implication(s): Chance of water damage to contents, finishes and/or structure

Task: Replace

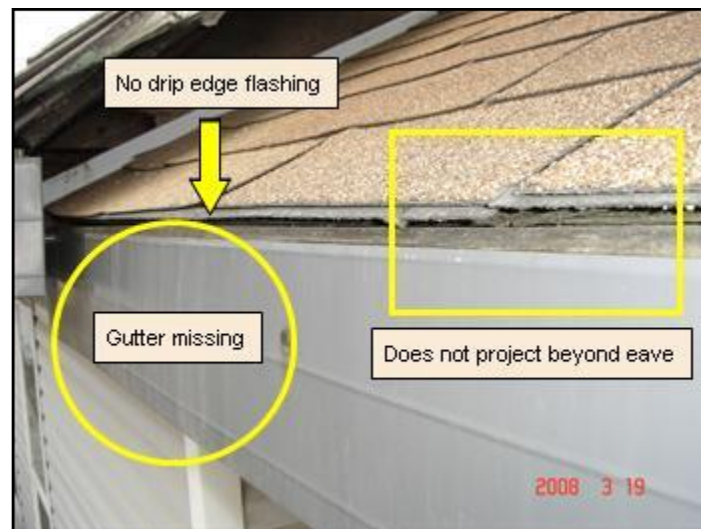
3.

SLOPED ROOFING \ Wood shingles and shakes

Condition: • [Old, worn out](#)

Implication(s): Chance of water damage to contents, finishes and/or structure

Task: Replace

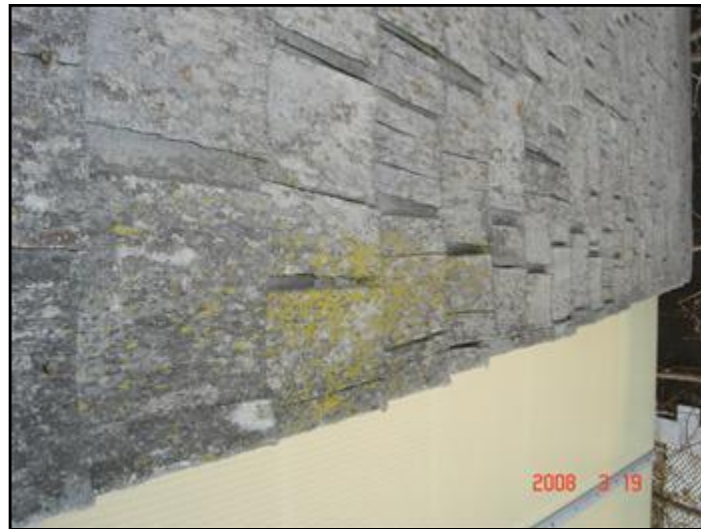
4.

Condition: • [Damaged, broken or missing pieces](#)

Implication(s): Chance of water damage to contents, finishes and/or structure

Task: Replace

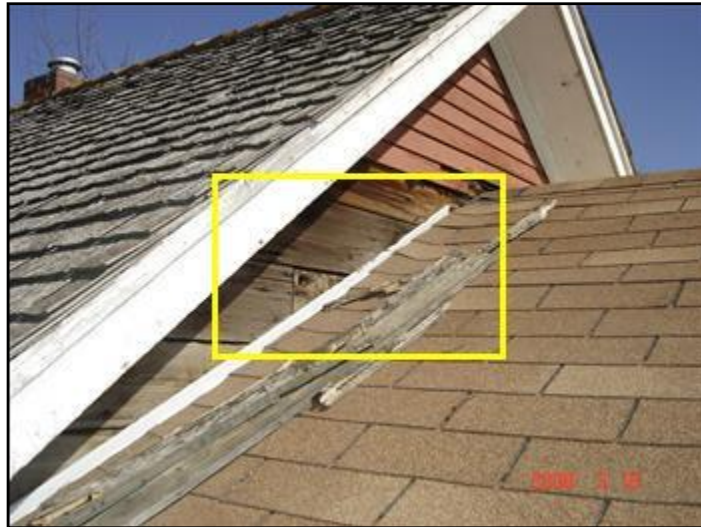
7.

SLOPED ROOF FLASHINGS \ Pipe/stack flashings

Condition: • Very old plumbing stack flashing, likely failed, replace when re-roofing.

Implication(s): Leakage

Task: Replace

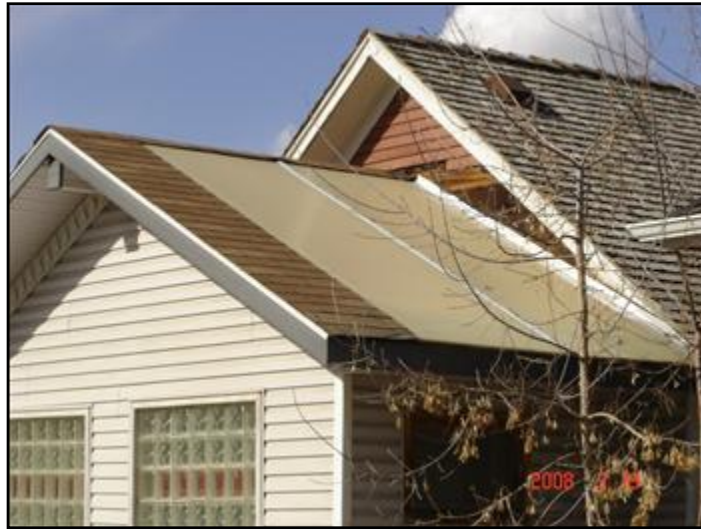
9.

SLOPED ROOF FLASHINGS \ Drip edge flashings

Condition: • [Missing](#)

Implication(s): Chance of water damage to contents, finishes and/or structure

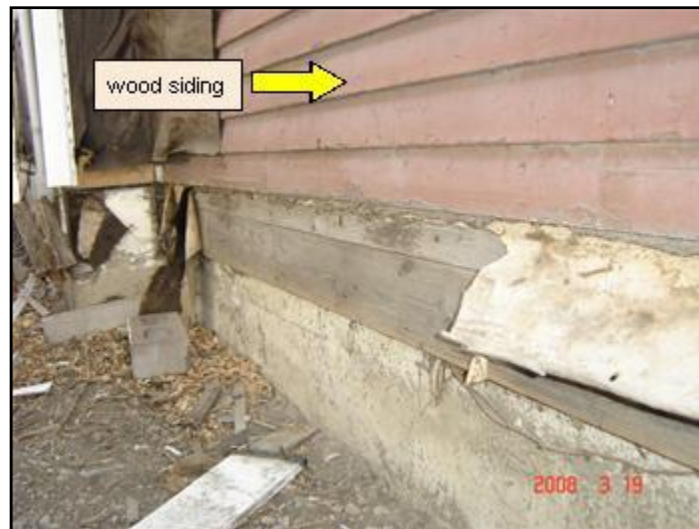
12.

Fence in very poor condition, several trees growing on both fence lines.

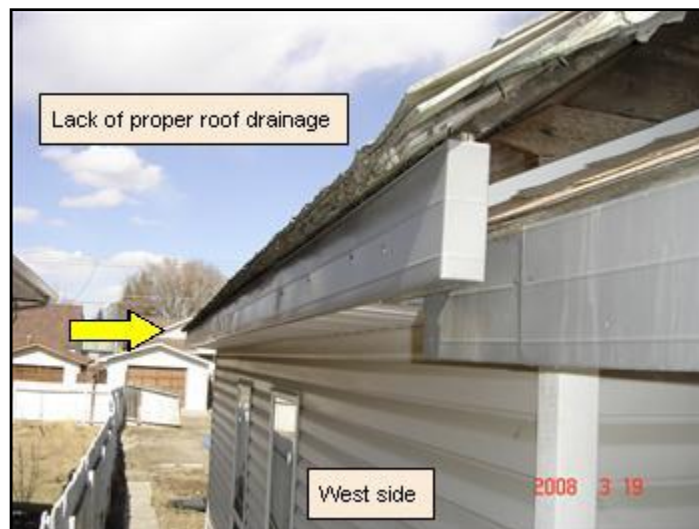
17.

ROOF DRAINAGE \ Downspouts

Condition: • [Missing](#)

Implication(s): Chance of water damage to contents, finishes and/or structure

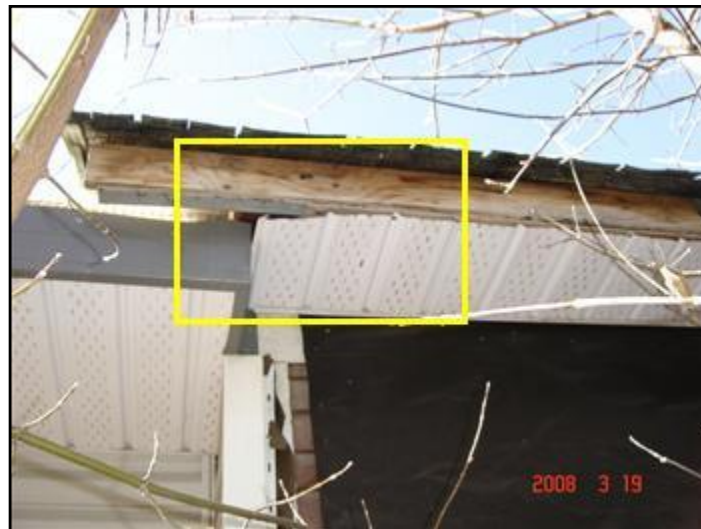
18.

WALLS \ Flashings and caulking

Condition: • [Flashings missing](#)

Implication(s): Chance of water damage to contents, finishes and/or structure

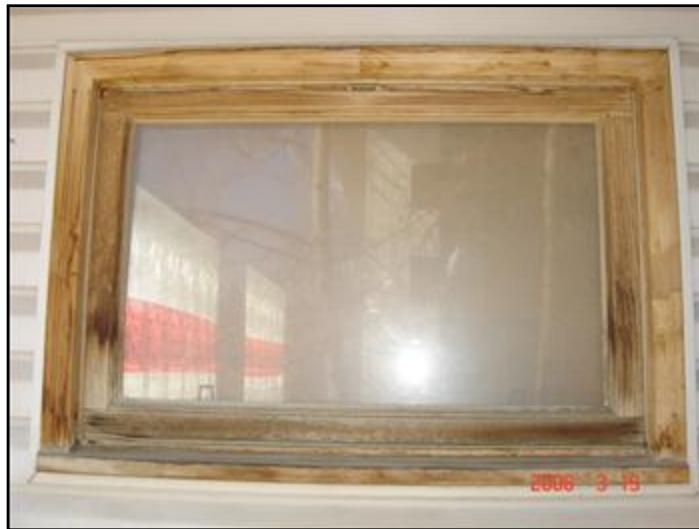
24.

EXTERIOR GLASS \ Exterior trim

Condition: • [Missing or loose pieces](#)

Implication(s): Cosmetic defects | Chance of water damage to contents, finishes and/or structure

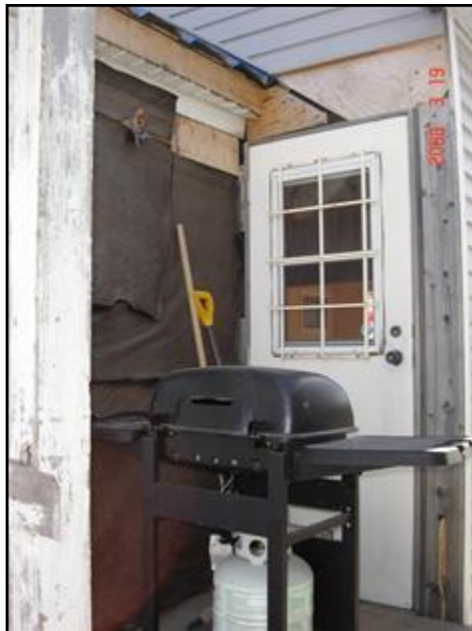
28.

DOORS \ Exterior drip caps

Condition: • [Missing](#)

Implication(s): Chance of damage to finishes and structure

Task: Provide

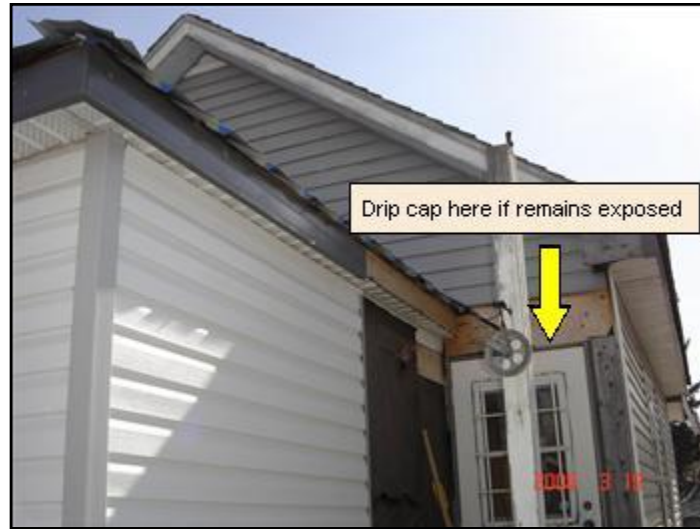
29.

DOORS \ Glass

Condition: • Back door window difficult to operate

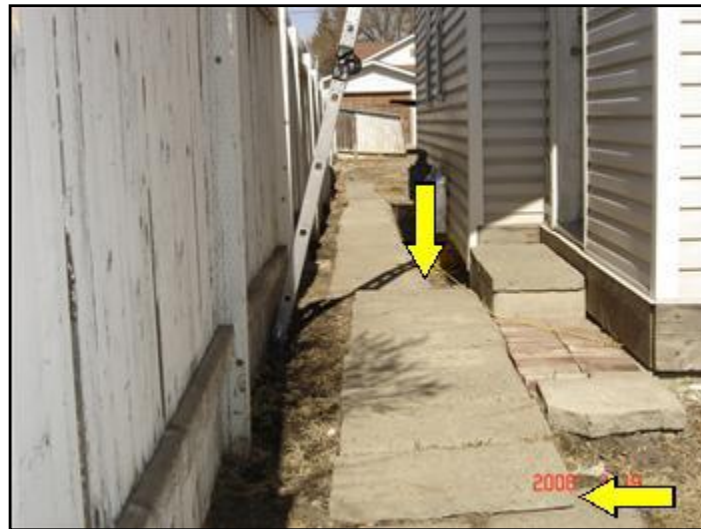
30.

PORCHES, DECKS, STEPS, PATIOS AND BALCONIES \ General

Condition: • Unsafe

Unfinished back porch area exposed to elements and unsafe for use.

Task: Improve

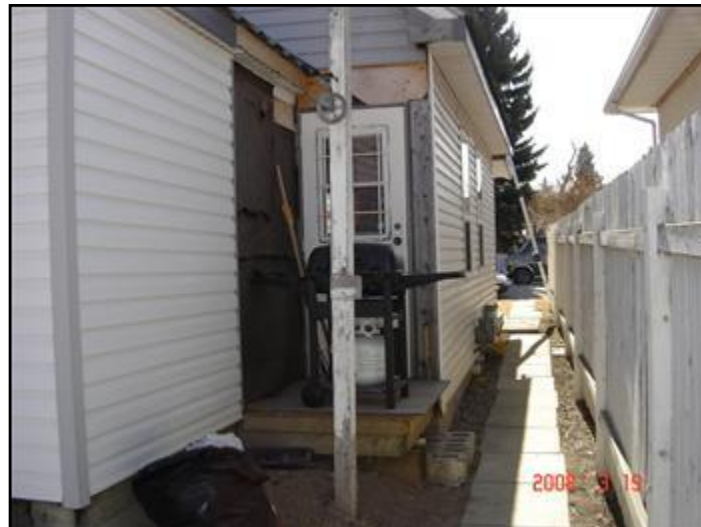
31.

LANDSCAPING \ Lot grading

Condition: • [Improper slope](#)

Implication(s): Chance of water damage to contents, finishes and/or structure

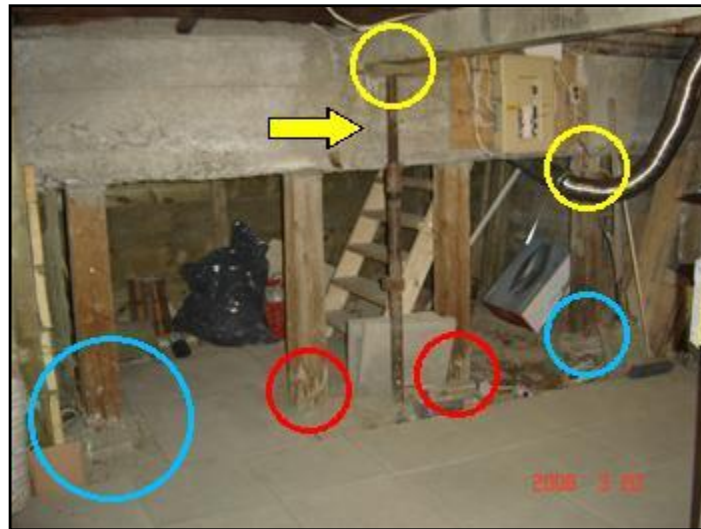
43.

Condition: • [Poorly secured at top or bottom](#)

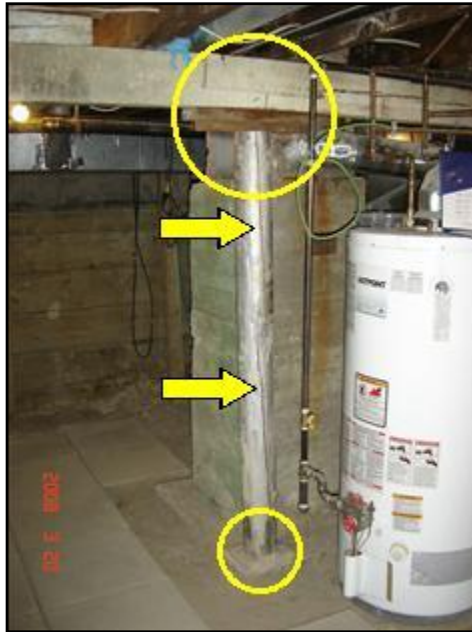
44.

Condition: • [Prior repairs](#)

Steel columns used to replace/augment older wood columns.

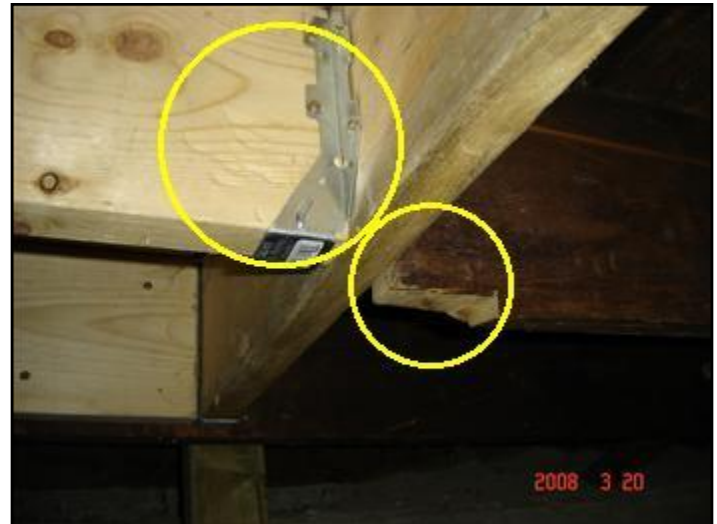
51.

Condition: • [Prior repairs](#)

Below rear entrance interior floor, existing joist unsupported as previously noted.

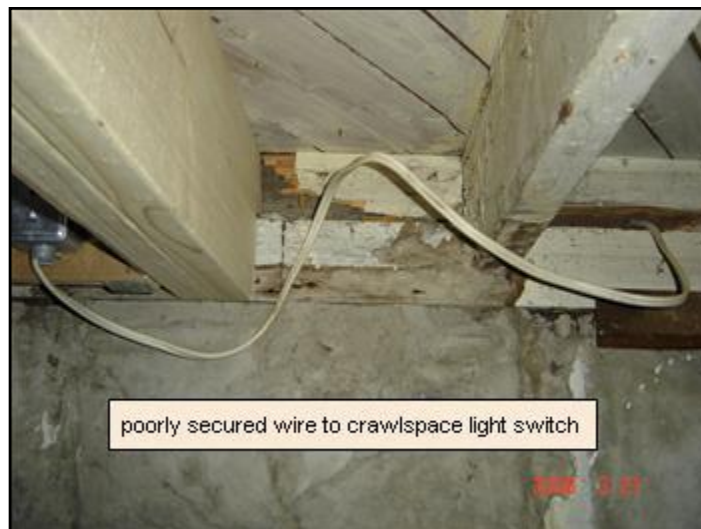
58.

Condition: • [Abandoned wire](#)

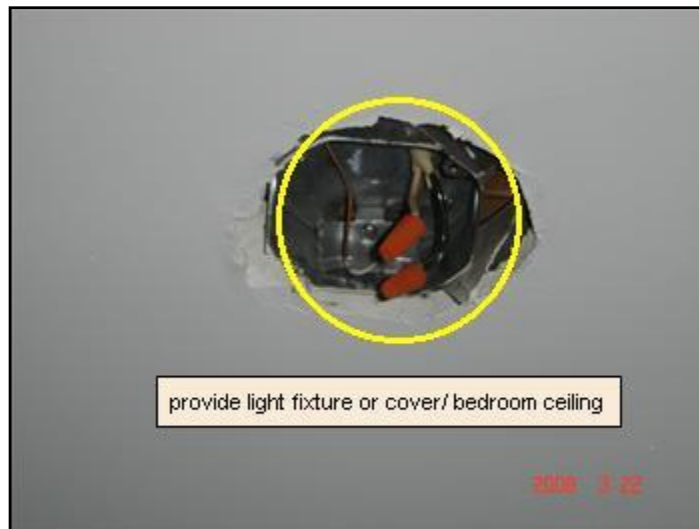
62.

DISTRIBUTION SYSTEM \ Switches

Condition: • [Inoperative](#)

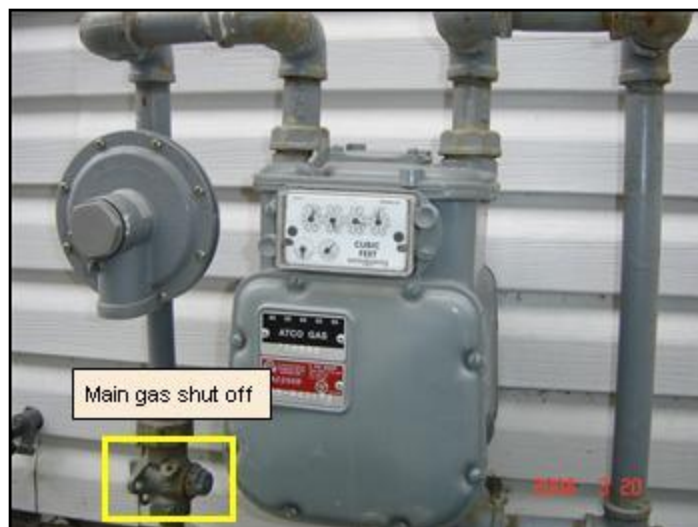
72.

Main gas shut off located at meter on west side of house

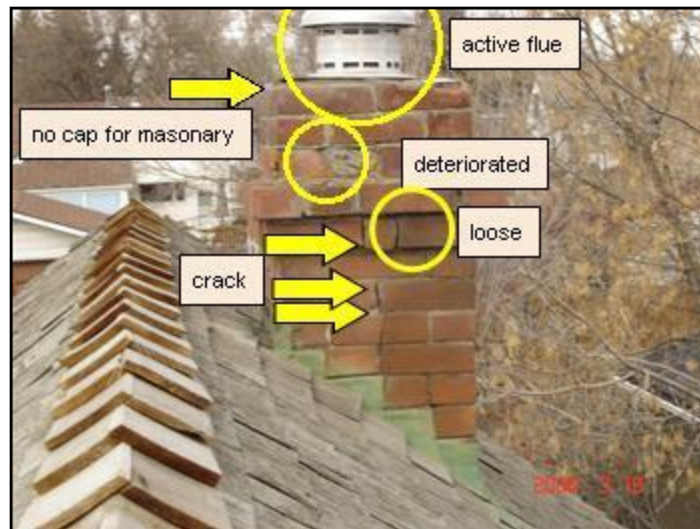
80.

Deteriorated clay chimney liner

Condition: • [Loose, missing or deteriorated mortar](#)

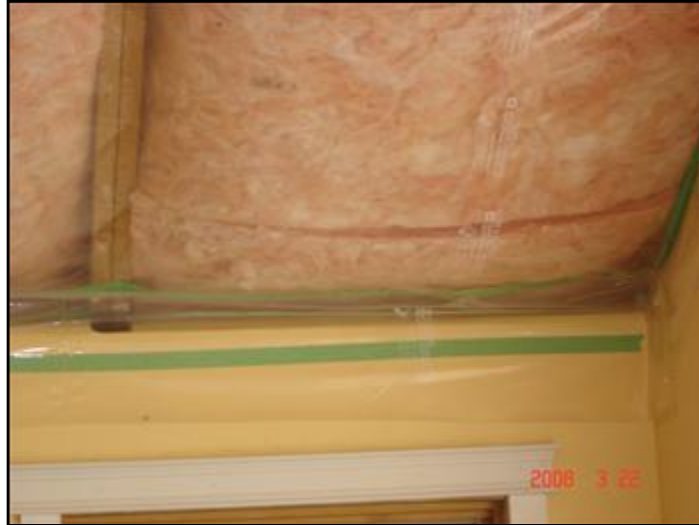
81.

Temporary installation of R-20 batts beneath skylight sections

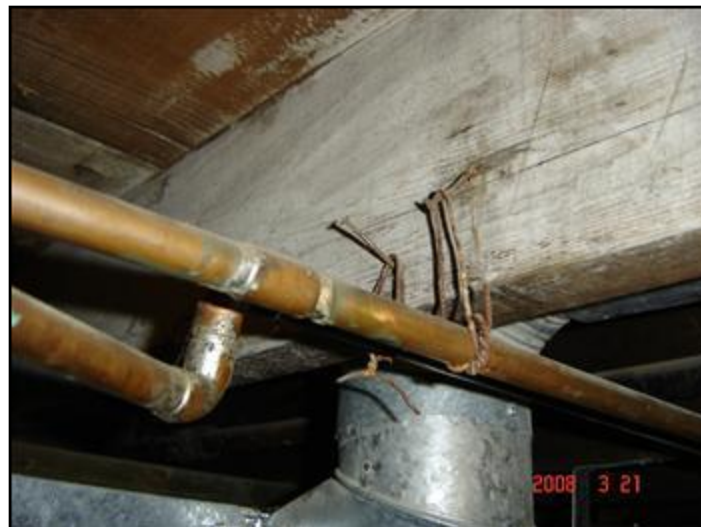
87.

Condition: • [Poor support](#)

some areas of poor support noted in crawlspace

Implication(s): Chance of water damage to contents, finishes and/or structure | Leakage

Task: improve

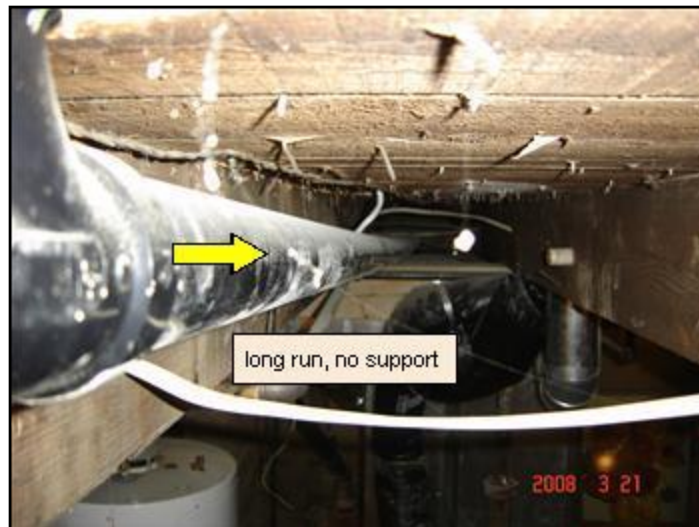
90.

WASTE PLUMBING \ Drain piping - installation

Condition: • [Poor support](#)

Implication(s): Chance of water damage to contents, finishes and/or structure | Sewage entering the building

Task: improve

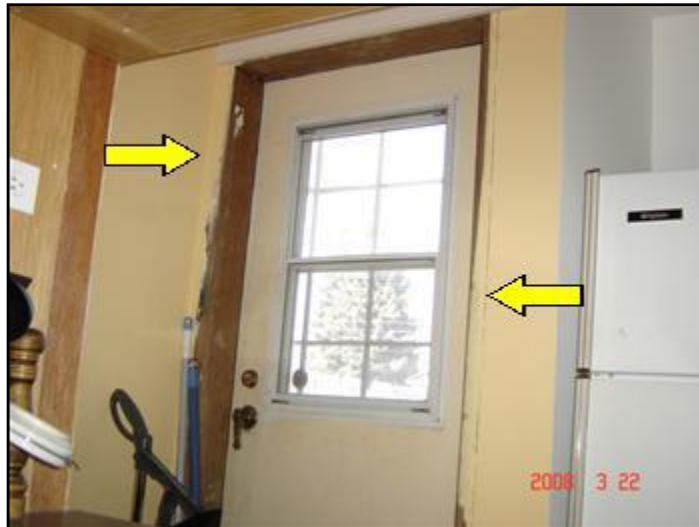
98.

Condition: • [Inoperable](#)

Interior side of keyed deadbolt inoperable, serious impediment for use as primary fire exit, thumb latch recommended.

Task: Replace

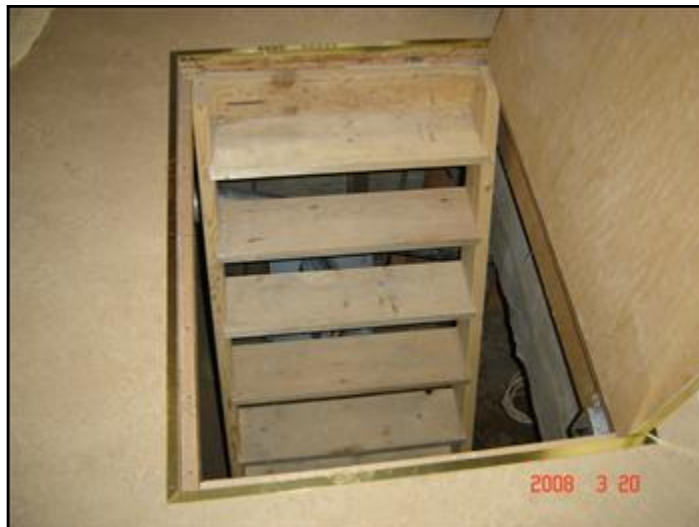
99.

STAIRS \ Treads

Condition: • [Rise or run not uniform](#)

Implication(s): Trip or fall hazard

Task: Monitor
