YOUR Inspection Report

2730 Ferol Ln
Lynn Haven, FL 32444

Wednesday, August 5, 2020

RE: Report No. 1010
2730 Ferol Ln
Lynn Haven, FL
32444

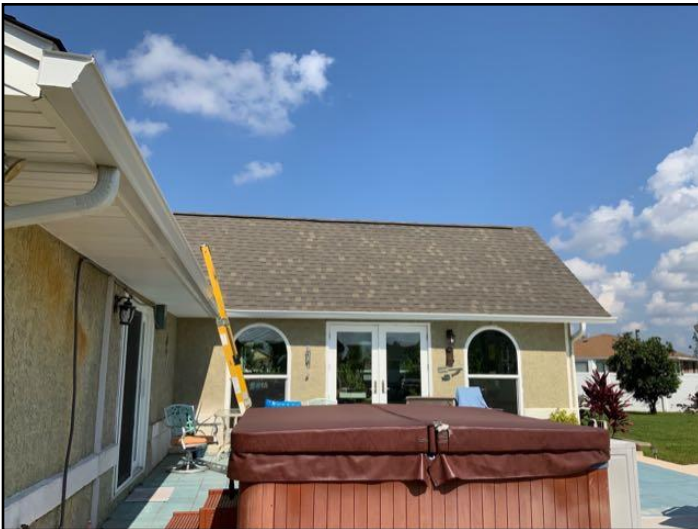
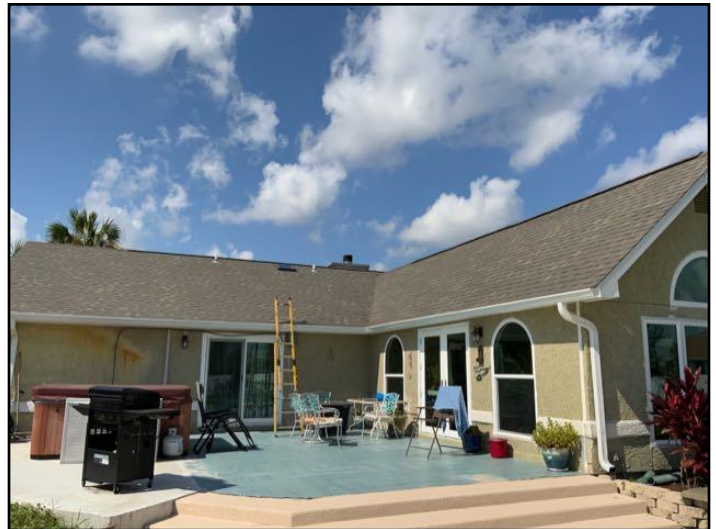
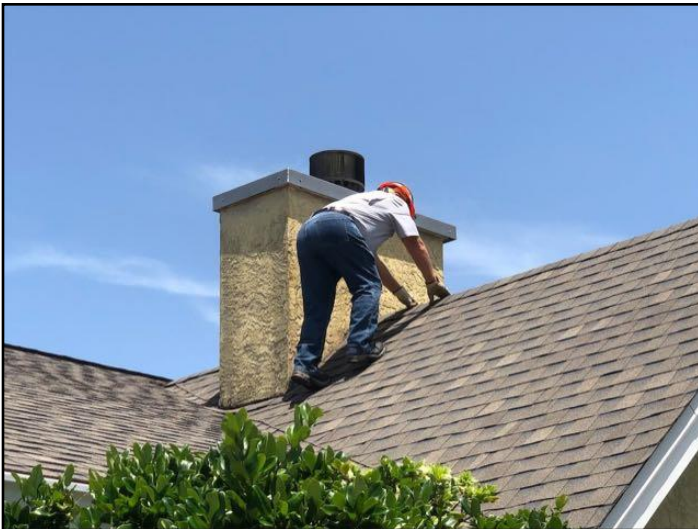
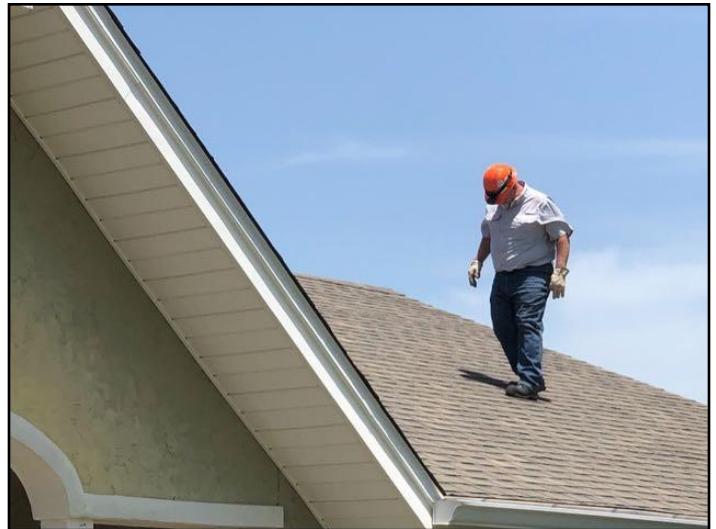
General: • Roof is just over one year old and is in condition appropriate to age.

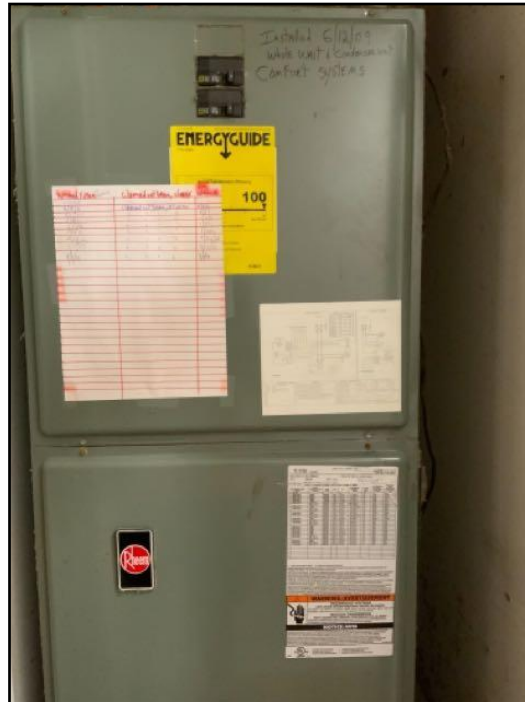
29. Electricity

Air handler is a 2009 approximately 11 years old average life of a air handler is 15 years

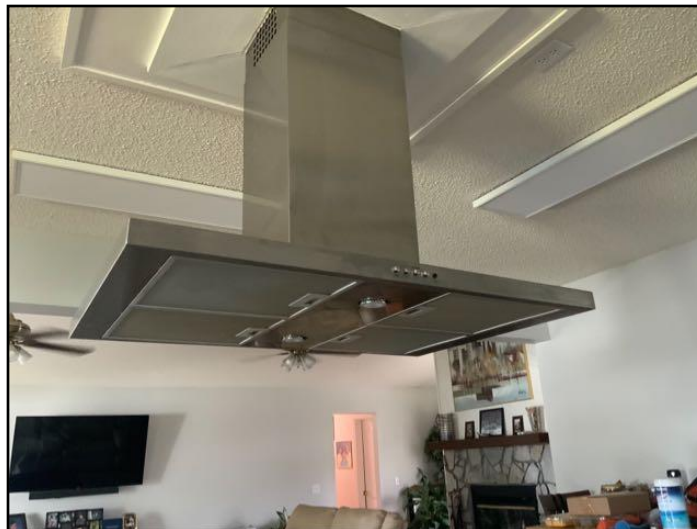
34. Direct vent

Kitchen exhaust vent directed through roof to exterior of home.

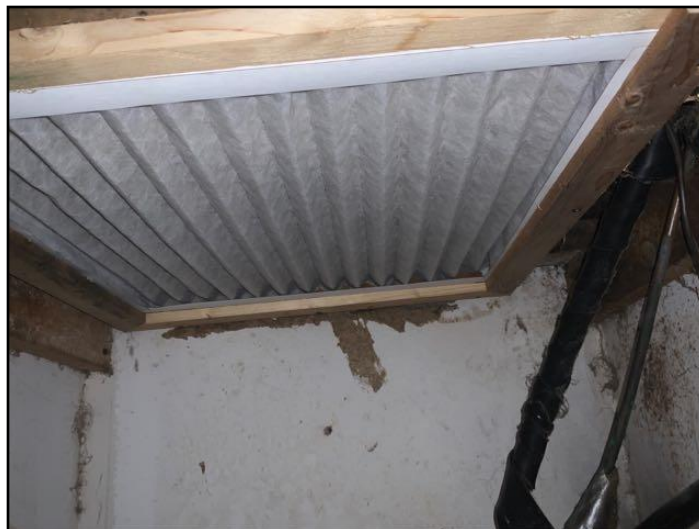
36. 12" x 20"

Air filter appears to be new.

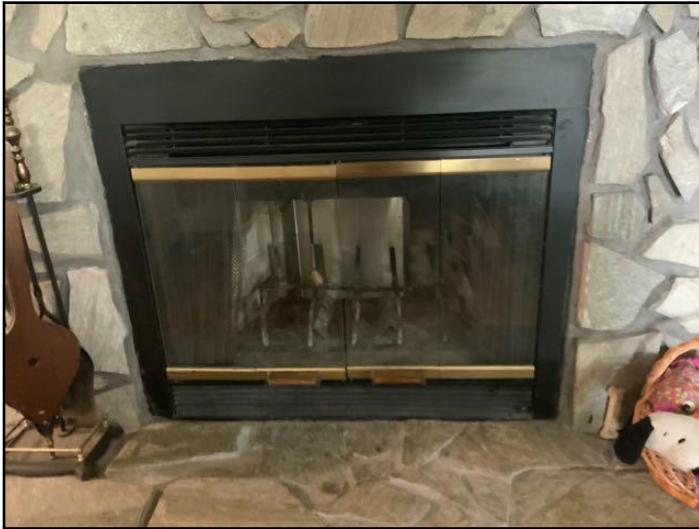
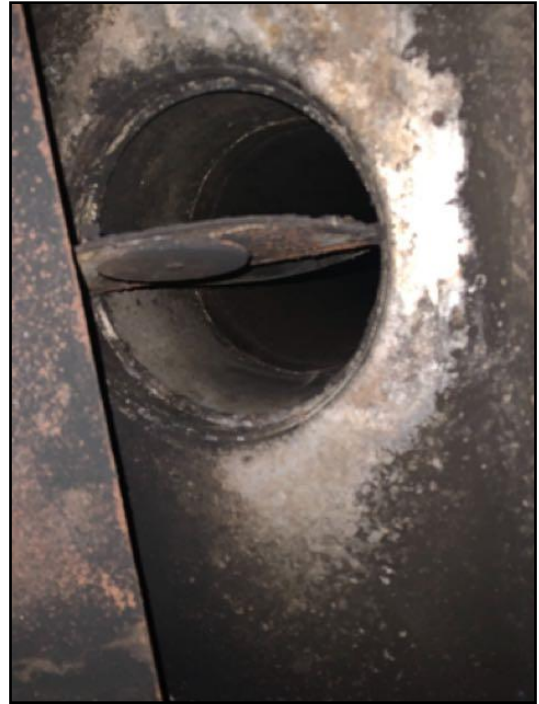
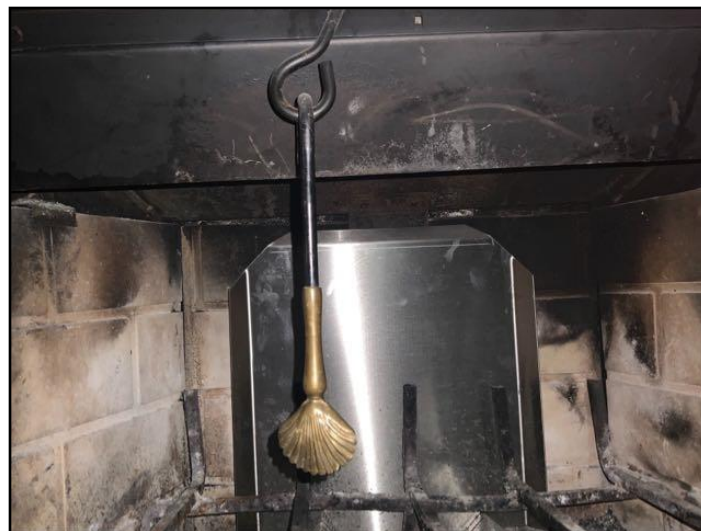
Hearth measurements meet requirements glass doors seal well, heat distribution fan works properly interior fire brick in appropriate shape for age, damper draft working correctly flu queen at time of inspection.

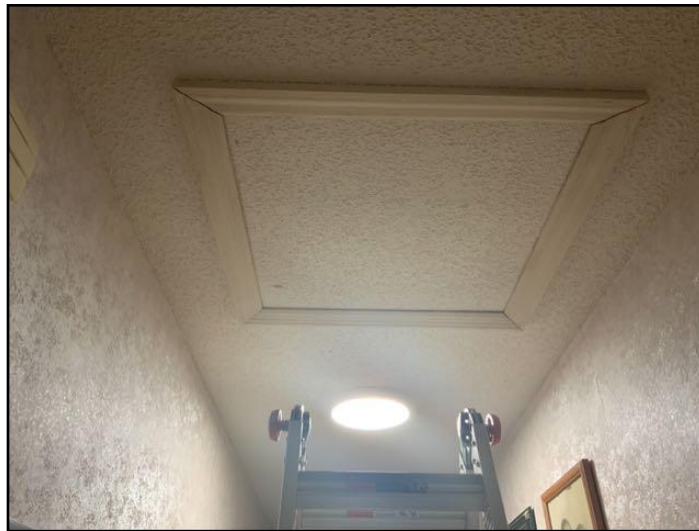
45. From access hatch

If ever any interior work is done it is suggested to change the attic access to the new dimensions of 30 x 22 1/2.

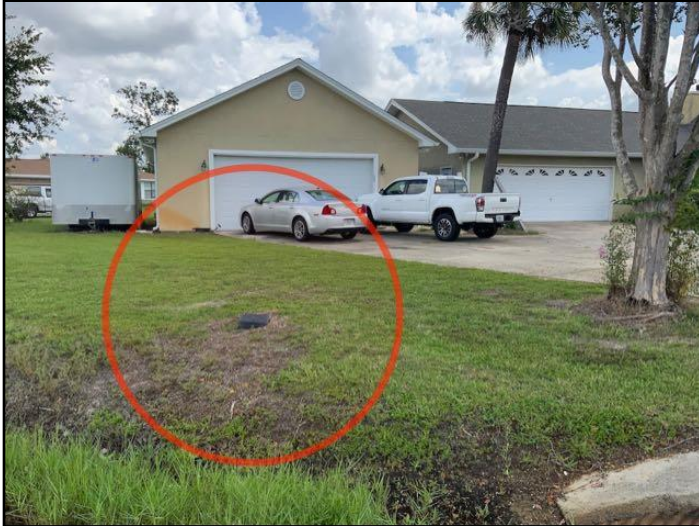
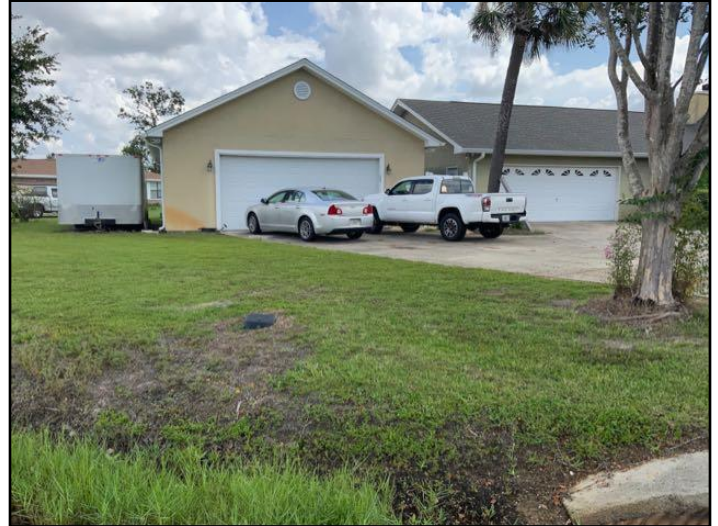
Main water shut off valve at the: • Main shut off valve located in front yard left side of the home close to drainage ditch.

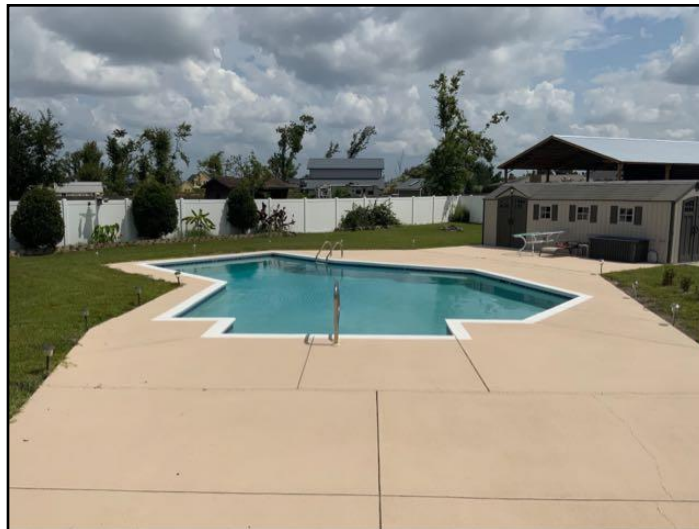
51. Pool

Pool not included in inspection

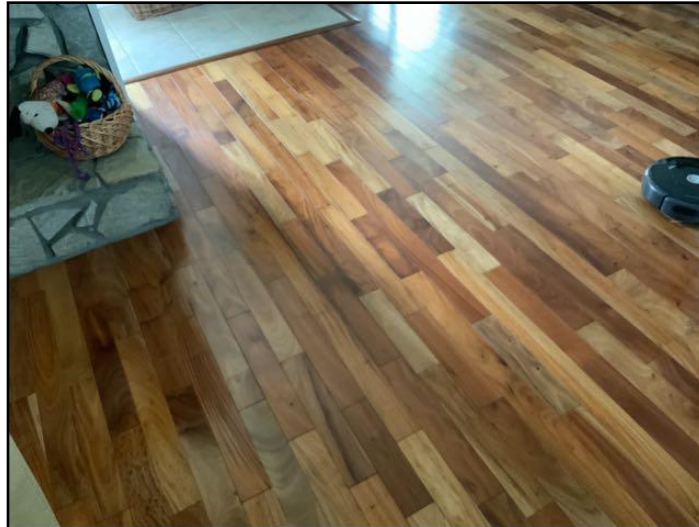
54. Hardwood

Hardwood has been glued to concrete and is causing buckling

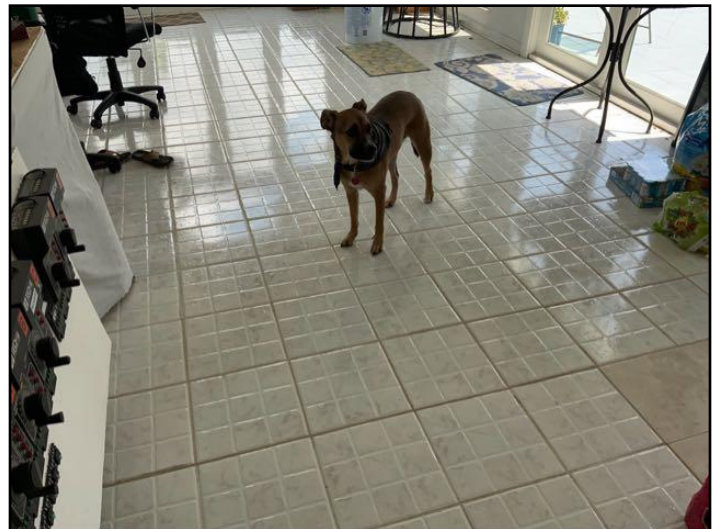
Tile is in two layers in kitchen and utility areas.

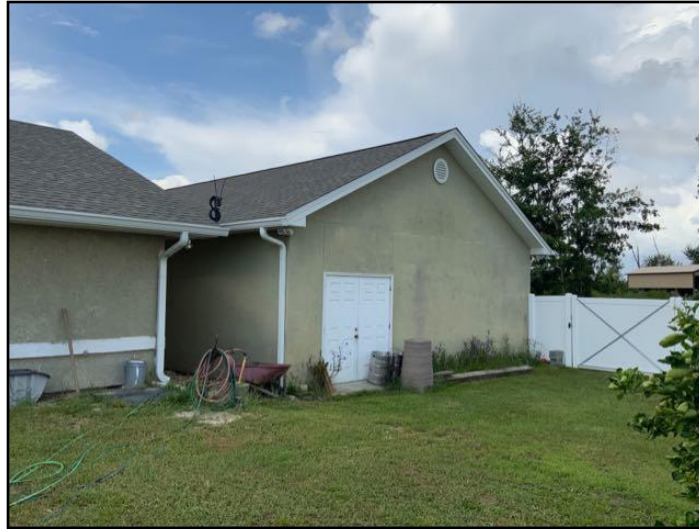
85. Detached garage

Garage, carport and outbuildings: • 30 x 40 pole barn
